EXARO Technologies Corporation

Subsurface Utility Report	
Client	ACPWA - Vincent SendayDiego
Project #	16-1127
City	Hayward
Date	9/18/2017

Pothole # 2A

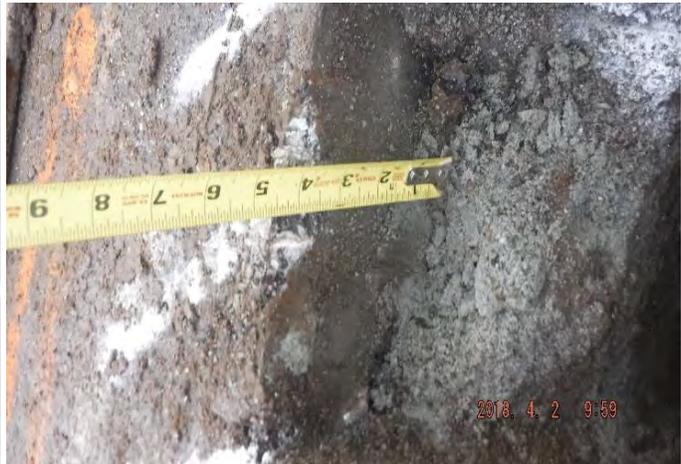
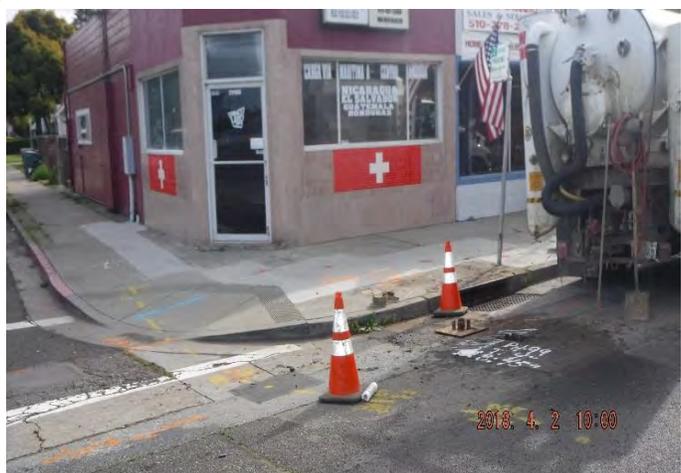
Street: 171st Ave & East 14th St

Cut Size: 1' x 1'		Location: 64" SW of Face of Curb. 50" NW of Storm Drain.
Asphalt: 4" Concrete: Top: 4" Depth: Bottom: 45" Utility: Joint trench Size: 0 Material: Slurry Soil: Hard dirt, rocks, sand		Notes:

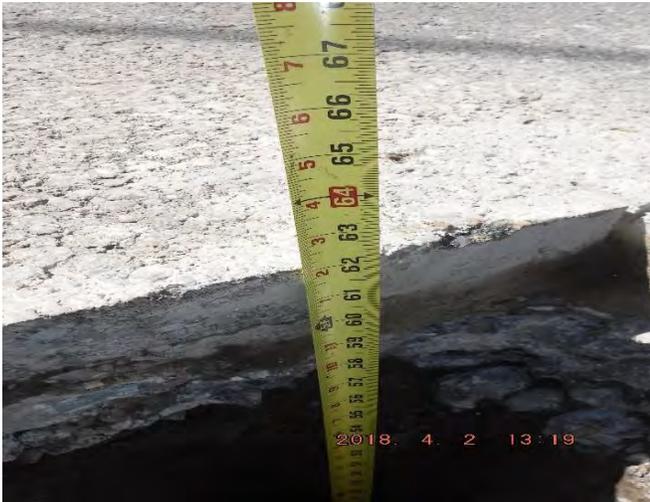
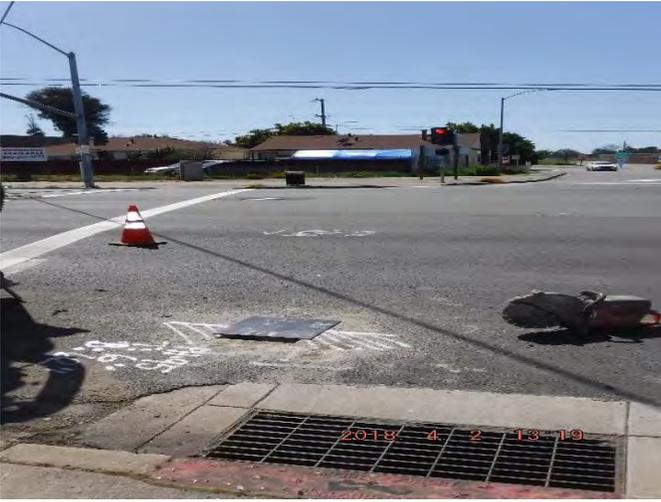
Street: 170th Ave & East 14th Street

Cut Size: 1' x 1'		Location: 72" SW Face of Curb, in-line with Street Light.
Asphalt: 5" Concrete: Top: 6" Depth: Bottom: 62" Utility: Joint trench Size: Material: Slurry Soil: Hard dirt, rocks, sand		Notes:

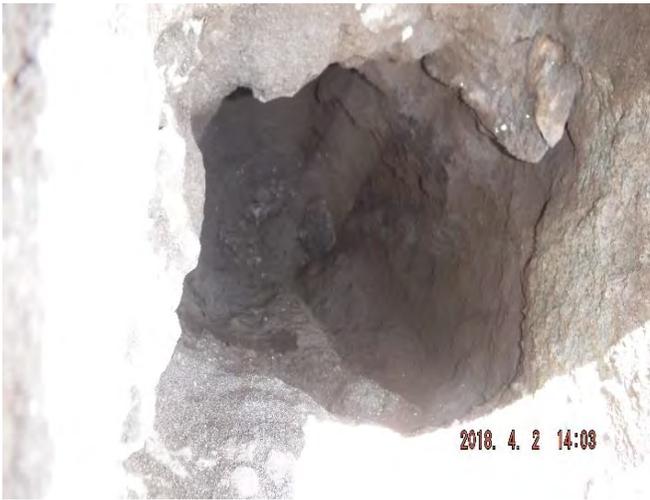
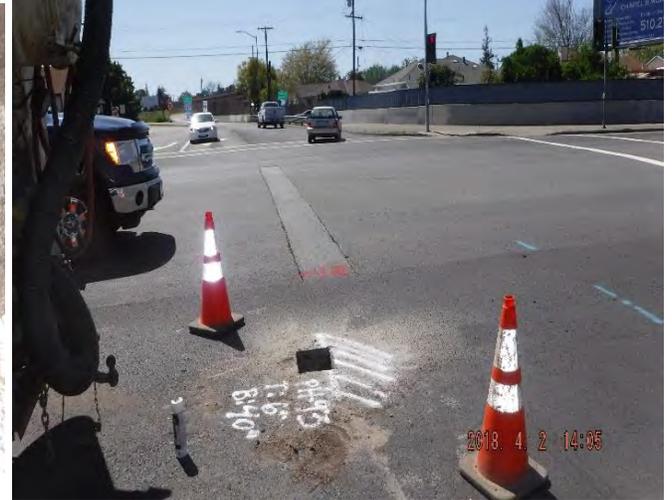
Street: 170th Ave & East 14th Street

<p>Cut Size: 1' x 1'</p>			<p>Location: 170" Southwest of Fire Hydrant. 200" Northwest of Fire Hydrant.</p>
<p>Asphalt: 5"</p> <p>Concrete:</p> <p>Top: 6"</p> <p>Depth: Bottom: 40"</p> <p>Utility: Joint trench</p> <p>Size:</p> <p>Material: Slurry</p> <p>Soil: Hard dirt, rocks, sand</p>	<p>Notes:</p>

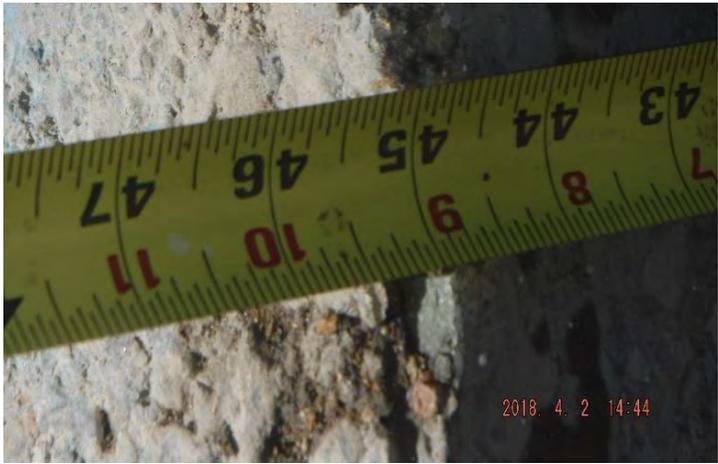
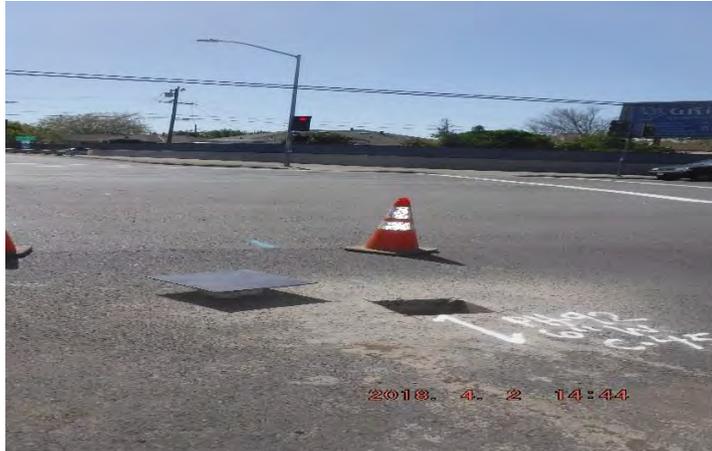
Asphalt:	5"	Concrete:		Depth:	45"	Utility:	Water	Size:	6"	Material:	Yellow pipe	Soil:	Hard dirt, rocks, sand	<p>Location: 174" Southwest of crosswalk. 96" SE of Pacific Bell Manhole.</p> <p>Notes:</p>
Asphalt:	5"														
Concrete:															
Depth:	45"														
Utility:	Water														
Size:	6"														
Material:	Yellow pipe														
Soil:	Hard dirt, rocks, sand

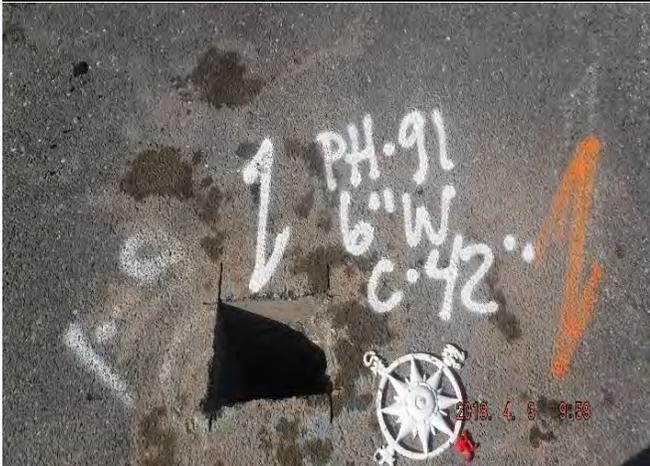
Street: 170th Ave & East 14th St

<p>Cut Size: 1' x 1'</p> <p>Asphalt: 5"</p> <p>Concrete:</p> <p>Depth: 42"</p> <p>Utility: Water</p> <p>Size: 6"</p> <p>Material: Yellow pipe</p> <p>Soil: Hard dirt, rocks, sand</p>	<p>Location: 128" Northeast of water valve, in-line with valve.</p> <p>Notes:</p>
---	---

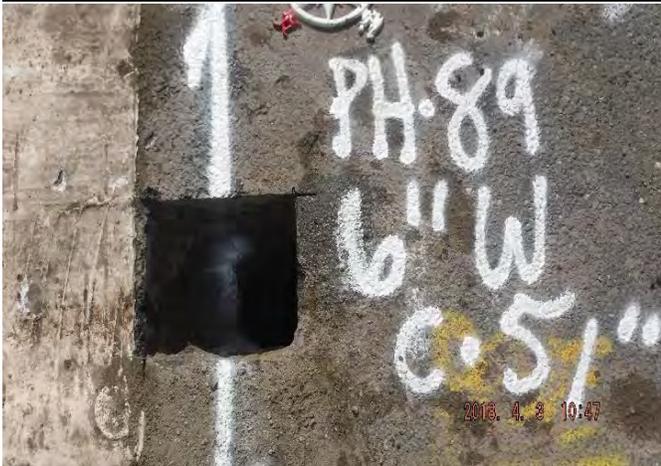
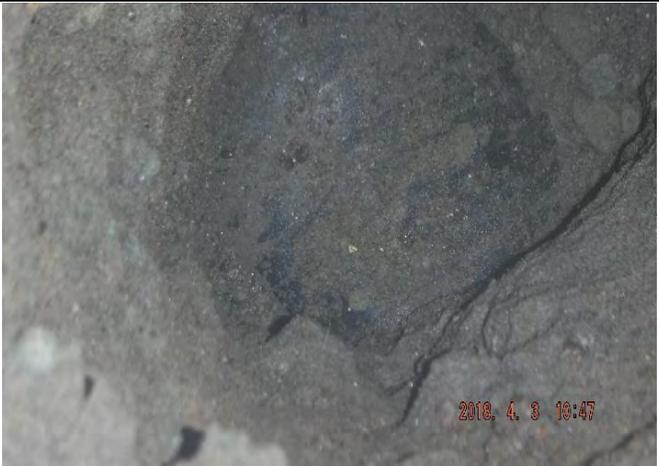
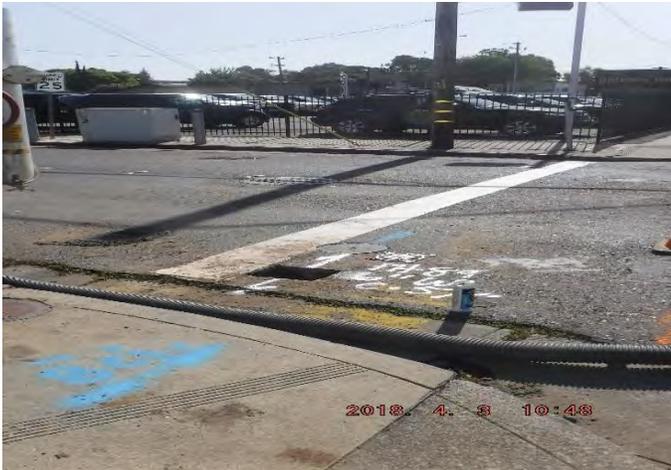
Street: 170th Ave & East 14th St

Cut Size: 1' x 1'		Location: 20" Northwest of water valve, in-line with valve.
Asphalt: 5" Concrete: Depth: 51" Utility: Water Size: 6" Material: Black pipe Soil: Hard dirt, rocks, sand		Notes:

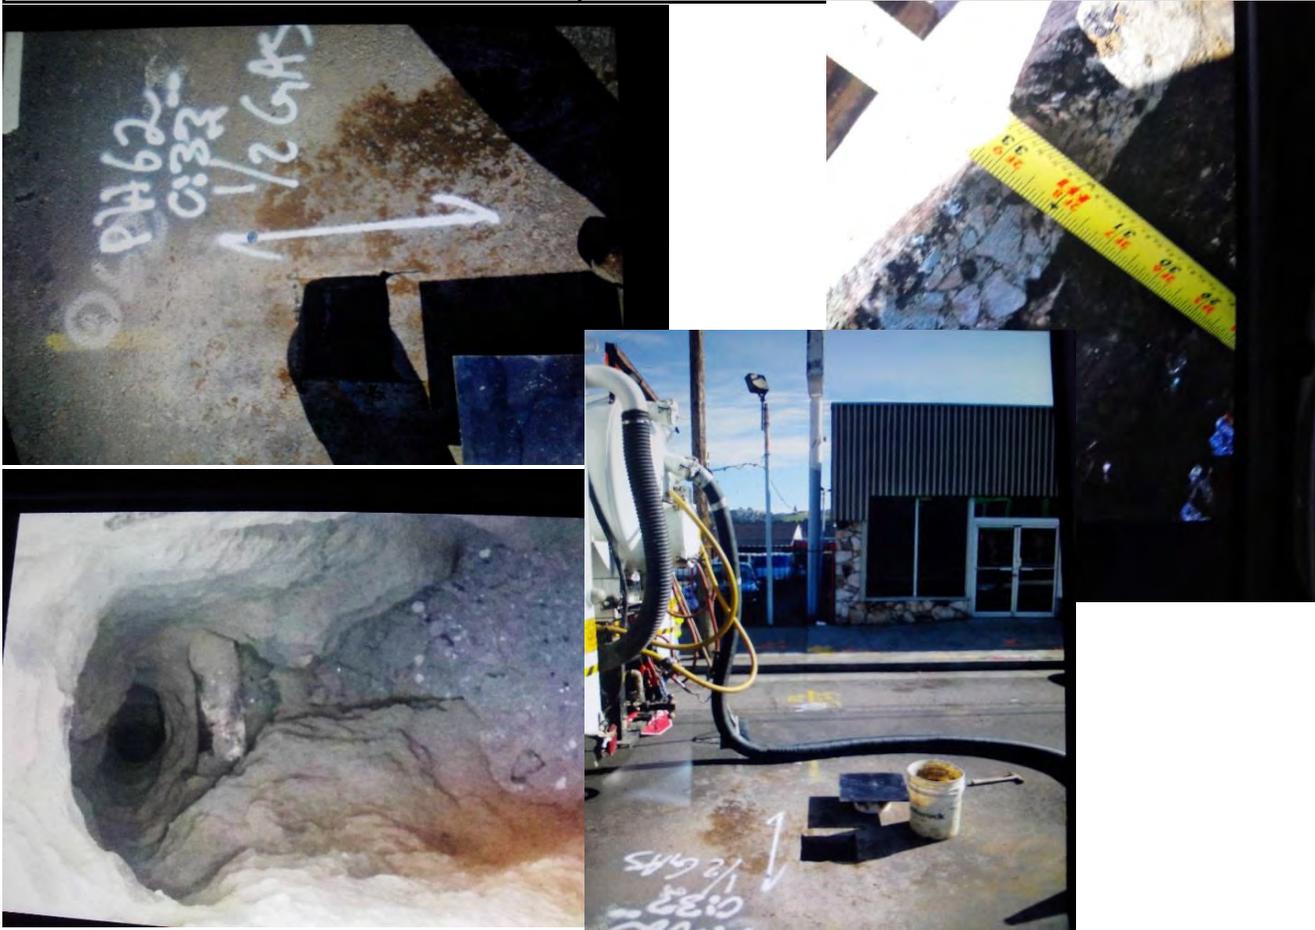
Asphalt:	10"	Concrete:	2"	Depth:	33"	Utility:	Gas	Size:	.5"	Material:	Plastic	Soil:	Hard rocks, mud	<p>Location: 190" SW of edge of road. 60" SE of power pole.</p> <p>Notes:</p>
Asphalt:	10"														
Concrete:	2"														
Depth:	33"														
Utility:	Gas														
Size:	.5"														
Material:	Plastic														
Soil:	Hard rocks, mud

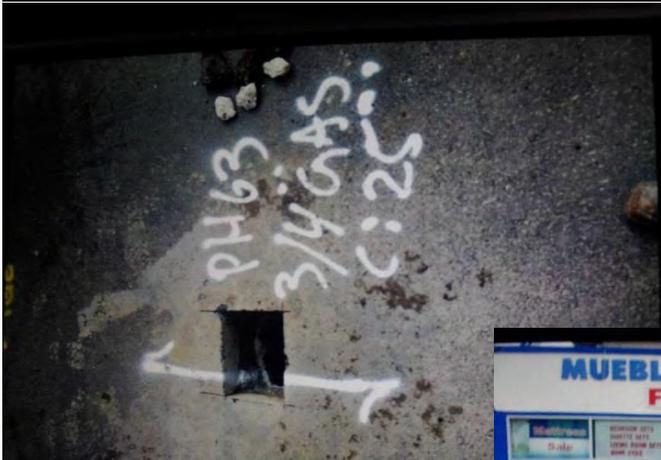
Asphalt:	10"	Concrete:	2"	Depth:	25"	Utility:	Gas	Size:	.75"	Material:	Plastic	Soil:	Hard rocks, mud	<p>Location: 162" SW of edge of road. 31' NW of power pole.</p> <p>Notes:</p>
Asphalt:	10"														
Concrete:	2"														
Depth:	25"														
Utility:	Gas														
Size:	.75"														
Material:	Plastic														
Soil:	Hard rocks, mud

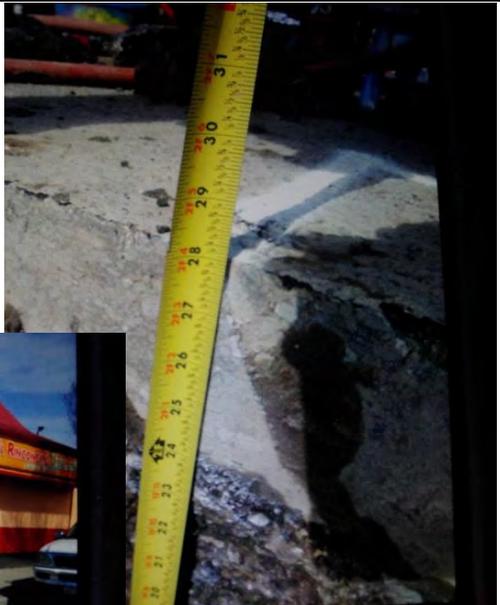
Street: East 14th Street & 165th Street

Cut Size: 1' x 1'		Location: 40" West of white fog line. 99" E of traffic light.
Asphalt: 10" Concrete: Depth: 28" Utility: AT&T / JT Size: 3" Material: PVC Soil: Hard rocks, mud		Notes:

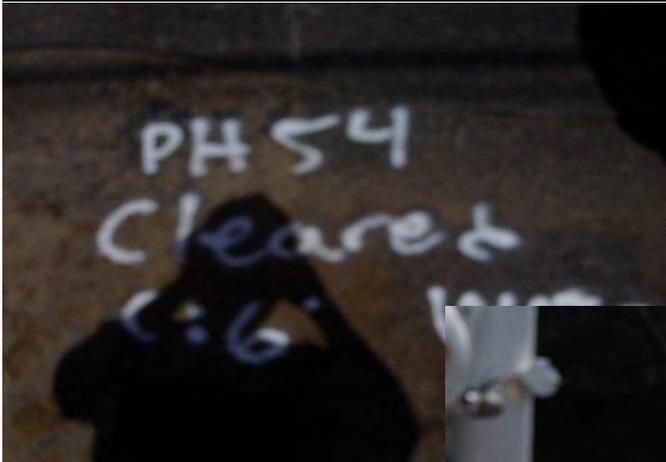
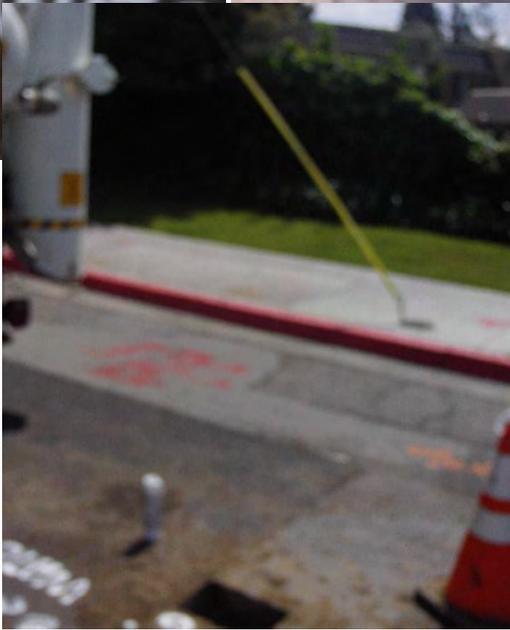
Street: just NE of 165th - SW side of East 14th Street

<p>Cut Size: 1' x 1'</p> <p>Asphalt: 2"</p> <p>Concrete: 2"</p> <p>Depth: [Diagram shows depth]</p> <p>Utility: Water</p> <p>Size: 8"</p> <p>Material: bestos Cement</p> <p>Soil: Hard rocks, mud</p>	<p>Location: Dryhole, cleared 6'. Pothole is 152" NE of curb. 68" NW of PG&E box.</p> <p>Notes:</p>
---	---

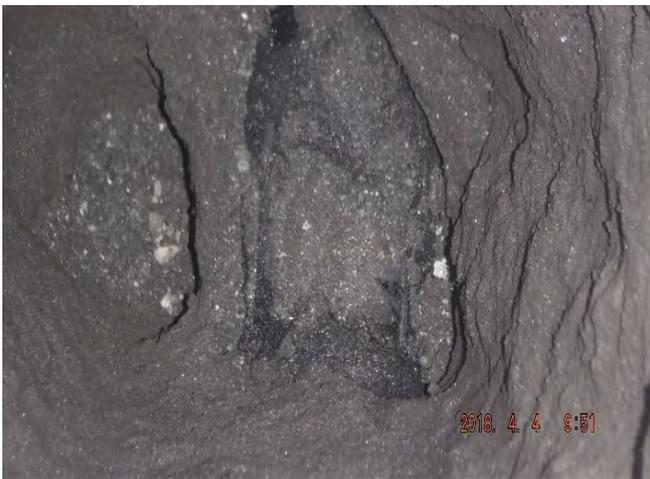
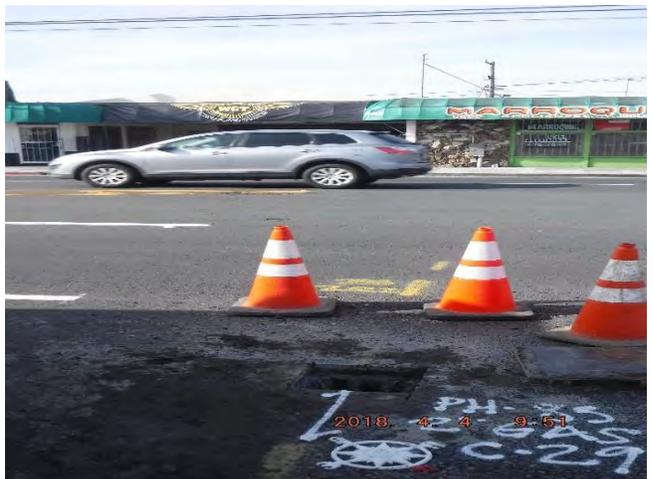
Street: 168th Ave & East 14th Street

<p>Cut Size: 1' x 1'</p> <p>Asphalt: 5"</p> <p>Concrete:</p> <p>Depth: 29"</p> <p>Utility: Gas</p> <p>Size: 2"</p> <p>Material: Steel</p> <p>Soil: Hard dirt, rocks, sand</p>	<p>Location: 285" SW of gas valve, in-line with valve.</p> <p>Notes:</p>
---	--

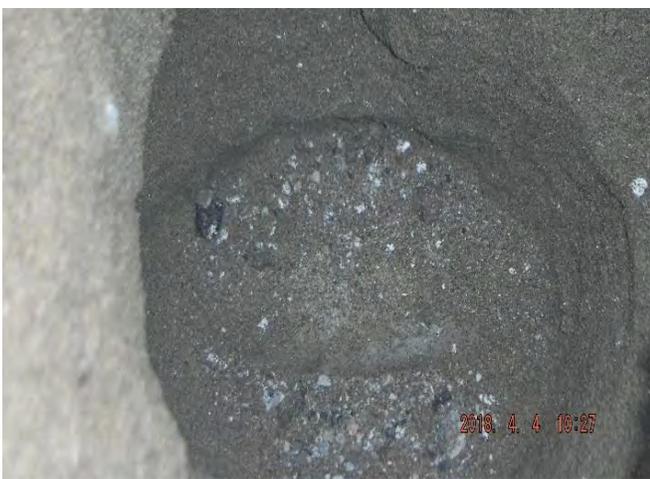
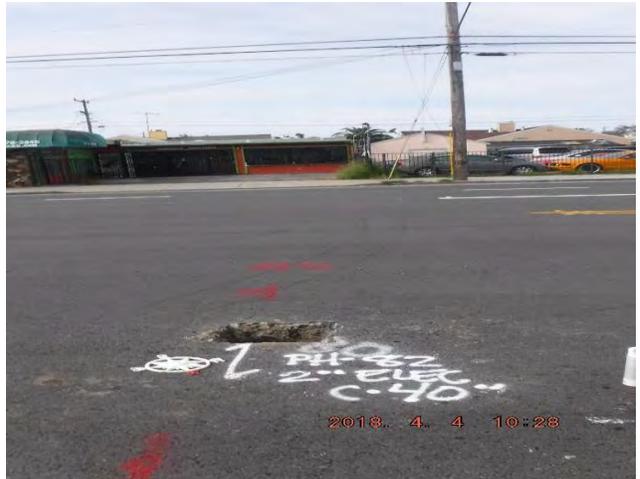
Street: 168th Ave & East 14th Street

<p>Cut Size: 1' x 1'</p> <p>Asphalt: 5"</p> <p>Concrete:</p> <p>Depth: 40"</p> <p>Utility: Electrical</p> <p>Size: 2"</p> <p>Material: PVC</p> <p>Soil: Hard dirt, rocks, sand</p>	<p>Location: 214" SW of crosswalk. 264" NW of manhole.</p> <p>Notes:</p>
--	--

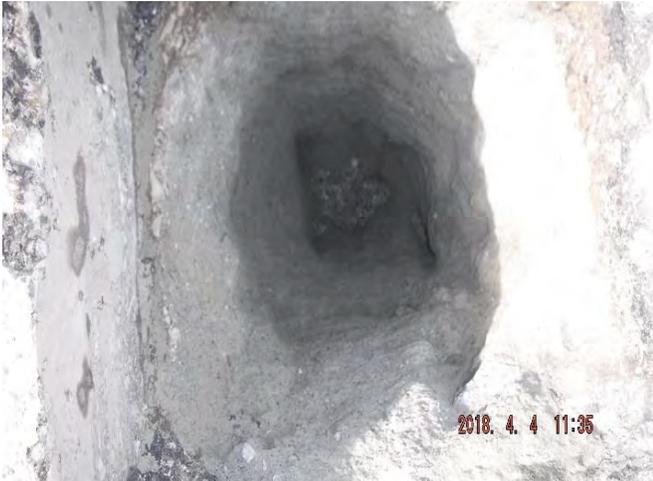
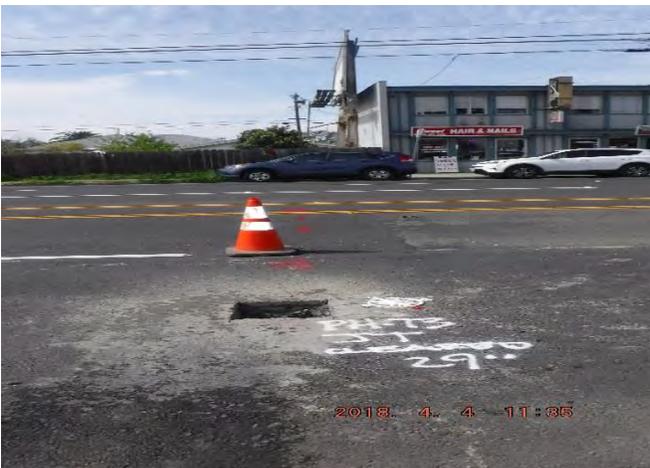
Street: just SE of 16754 East 14th Street

Cut Size: 1' x 1'		Location: Hit slurry at 29".169" Southeast of face of curb. 284" Northeast of electrical box.
Asphalt: 4" Concrete: Depth: Hit Slurry Utility: Joint trench Size: Material: Slurry Soil: Hard dirt, rocks, sand		Notes:

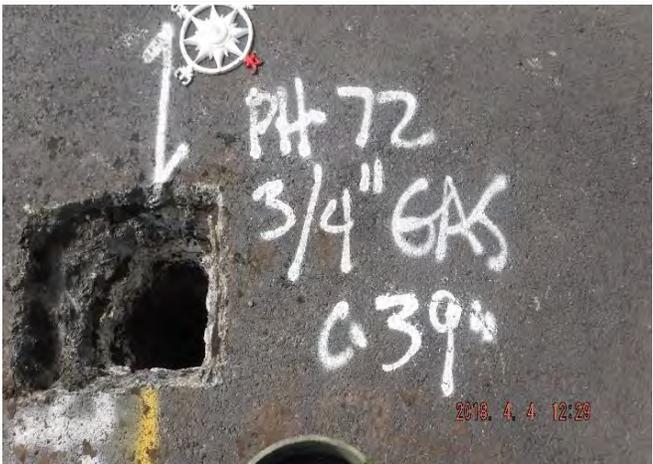
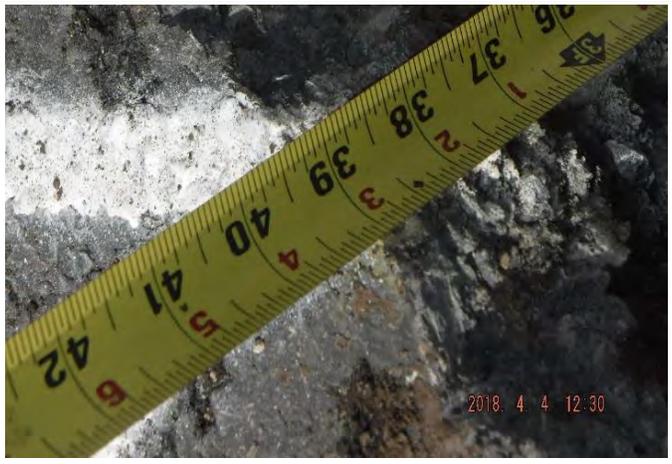
Street: 16754 East 14th Street

Cut Size: 1' x 1'		Location: 132" SW of face of curb. 134" SE of water valve.
Asphalt: 4" Concrete: 8" Depth: 39" Utility: Gas Size: .75" Material: Steel Soil: Hard dirt, rocks, sand		Notes:

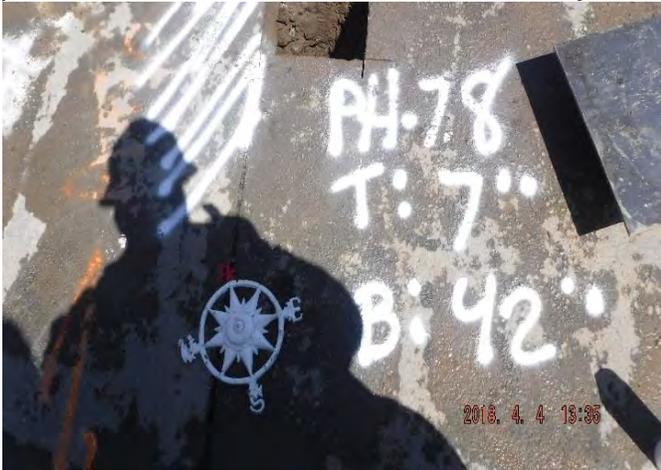
Street: 167th Ave & East 14th Street

<p>Cut Size: 1' x 1'</p> <p>Asphalt: 4"</p> <p>Concrete:</p> <p>Top: 7"</p> <p>Depth: Bottom 42"</p> <p>Utility: Joint trench</p> <p>Size:</p> <p>Material: Slurry</p> <p>Soil: Hard dirt, rocks, sand</p>	<p>Location: 64" Northeast of AT&T box, in line with box.</p> <p>Notes:</p>
--	---

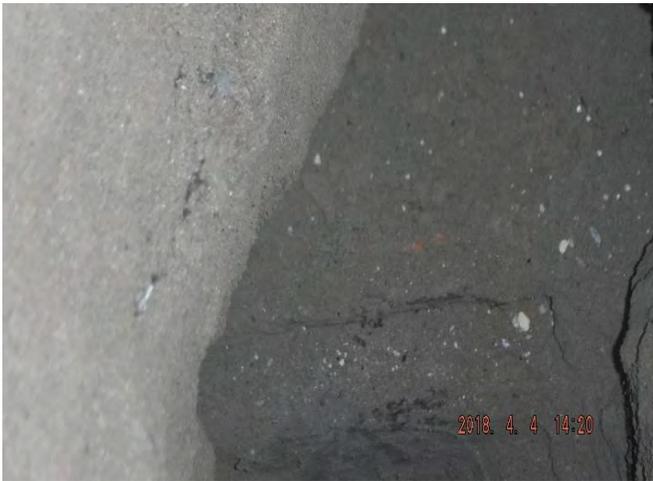
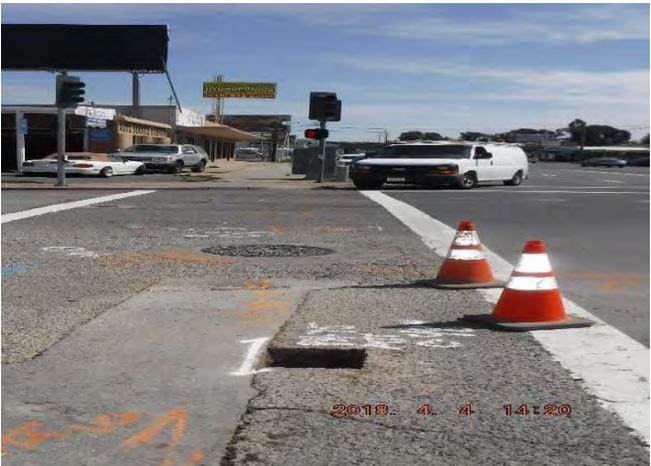
Street: 167th Ave & East 14th Street

Cut Size: 1' x 1'		Location: 140" Southeast of sanitary sewer manhole, in-line with manhole.
Asphalt: 4" Concrete: Depth: 48" Utility: AT&T Size: Material: Steel Case Soil: Hard dirt, rocks, sand		Notes:

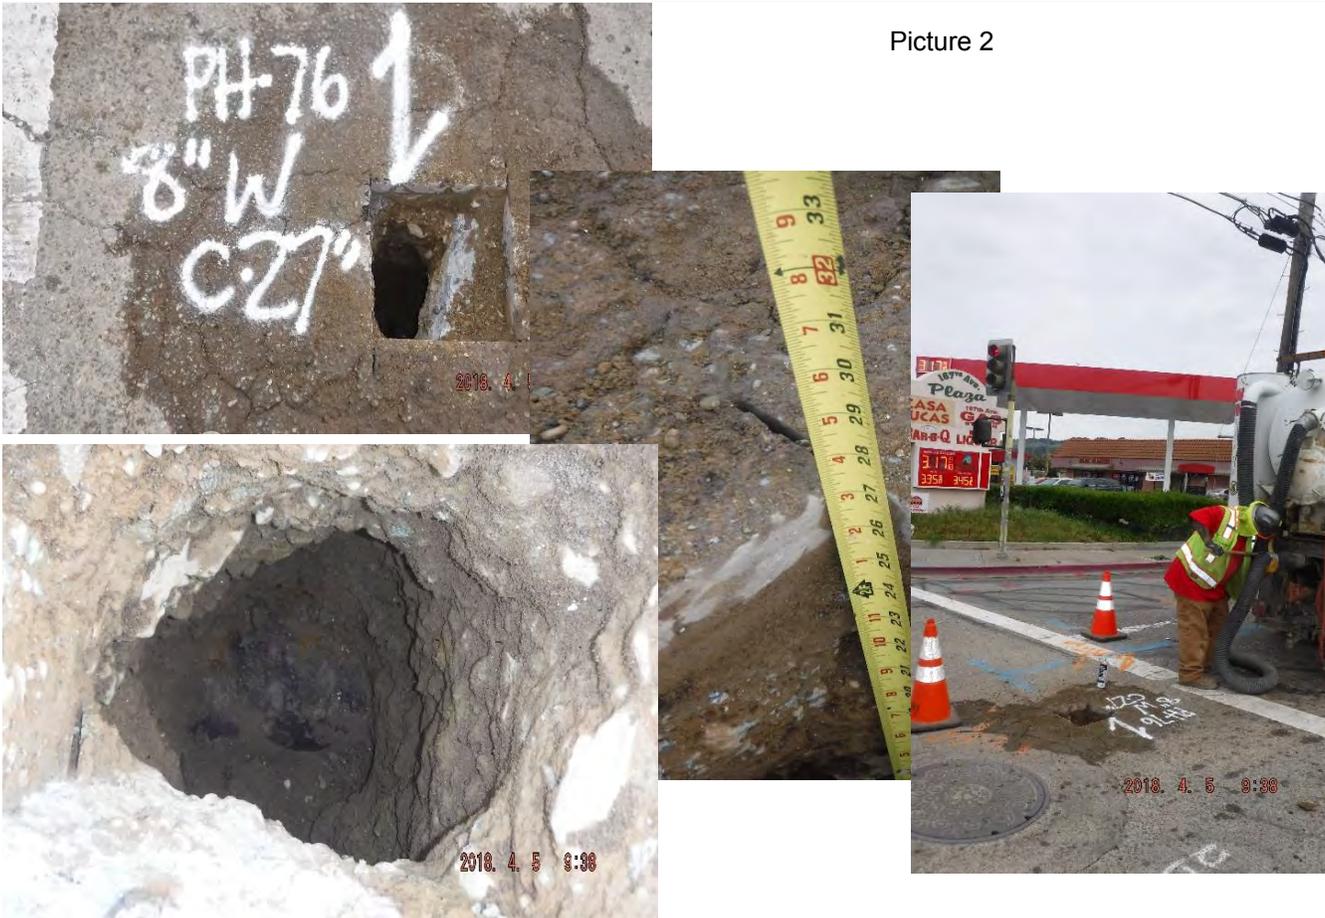
Cut Size: 1' x 1'		Location: 38" NE of crosswalk. 24" SW of crosswalk. Next to MH in the center of crosswalk.
Asphalt: 4" Concrete: Depth: 27" Utility: Water Size: 8" Material: Steel Soil: Hard dirt, rocks, sand		Notes:

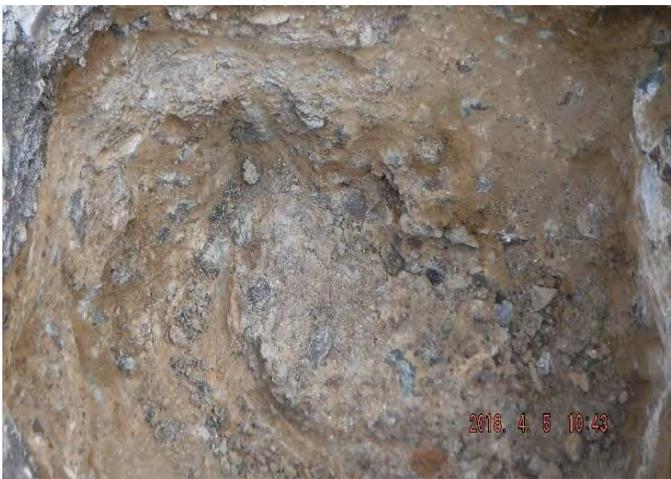
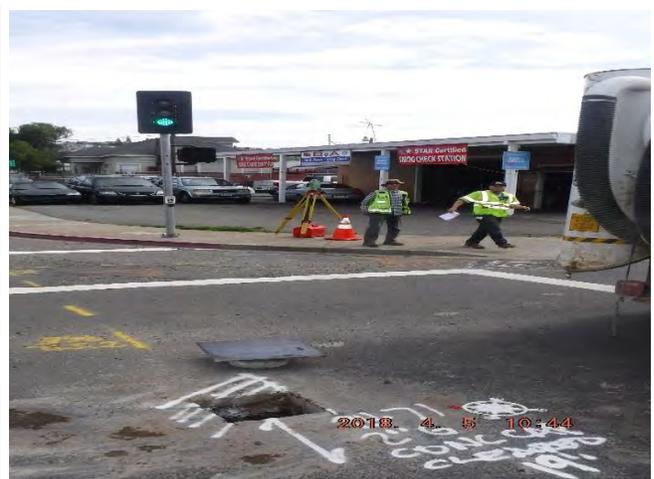
<p>Location: Hit concrete cap at 19" (See Pic). ED location 124" SW of crosswalk. 130" NW of crosswalk.</p> <p>Notes:</p>
---	--	---

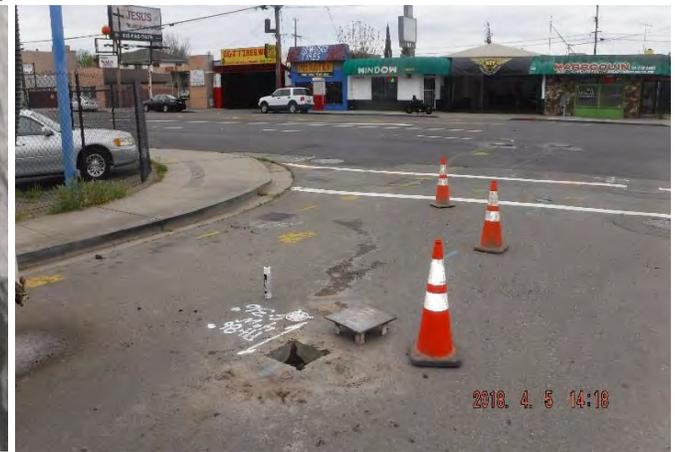
Street: 168th Ave & East 14th Street

<p>Cut Size: 1' x 1'</p> <p>Asphalt: 5"</p> <p>Concrete:</p> <p>Depth: 36"</p> <p>Utility: Water</p> <p>Size: 4"</p> <p>Material: Steel</p> <p>Soil: Hard dirt, rocks, sand</p>	<p>Location: 157" NW of face of curb. 251" NE of crosswalk.</p> <p>Notes:</p>
---	---

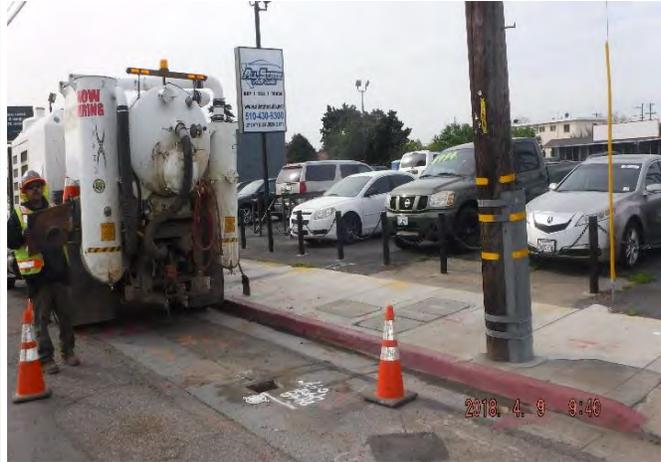
Street: 16611 East 14th Street

Cut Size: 1' x 1'		Location: 65" Northeast of face of curb. 64" SE of electrical pole.
Asphalt: 5" Concrete: Depth: 44" Utility: AT&T Size: 4" Material: PVC Soil: Hard dirt, slurry		Notes:

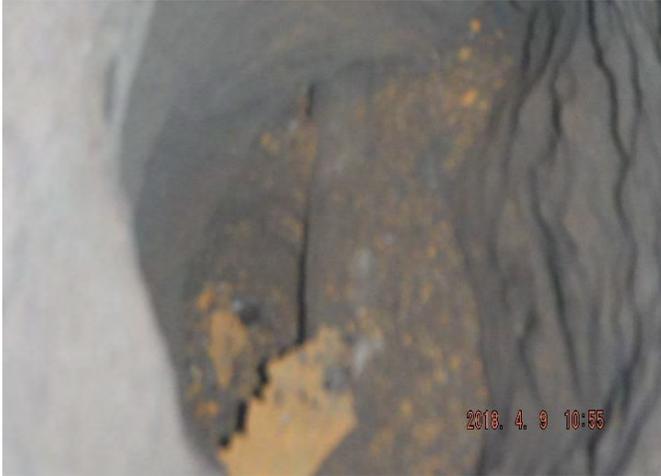
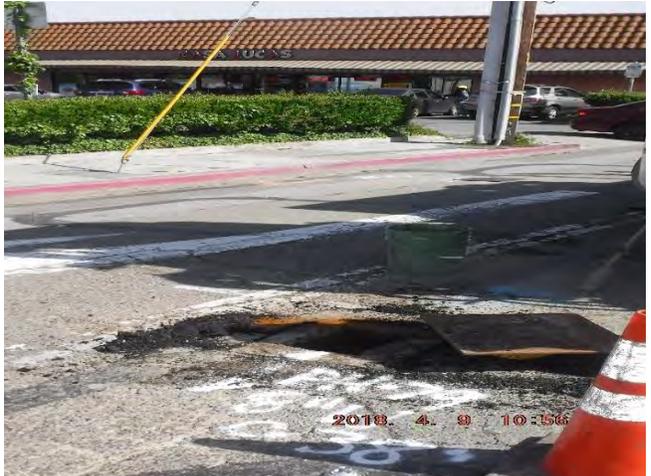
Street: 167th Ave. & East 14th Street

Cut Size: 1' x 1'		Location: 216" NE of Water valve, in-line with valve.
Asphalt: 5" Concrete: Depth: 38" Utility: Water Size: 8" Material: Steel Soil: Hard dirt, slurry		Notes:

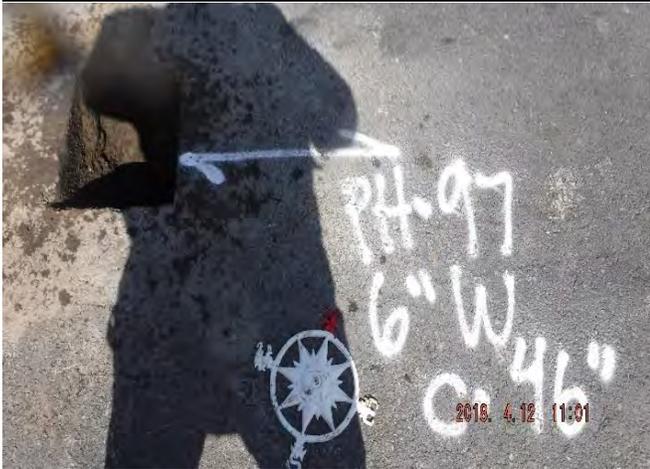
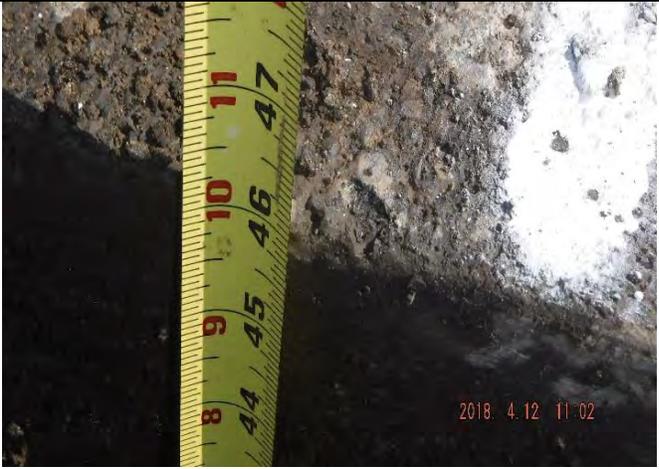
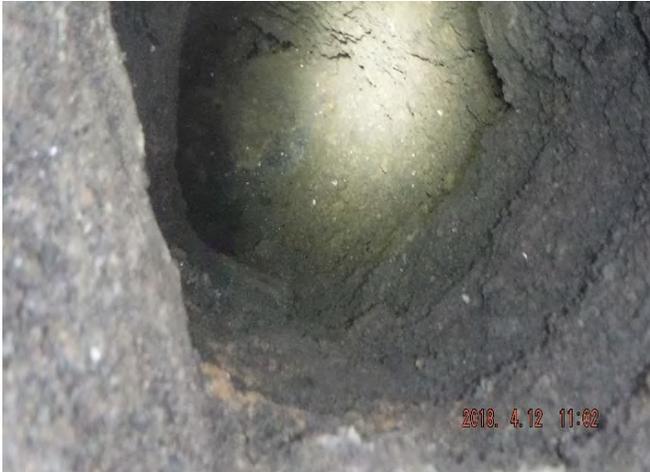
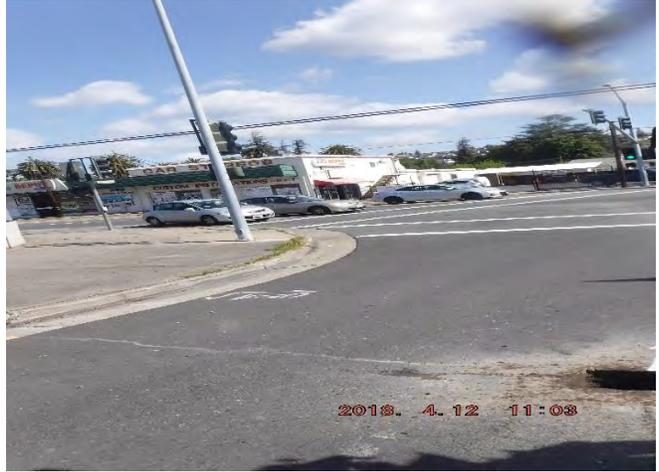
Street: 170th Ave & East 14th Street (238 Entrance)

<p>Cut Size: 1' x 1'</p> <p>Asphalt: 5"</p> <p>Concrete:</p> <p>Depth: 46"</p> <p>Utility: Water</p> <p>Size: 6"</p> <p>Material: Steel</p> <p>Soil: Hard dirt, slurry</p>	<p>Location: 149" SE of face of curb. 371" SW of crosswalk.</p> <p>Notes:</p>
--	---

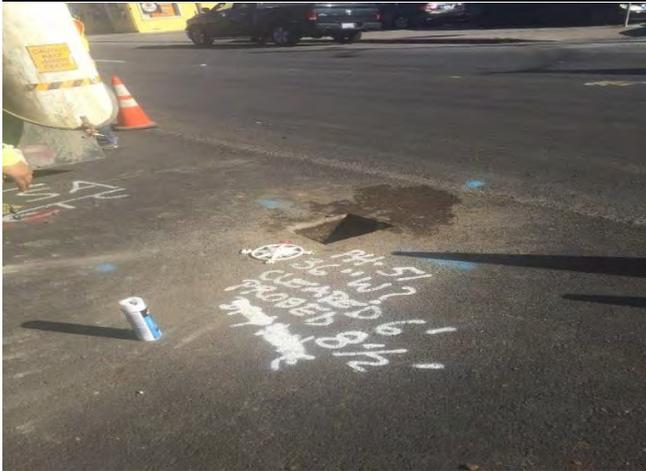
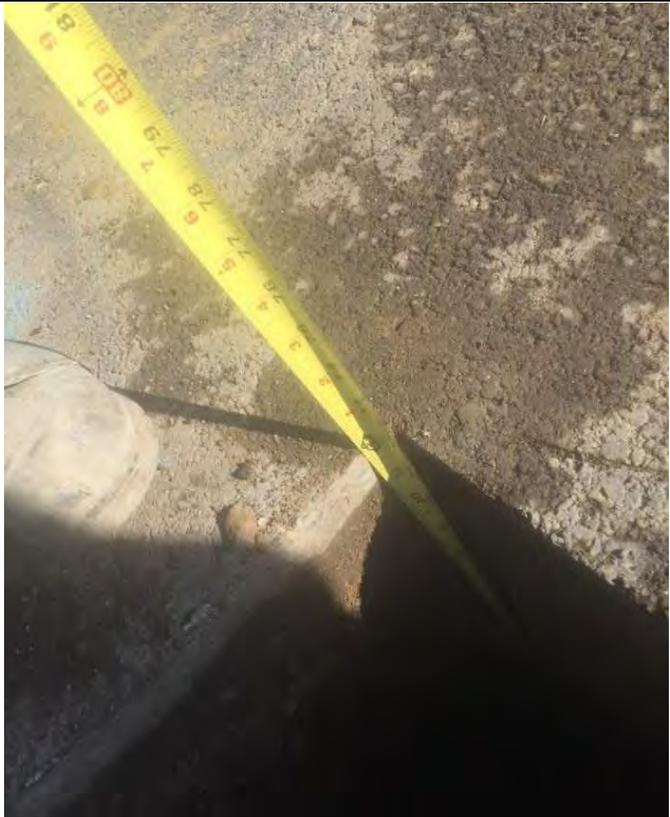
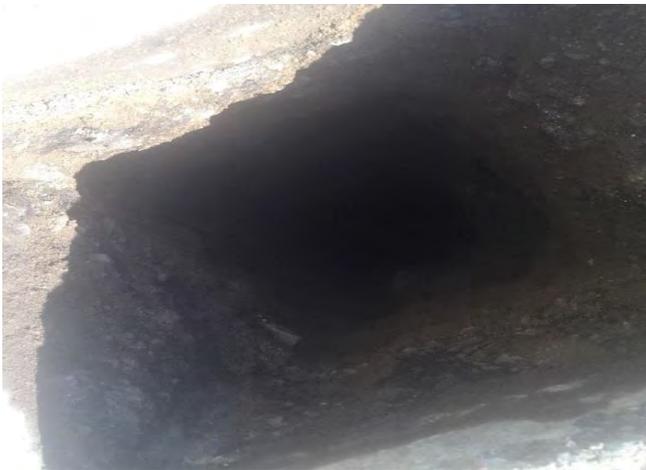
Street: 16446 East 14th Street

<p>Cut Size: 1' x 1'</p> <p>Asphalt: 5"</p> <p>Concrete:</p> <p>Depth:</p> <p>Utility: Water</p> <p>Size: 36"</p> <p>Material: Unknown</p> <p>Soil: Hard dirt, clay</p>		<p>Location: Cleared 6', probed down to 8.5'. Pothole is 32" Northeast of Double yellow lines. 69" NW of Electric post.</p> <p>Notes:</p>
---	--	---

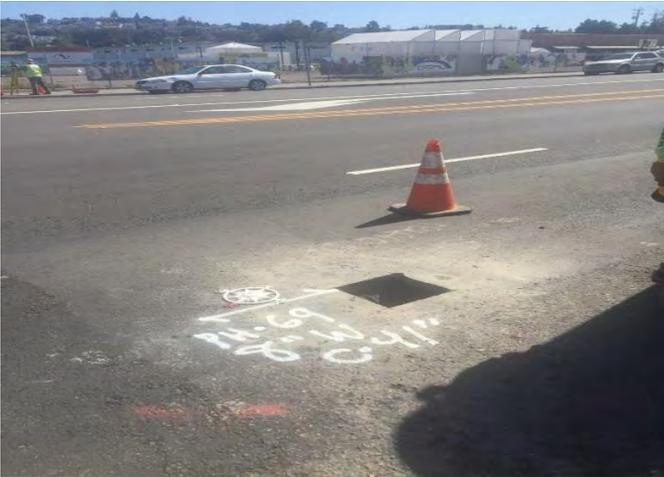
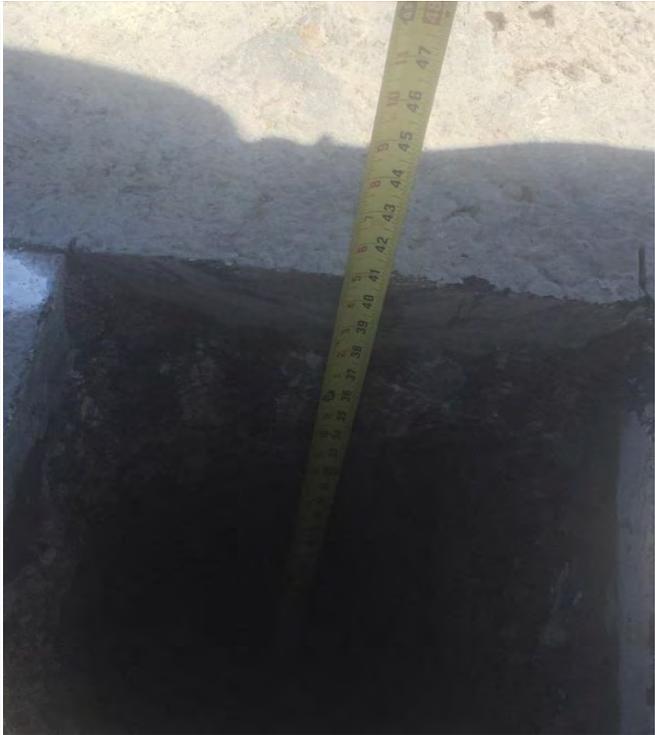
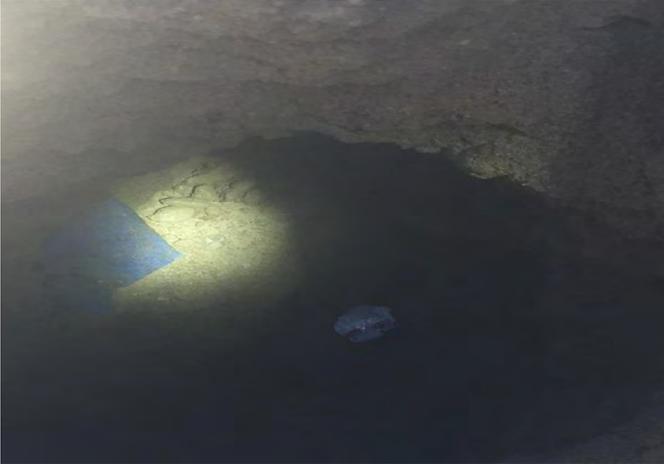
Street: 166th Ave & East 14th Street

<p>Cut Size: 1' x 1'</p> <p>Asphalt: 5"</p> <p>Concrete:</p> <p>Depth: 41"</p> <p>Utility: Water</p> <p>Size: 8"</p> <p>Material: Steel</p> <p>Soil: Hard dirt, clay</p>	<p>Location: 147" Northeast of Face of Curb. 96" SE of TV Box.</p> <p>Notes:</p>
--	--
