EXARO Technologies Corporation

Subsurface Utility Report	
Client	ACPWA - Vincent SendayDiego
Project #	16-1127
City	Hayward
Date	9/18/2017

Pothole # 2A

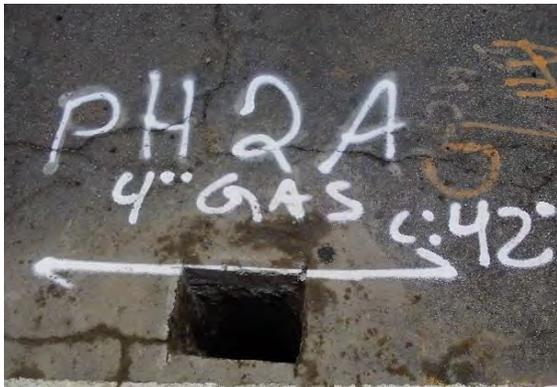
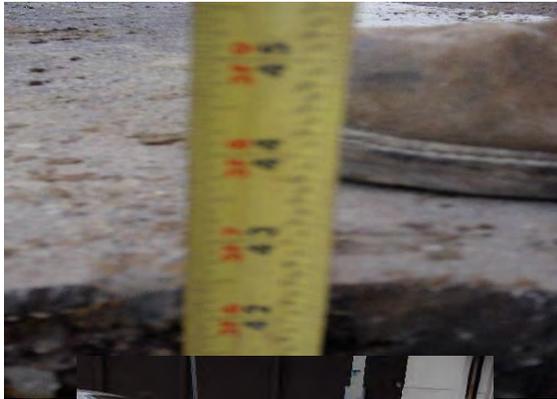
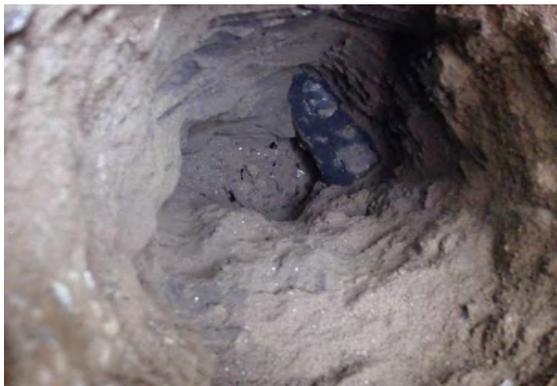
Utility	Depth	Material	Soil Type	Location		
4" Gas	42"	Steel	Hard dirt, sand, clay	164th St and E 14th Ave		
Cut Size	1' x 1'	Asphalt Thickness	5"	Concrete Thickness	0	
Location Reference	72" Southeast of Sanitary Sewer manhole. 4" Southwest from white fog line.

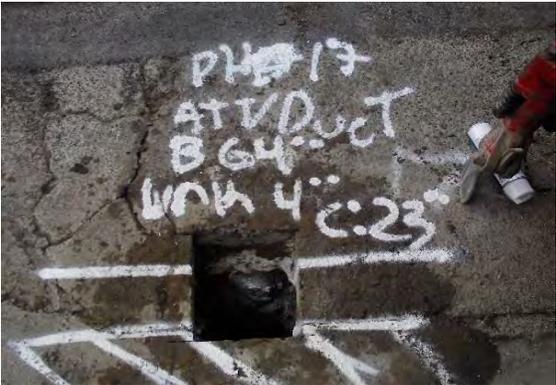
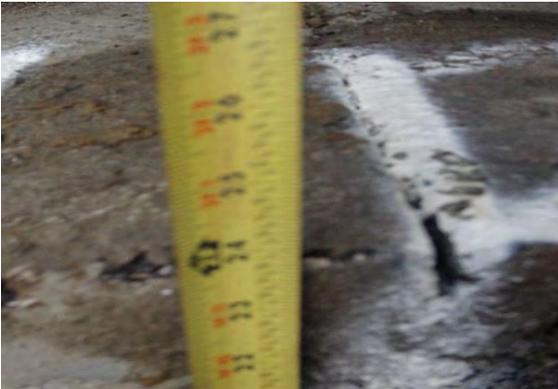
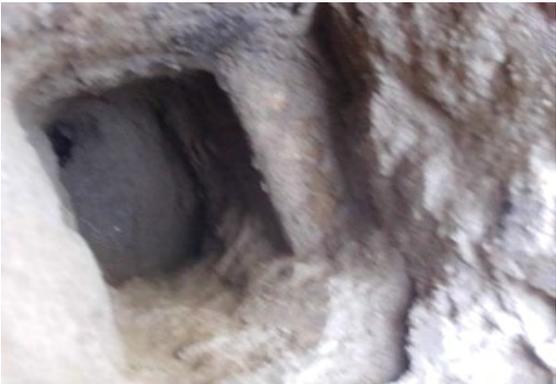
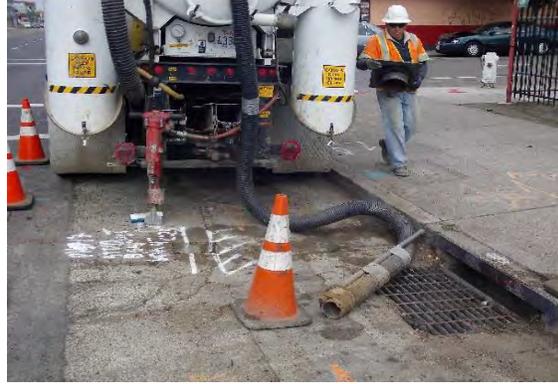
Pothole # 17

Utility	Depth	Material	Soil Type	Location		
4" Unknown	23"	Steel	Hard dirt, sand, clay	165th St and E 14th Ave		
Cut Size	1' x 1'	Asphalt Thickness	5"	Concrete Thickness	0	
Location Reference	60" Southwest from of face of curb. 17" Northwest from storm drain.

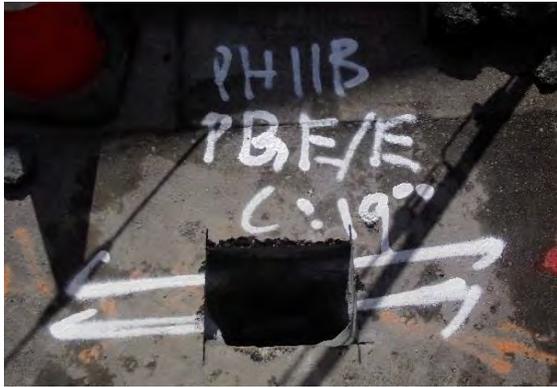
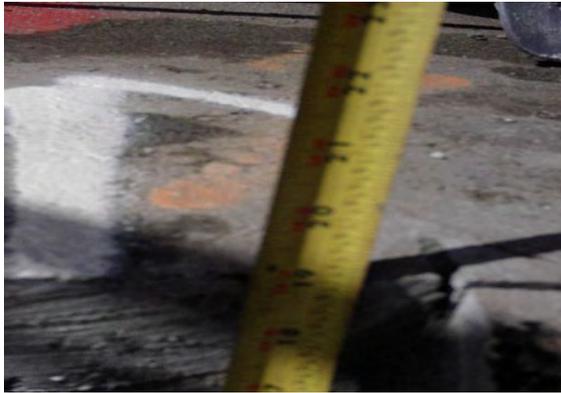
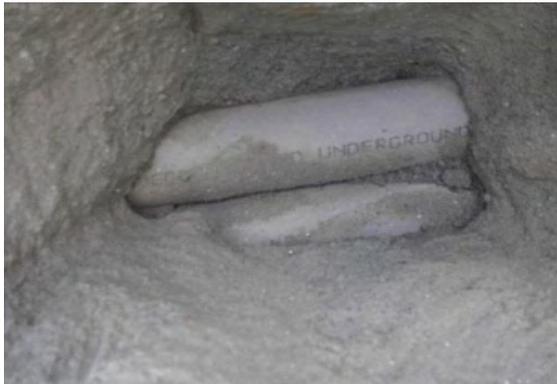
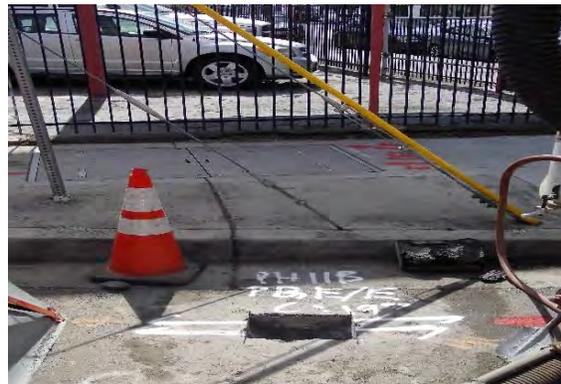
Pothole # 11B

Utility	Depth	Material	Soil Type	Location		
4" Electric/PGE	19"	PVC	Hard dirt, sand, clay	165th St and E 14th Ave		
Cut Size	1' x 1'	Asphalt Thickness	5"	Concrete Thickness	0	
Location Reference	27" Northwest of face of curb. 33" Southwest of water valve.

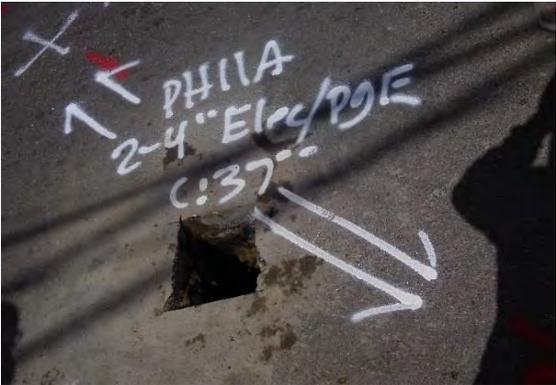
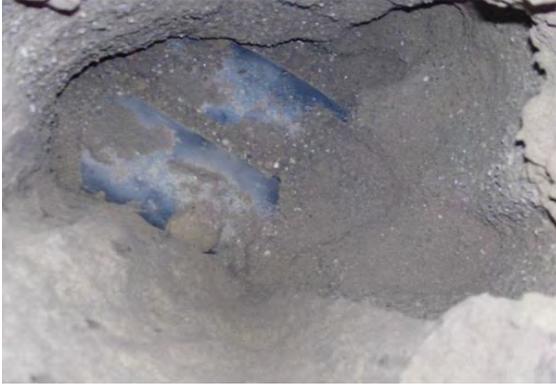
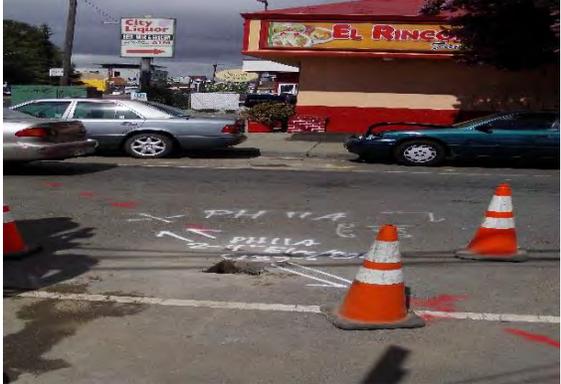
Pothole # 11A

Utility	Depth	Material	Soil Type	Location		
2 - 4" Electric/ PGE	37"	PVC	Hard dirt, sand, clay	165th St and E 14th Ave		
Cut Size	1' x 1'	Asphalt Thickness	5"	Concrete Thickness	0	
Location Reference	150" Northwest from face of curb. 60" Southwest from water valve.

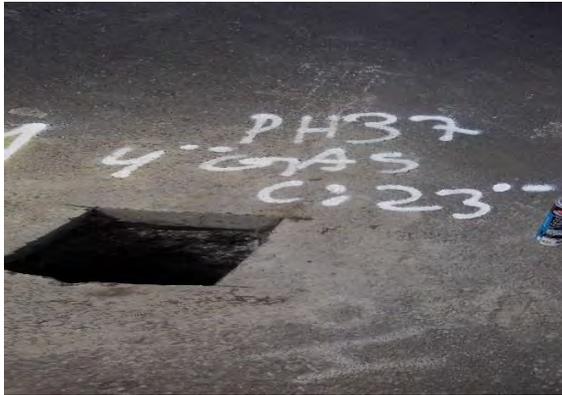
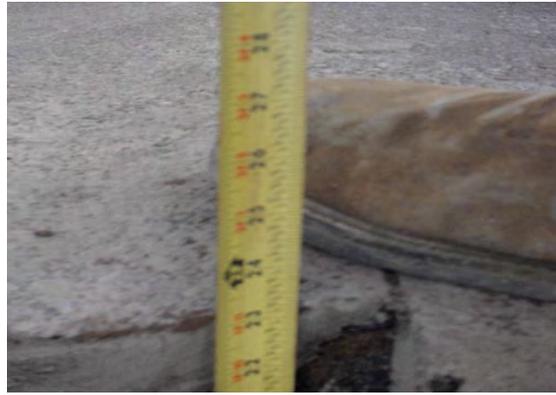
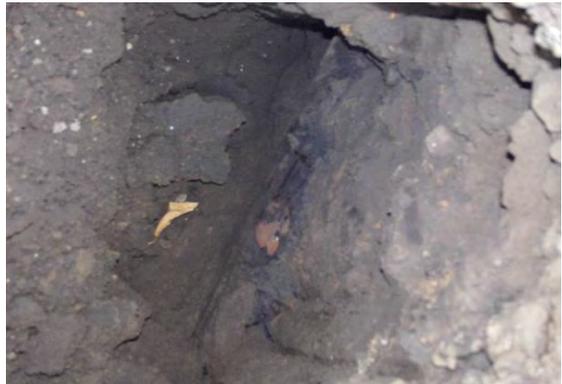
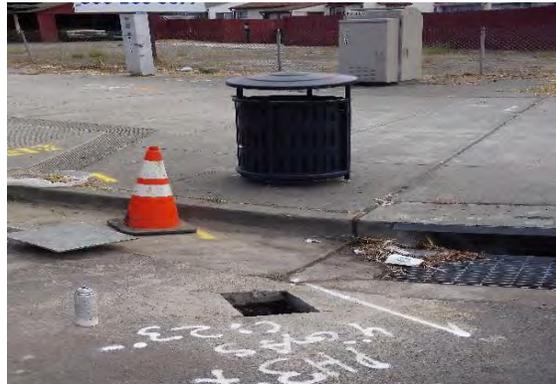
Pothole # 37

Utility	Depth	Material	Soil Type	Location		
4" Gas	23"	Steel	Hard dirt, sand, clay	170th St and E 14th Ave		
Cut Size	1' x 1'	Asphalt Thickness	5"	Concrete Thickness	0	
Location Reference	72" Northeast of storm drain. 72" Northwest of white pedestrian crosswalk.

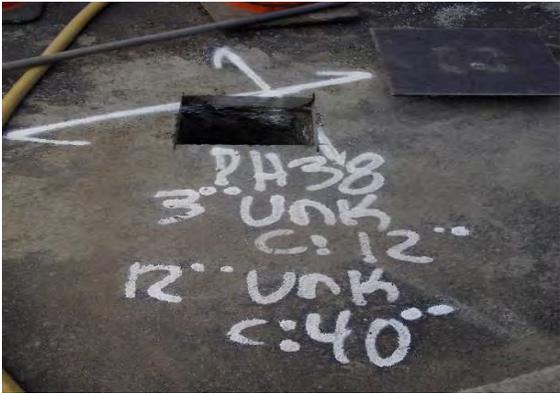
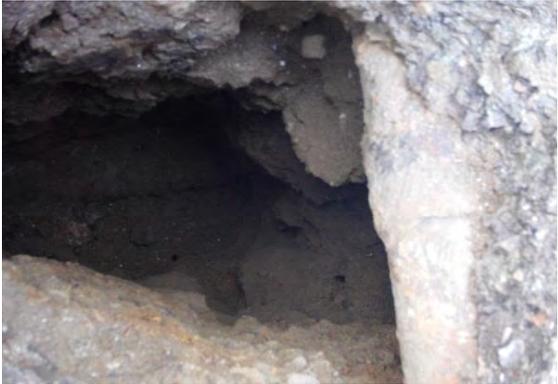
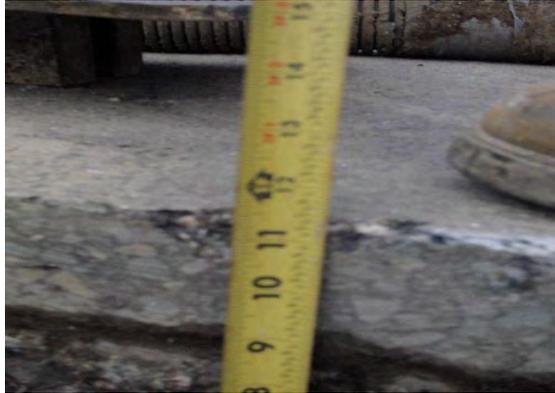
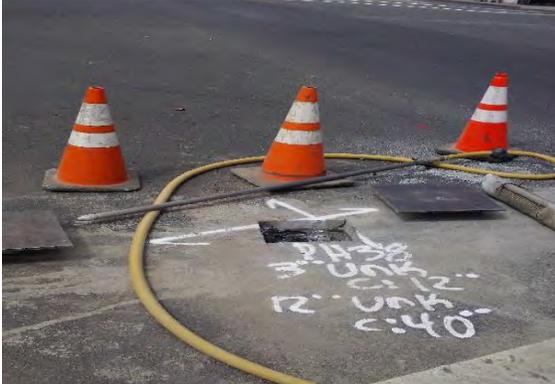
Pothole # 38

Utility	Depth	Material	Soil Type	Location		
4" Unknown	12"	Steel	Hard dirt, sand, clay	170th St and E 14th Ave		
Cut Size	1' x 1'	Asphalt Thickness	5"	Concrete Thickness	0	
Location Reference	39" Northwest of white pedestrian crosswalk. 163" Northeast of storm drain.

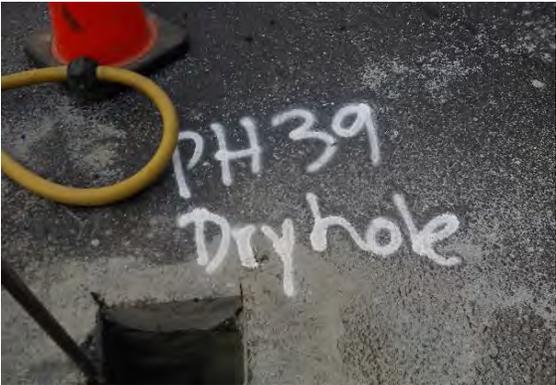
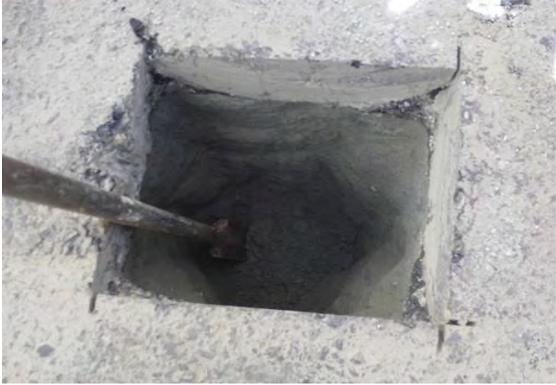
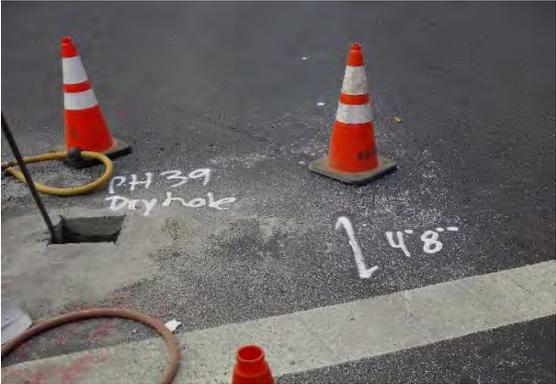
Pothole # 39

Utility	Depth	Material	Soil Type	Location		
Electric/PGE	Dry Hole		Hard dirt, sand, clay	170th St and E 14th Ave		
Cut Size	1' x 1'	Asphalt Thickness	5"	Concrete Thickness	0	
Location Reference	No locate. Clear to 3'. Pothole is 28" Northwest of white pedestrian crosswalk. 195" Northeast of storm drain.

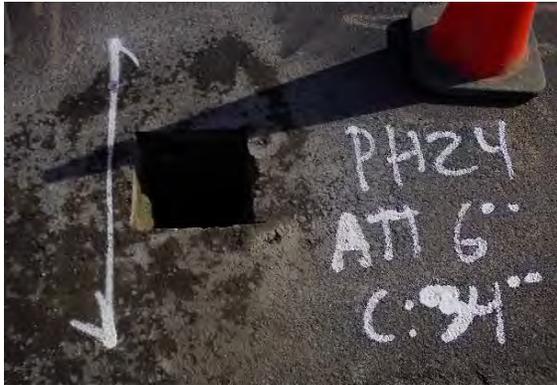
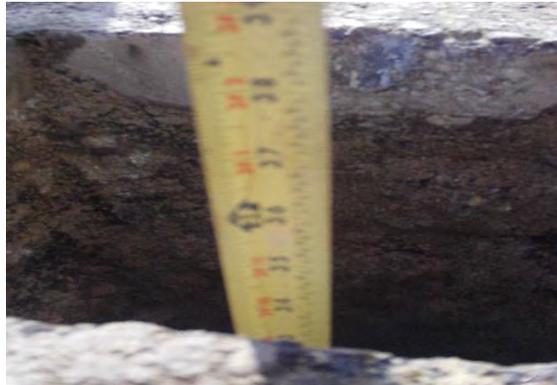
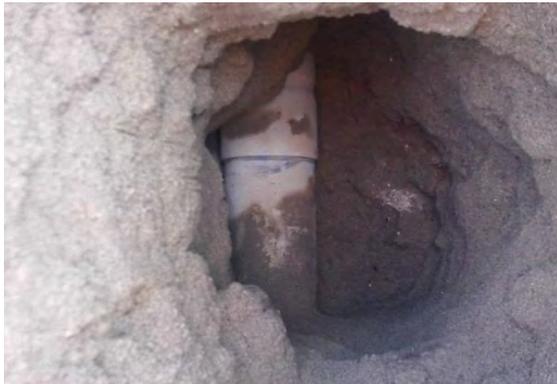
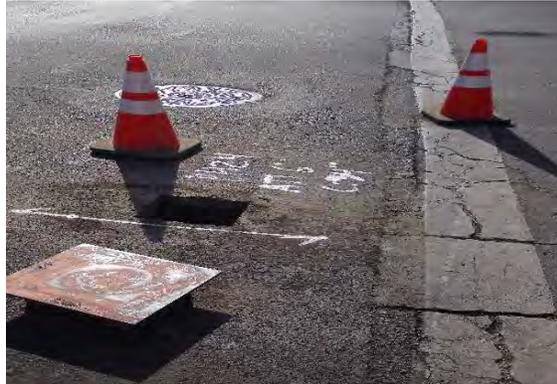
Pothole # 24

Utility	Depth	Material	Soil Type	Location		
6" ATT	34"	PVC	Hard dirt. Sand, clay	167th St and E 14th Ave		
Cut Size	1' x 1'	Asphalt Thickness	5"	Concrete Thickness	0	
Location Reference	64" Northwest from Sanitary Sewer manhole.

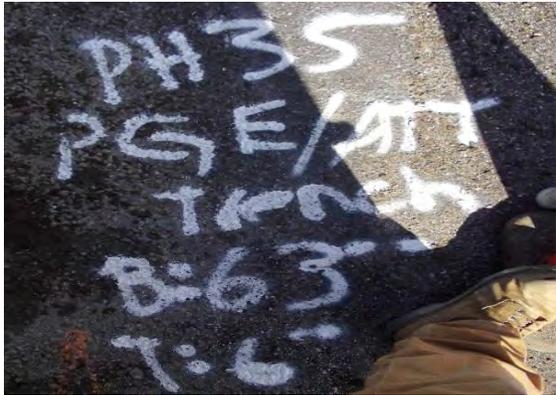
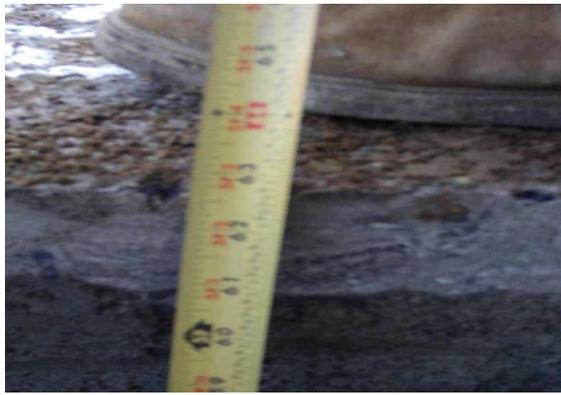
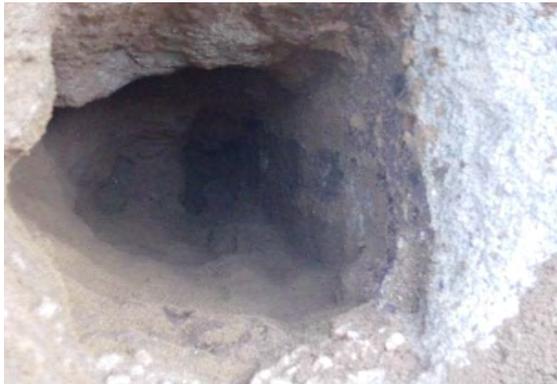
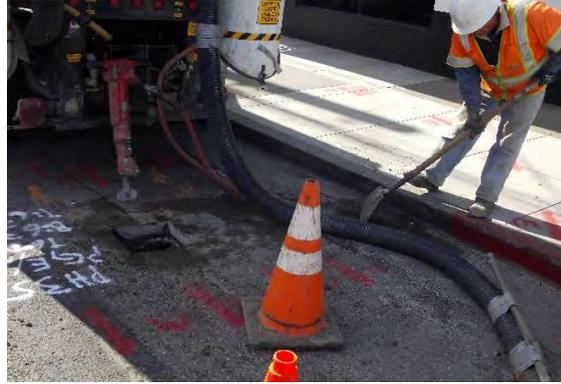
Pothole # 35

Utility	Depth	Material	Soil Type	Location		
ATT & PGE/Elec	Top: 6" Bot: 63"	Trench	Hard dirt. Sand, clay	168th St and E 14th Ave		
Cut Size	1' x 1'	Asphalt Thickness	5"	Concrete Thickness	0	
Location Reference	55" Northeast from face of curb. 70" Southeast from edge of driveway.

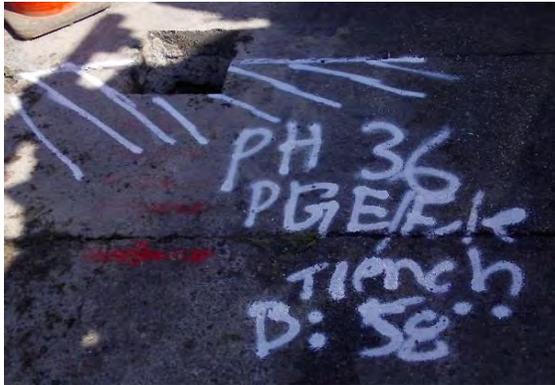
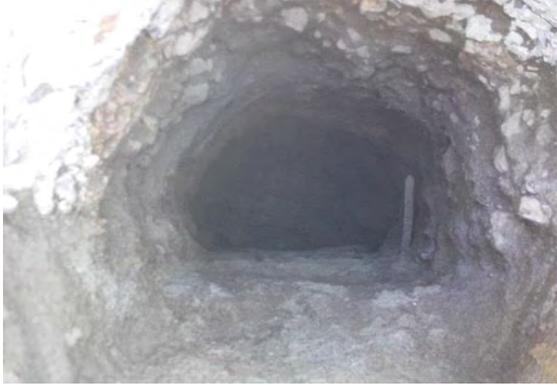
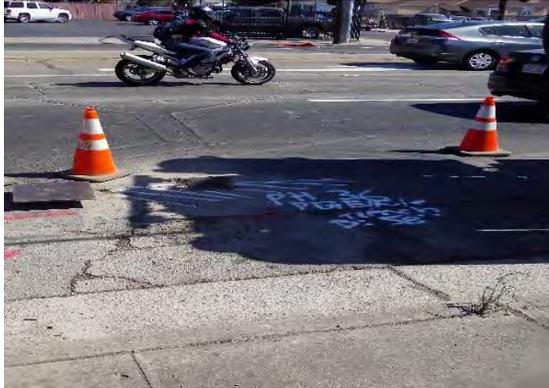
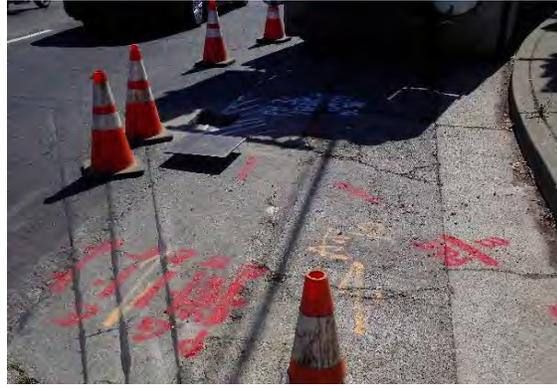
Pothole # 36

Utility	Depth	Material	Soil Type	Location		
ATT & PGE/Elec	Top: 6" Bot: 58"	Trench	Hard dirt. Sand, clay	170th St and E 14th Ave		
Cut Size	1' x 1'	Asphalt Thickness	5"	Concrete Thickness	0	
Location Reference	82" Northeast from face of curb. 180" Northeast from traffic light.

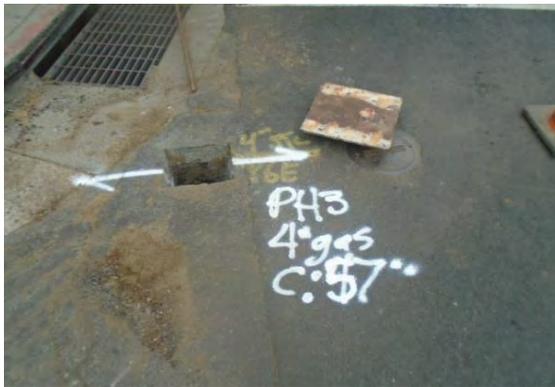
Pothole # 3

Utility	Depth	Material	Soil Type	Location		
4" Gas	57"	Steel	Hard dirt	164th Ave and E 14th St		
Cut Size	1' x 1'	Asphalt Thickness	6"	Concrete Thickness	0	
Location Reference	95" Northwest of signal light. 58" Southwest of edge of curb.

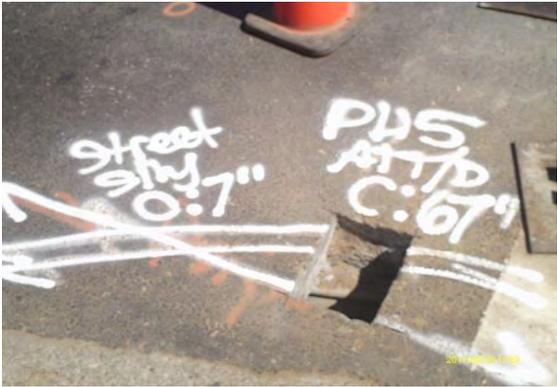
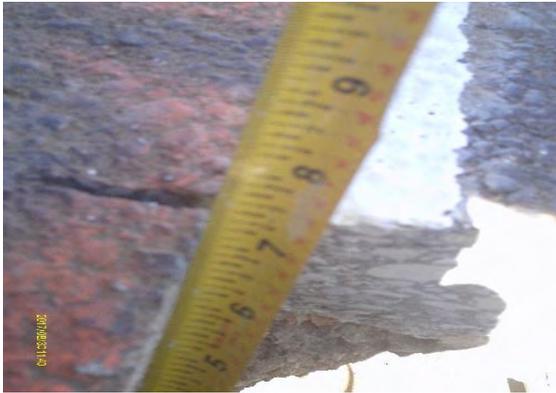
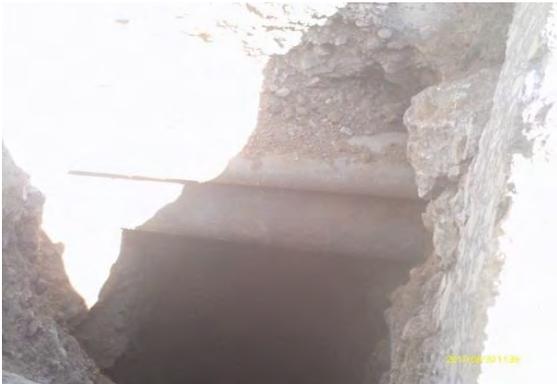
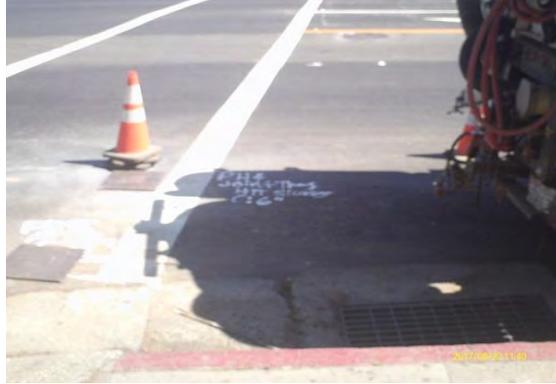
Pothole # 5

Utility	Depth	Material	Soil Type	Location		
2 -2" Traffic light	7"	Plastic	Hard dirt	164th Ave and E 14th St		
Cut Size	1' x 1'	Asphalt Thickness	5"	Concrete Thickness	0	
Location Reference	38" Northeast of face of curb. 124" Southeast of water valve.

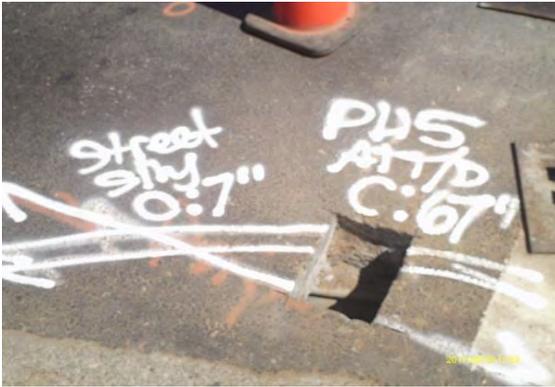
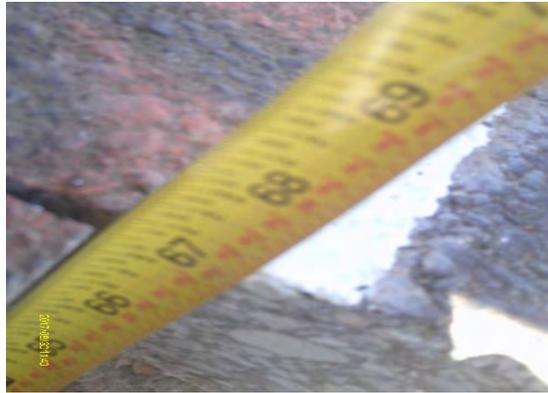
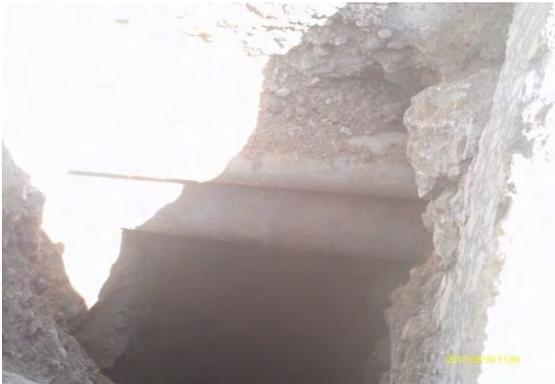
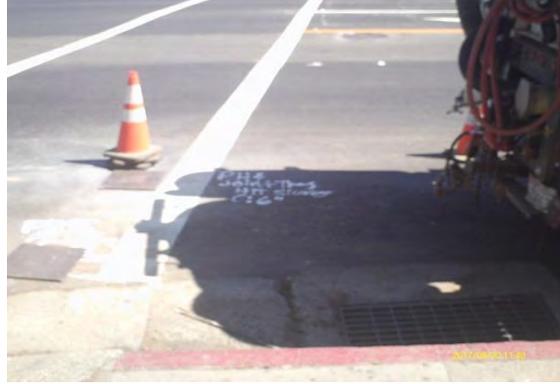
Pothole # 5 (2nd utility)

Utility	Depth	Material	Soil Type	Location		
ATT	67"	Concrete Duct	Hard dirt	164th Ave and E 14th St		
Cut Size	1' x 1' (2nd utility)	Asphalt Thickness	5"	Concrete Thickness	0	
Location Reference	38" Northeast of face of curb. 124" Southeast of water valve.

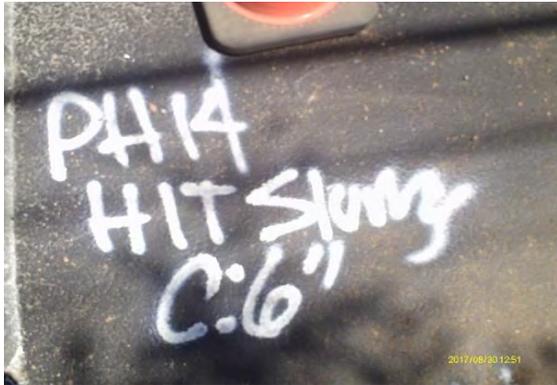
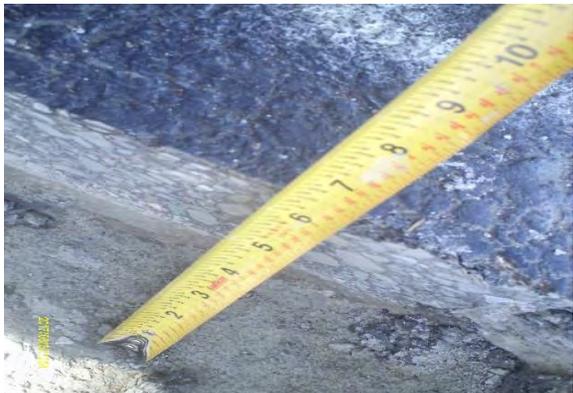
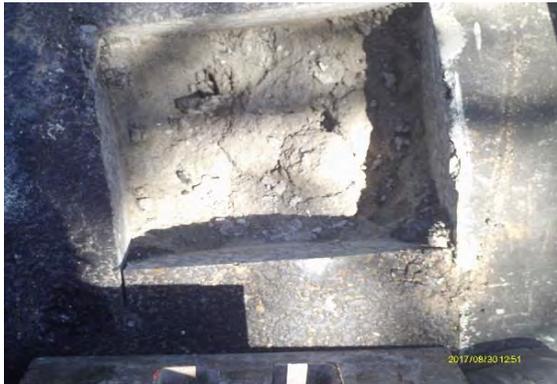
Pothole # 14

Utility	Depth	Material	Soil Type	Location		
Joint Trench	0		Hard dirt	165th Ave and E 14th St		
Cut Size	1' x 1'	Asphalt Thickness	5"	Concrete Thickness	0	
Location Reference	Hit slurry at 6". Pothole is 92" Northeast of face of curb. 74" Southeast of fire hydrant.

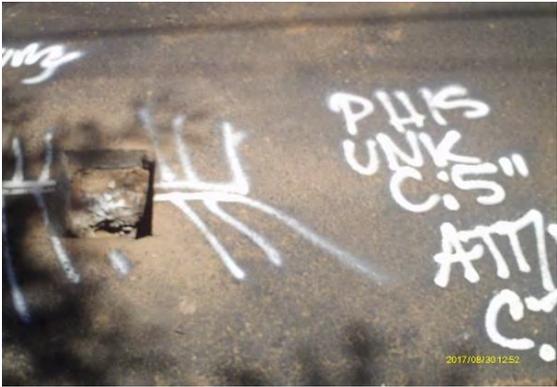
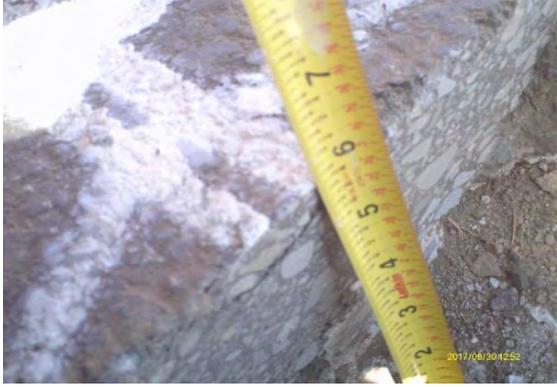
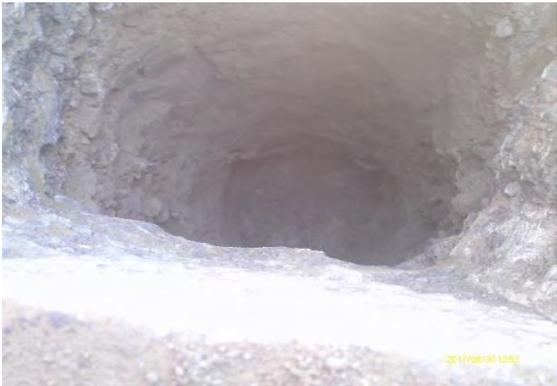
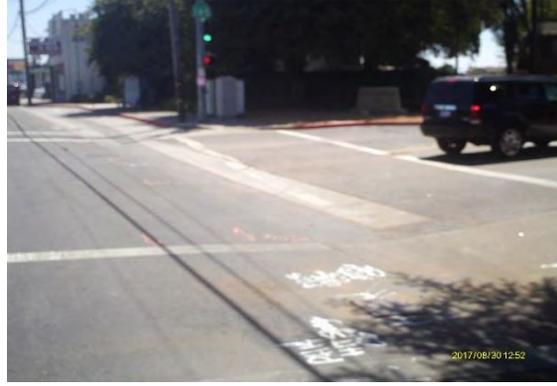
Pothole # 15

Utility	Depth	Material	Soil Type	Location		
Unknown	5"	Concrete	Hard dirt	165th Ave and E 14th St		
Cut Size	1' x 1'	Asphalt Thickness	5"	Concrete Thickness	0	
Location Reference	53" Northeast of face of curb. 134" Southeast of fire hydrant.

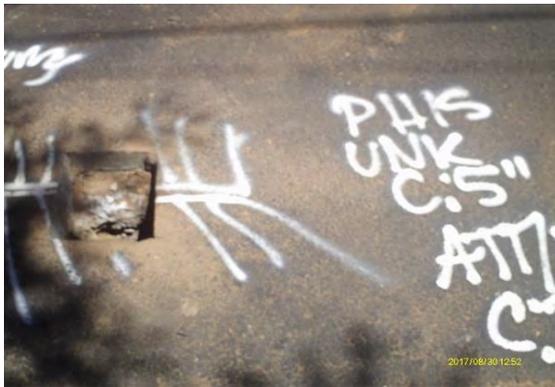
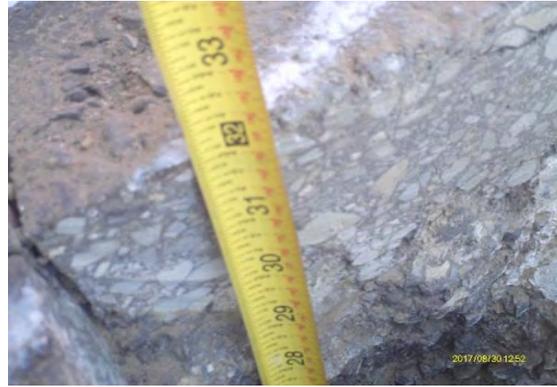
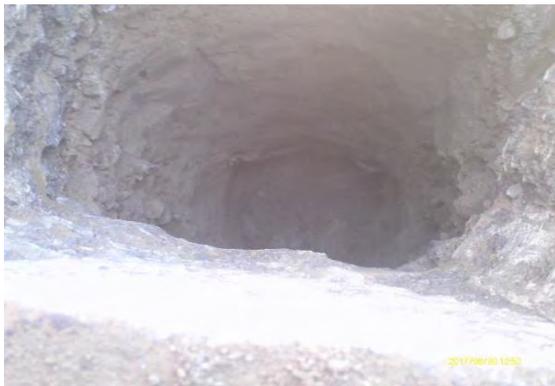
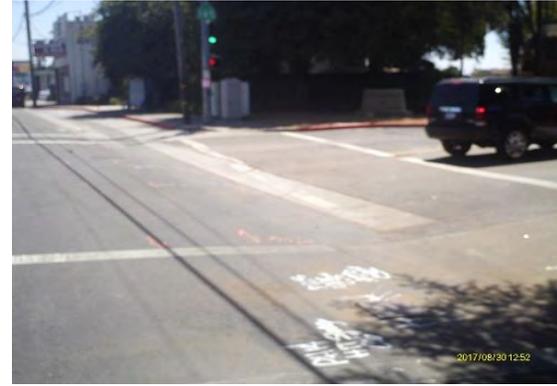
Pothole # 15 (2nd utility)

Utility	Depth	Material	Soil Type	Location		
ATT	32"	Concrete Duct	Hard dirt	165th Ave and E 14th St		
Cut Size	1' x 1' (2nd utility)	Asphalt Thickness	5"	Concrete Thickness	0	
Location Reference	53" Northeast of face of curb. 134" Southeast of fire hydrant.

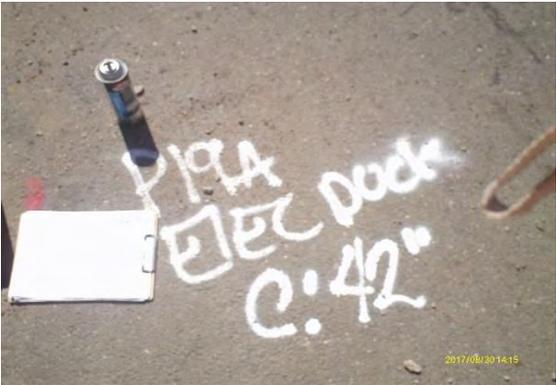
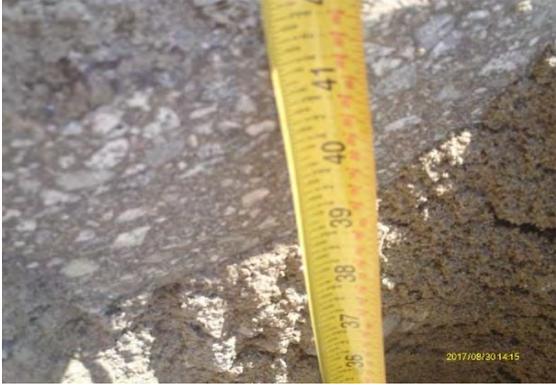
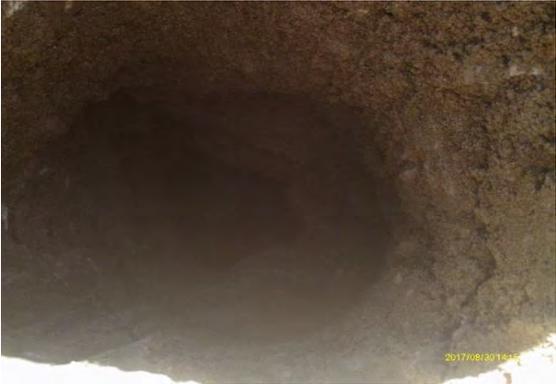
Pothole # 19A

Utility	Depth	Material	Soil Type	Location		
2 - 4" Electric	42"	Plastic	Hard dirt	166th Ave and E 14th St		
Cut Size	1' x 1'	Asphalt Thickness	0	Concrete Thickness	0	
Location Reference	70" Southwest of telephone pole. 94" Northwest of ATT box.

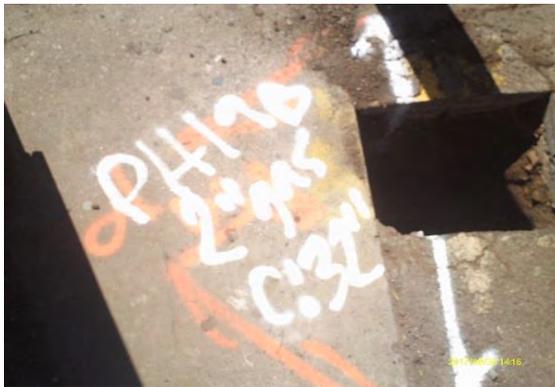
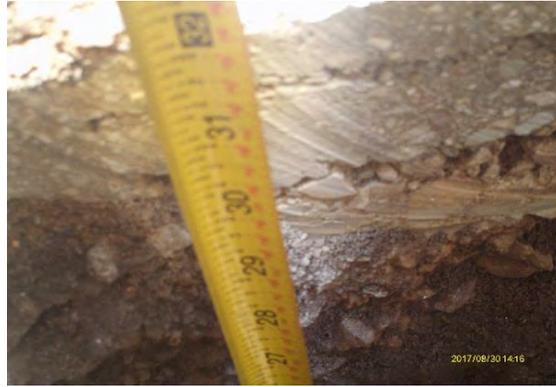
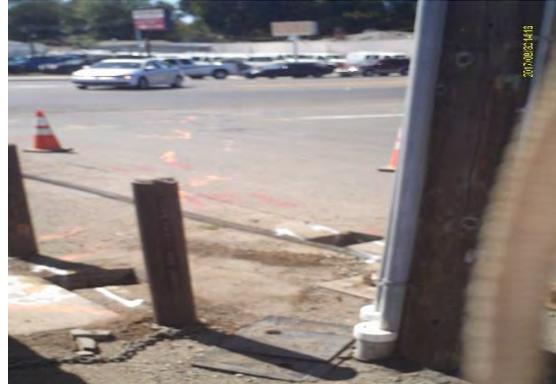
Pothole # 19B

Utility	Depth	Material	Soil Type	Location		
2" Gas	32"		Hard dirt	165th Ave and E 14th St		
Cut Size	1' x 1'	Asphalt Thickness	0	Concrete Thickness	0	
Location Reference	55" Southwest of telephone pole. 36" Northwest of ATT box.

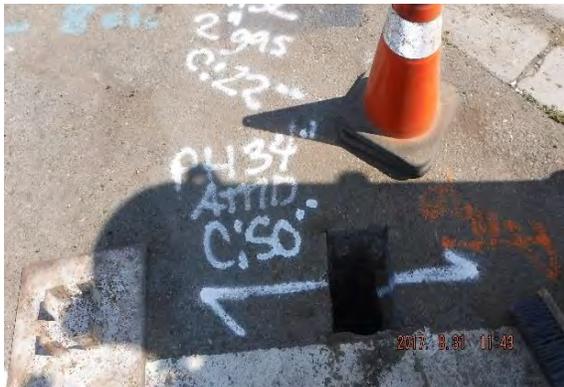
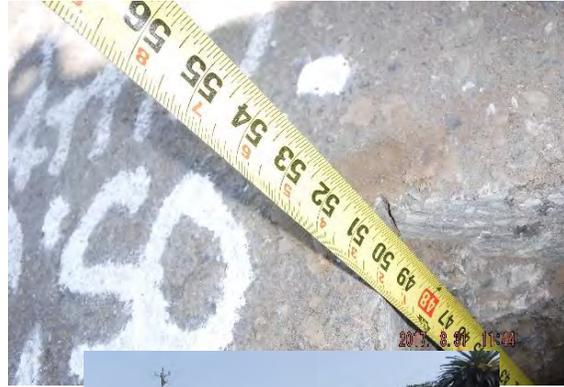
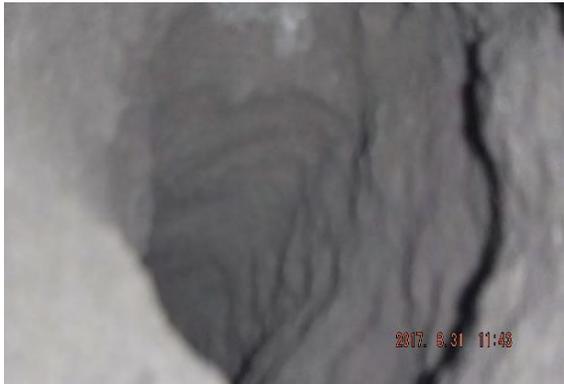
Pothole # 34

Utility	Depth	Material	Soil Type	Location		
ATT			Hard dirt, Clay, Sand	168th Ave and E 14th St		
Cut Size	1' x 1'	Asphalt Thickness	7"	Concrete Thickness	0	
Location Reference	No visual. Hole keeps caving in due to sand. Felt possible pipe at 50". Pothole is 120" Southeast of gas valve. 52" Southwest of gas valve.

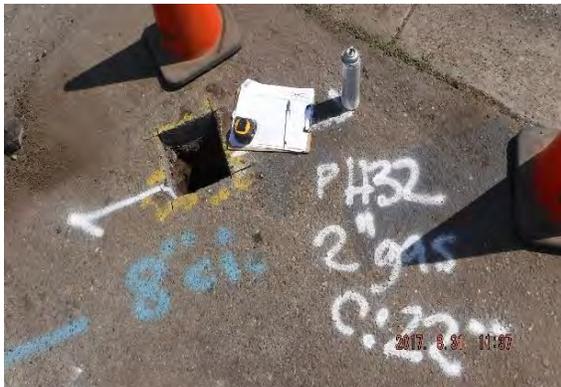
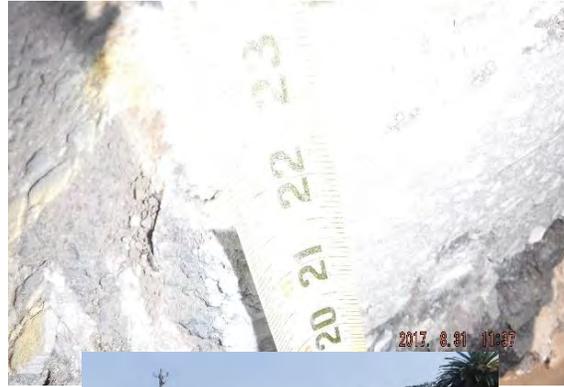
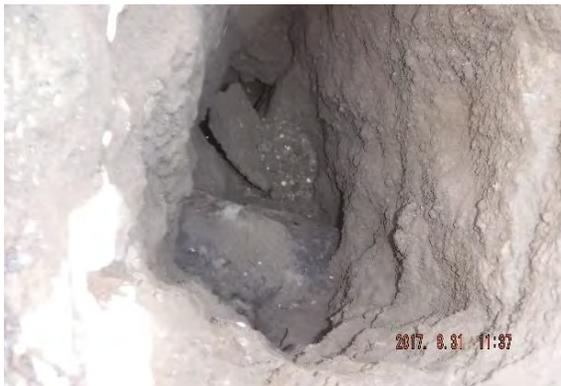
Pothole # 33

Utility	Depth	Material	Soil Type	Location		
2" Gas	22"	Steel	Hard dirt, Clay, Sand	168th Ave and E 14th St		
Cut Size	1' x 1'	Asphalt Thickness	7"	Concrete Thickness	0	
Location Reference	38" Southeast of gas valve. 20" Northeast of gas valve. Pothole mismarked as #32.

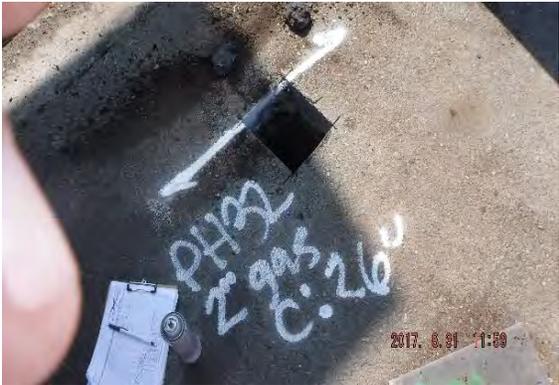
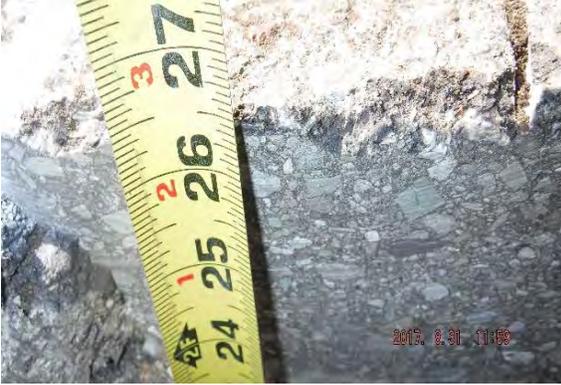
Pothole # 32

Utility	Depth	Material	Soil Type	Location		
2" Gas	26"	Steel	Hard dirt, Clay, Sand	168th Ave and E 14th St		
Cut Size	1' x 1'	Asphalt Thickness	6"	Concrete Thickness	0	
Location Reference	36" Northwest of face of curb. 130" Northeast of ATT manhole.

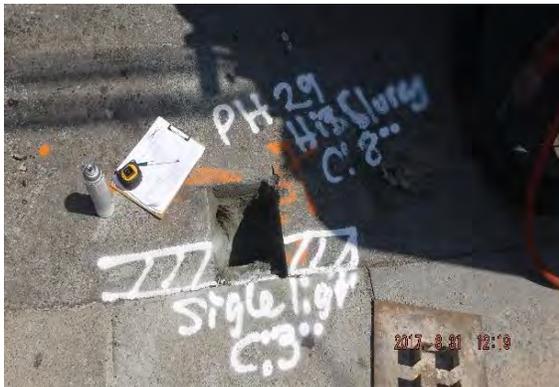
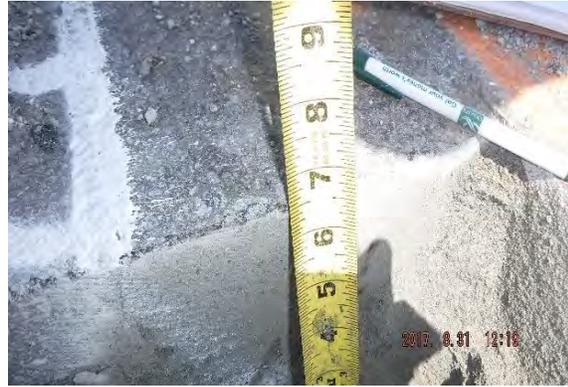
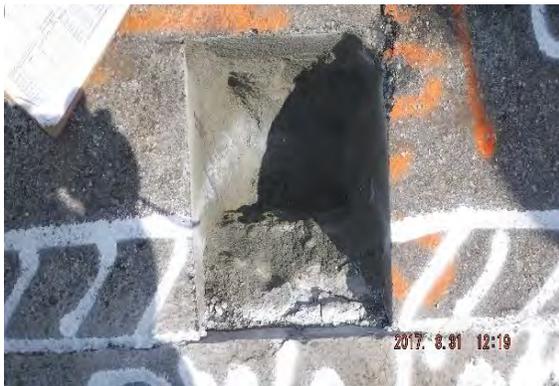
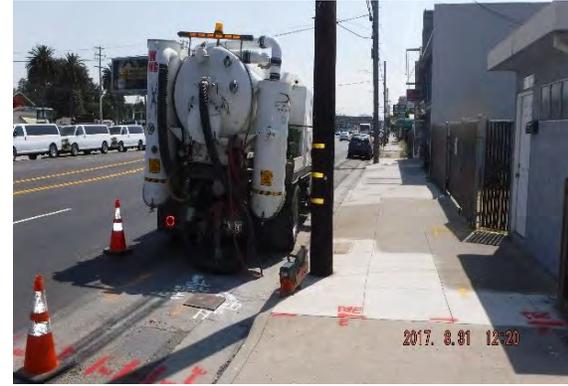
Pothole # 29

Utility	Depth	Material	Soil Type	Location		
ATT	8"	Slurry	Hard dirt, Clay, Sand	16721 E 14th St		
Cut Size	1' x 1'	Asphalt Thickness	6"	Concrete Thickness	0	
Location Reference	32" Northeast of face of curb. 39" Northwest of telephone pole.

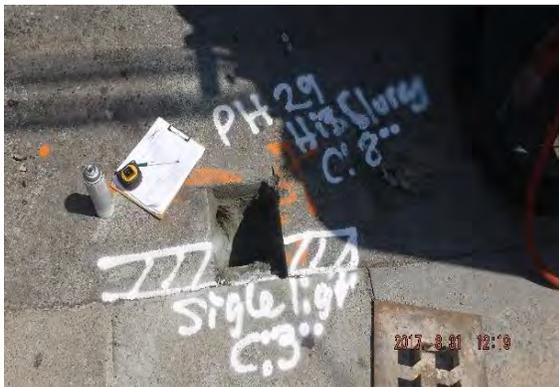
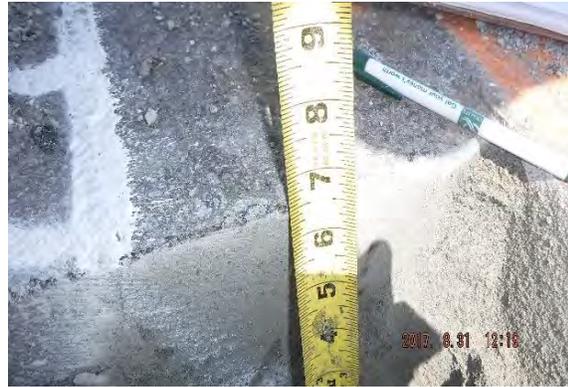
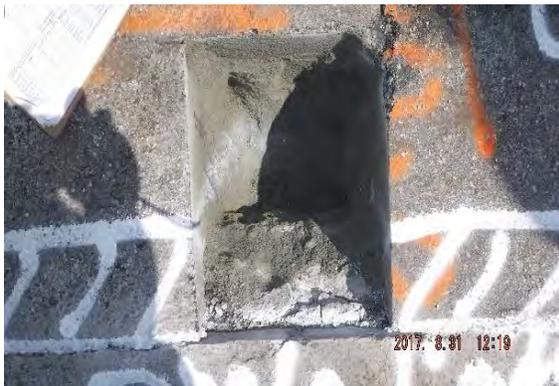
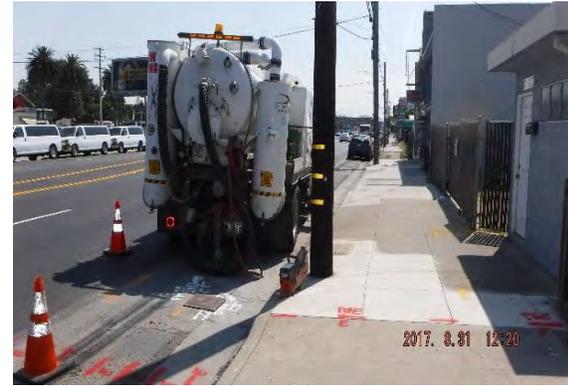
Pothole # 29 (2nd utility)

Utility	Depth	Material	Soil Type	Location		
Electric	8"	Slurry	Hard dirt, Clay, Sand	16721 E 14th St		
Cut Size	8' x 1' (2nd utility)	Asphalt Thickness	6"	Concrete Thickness	0	
Location Reference	32" Northeast of face of curb. 39" Northwest of telephone pole.

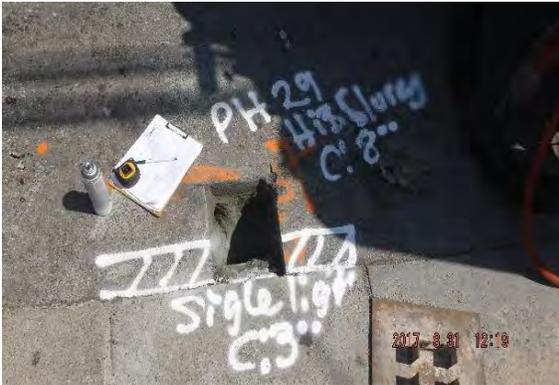
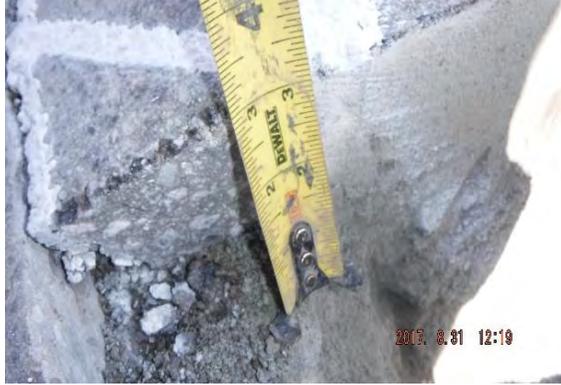
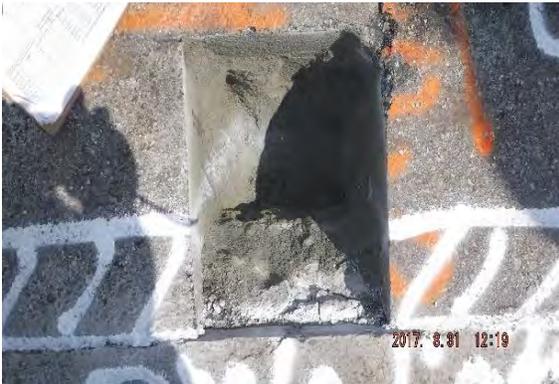
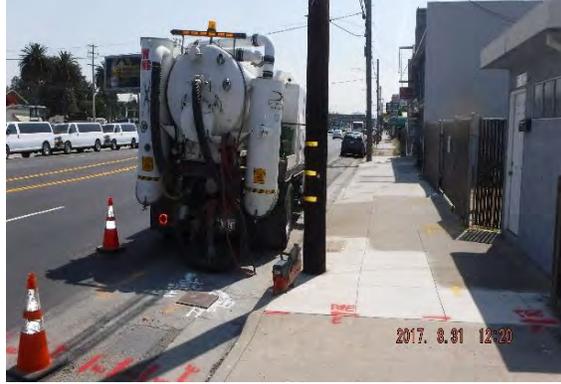
Pothole # 29 (3rd utility)

Utility	Depth	Material	Soil Type	Location		
Sanitary Sewer	3"	Concrete	Hard dirt, Clay, Sand	16721 E 14th St		
Cut Size	x 1' (3rd utility)	Asphalt Thickness	6"	Concrete Thickness	0	
Location Reference	32" Northeast of face of curb. 39" Northwest of telephone pole.

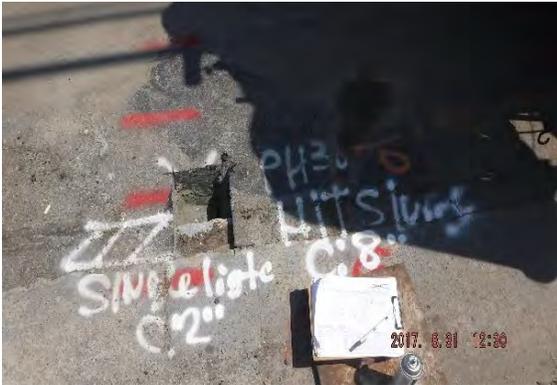
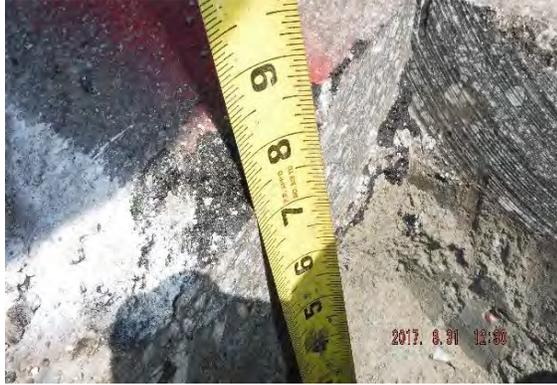
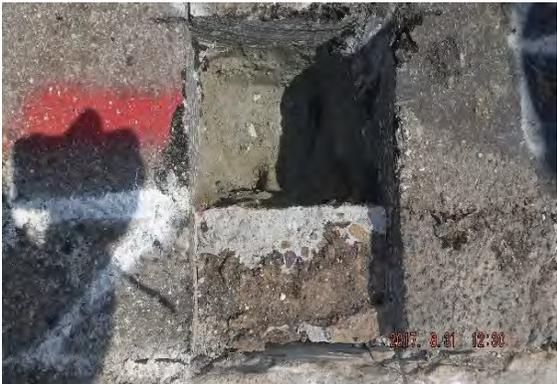
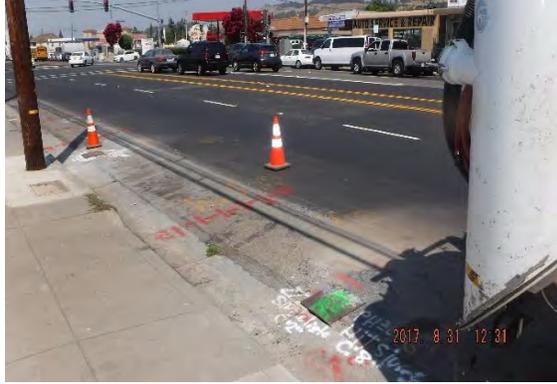
Pothole # 30

Utility	Depth	Material	Soil Type	Location		
ATT	8"	Slurry	Hard dirt, Clay, Sand	16721 E 14th St		
Cut Size	1' x 1'	Asphalt Thickness	5"	Concrete Thickness	0	
Location Reference	137" Northwest of Caltrans box. 28" Northeast of face of curb.

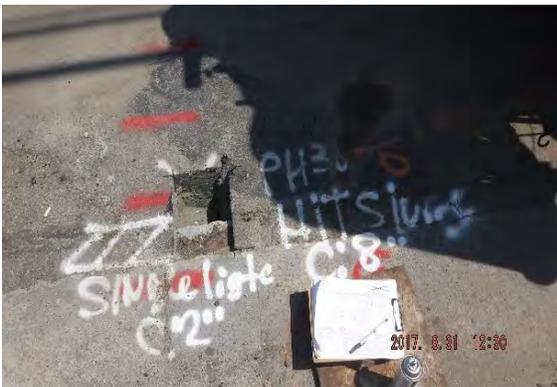
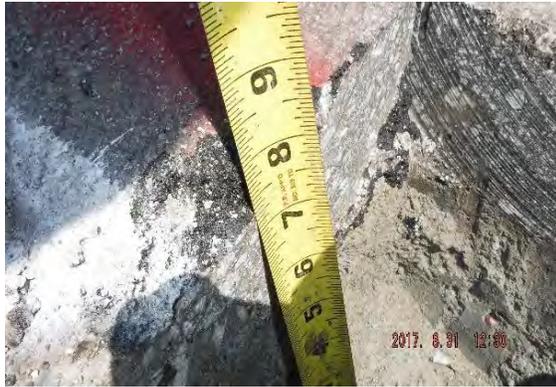
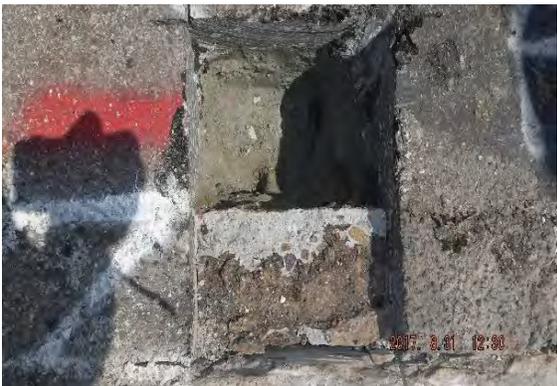
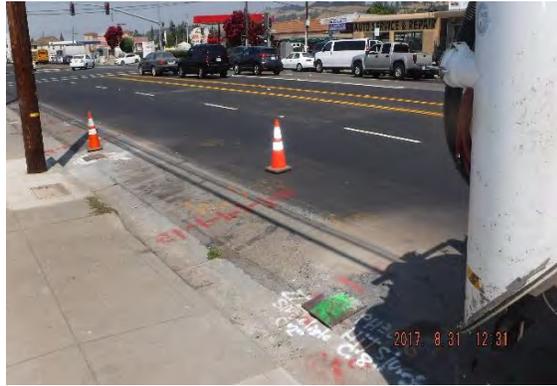
Pothole # 30 (2nd utility)

Utility	Depth	Material	Soil Type	Location		
Electric	8"	Slurry	Hard dirt, Clay, Sand	16721 E 14th St		
Cut Size	1' x 1' (2nd utility)	Asphalt Thickness	5"	Concrete Thickness	0	
Location Reference	137" Northwest of Caltrans box. 28" Northeast of face of curb.

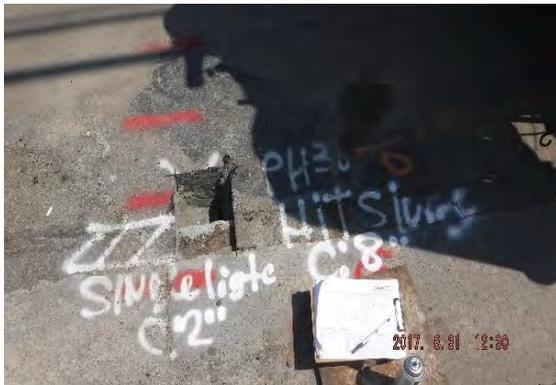
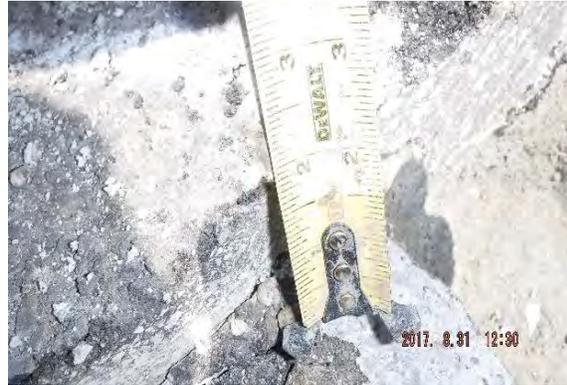
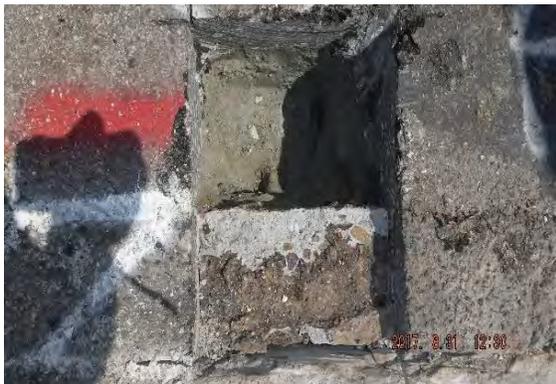
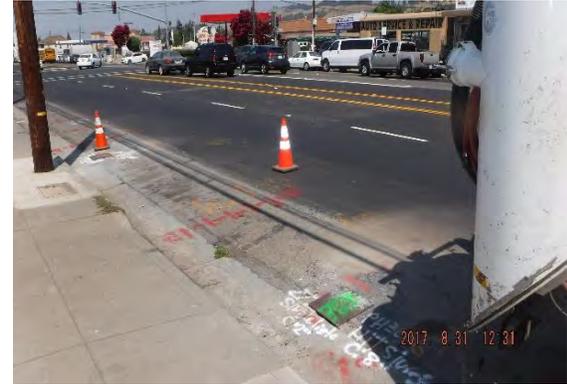
Pothole # 30 (3rd utility)

Utility	Depth	Material	Soil Type	Location		
Sanitary Sewer	2"	Concrete	Hard dirt, Clay, Sand	16721 E 14th St		
Cut Size	x 1' (3rd utility)	Asphalt Thickness	5"	Concrete Thickness	0	
Location Reference	137" Northwest of Caltrans box. 28" Northeast of face of curb.
