EXARO Technologies Corporation

Subsurface Utility Report	
Client	ACPWA - Vincent SendayDiego
Project #	16-1127
City	Hayward
Date	9/18/2017

Pothole # 2A

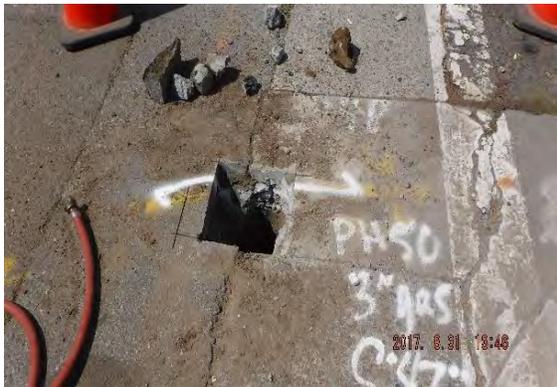
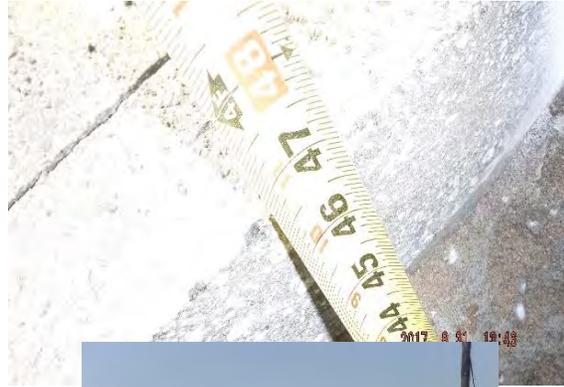
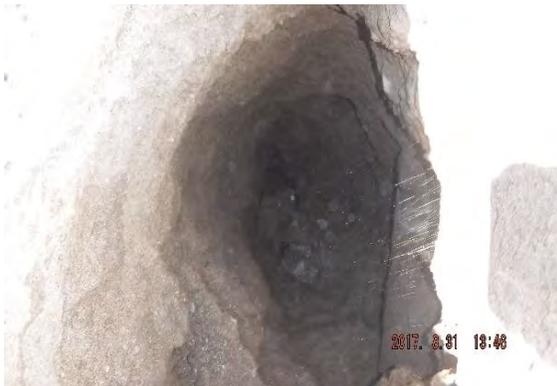
Pothole # 48

Utility	Depth	Material	Soil Type	Location		
3" Gas	47"	Plastic	Hard dirt, Clay, Sand	171st Ave and E 14th St		
Cut Size	1' x 1'	Asphalt Thickness	0	Concrete Thickness	6"	
Location Reference	70" Northwest of gas valve. 60" Southwest of gas valve. Pothole mismarked as #50.

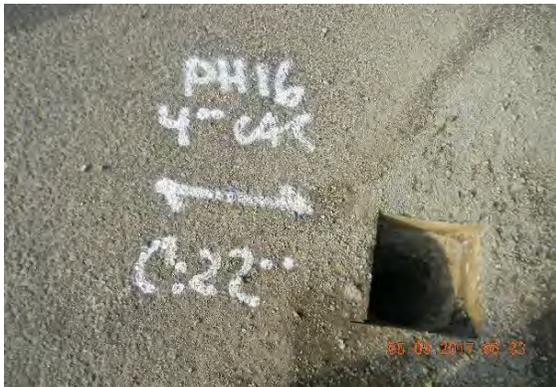
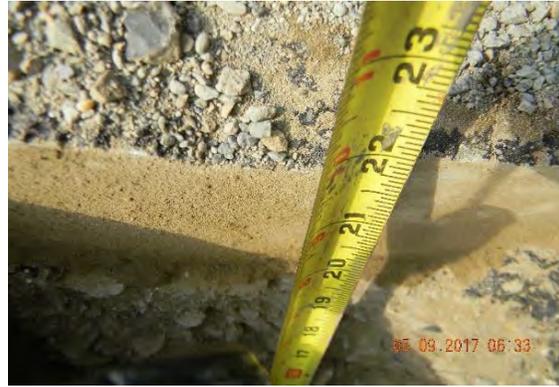
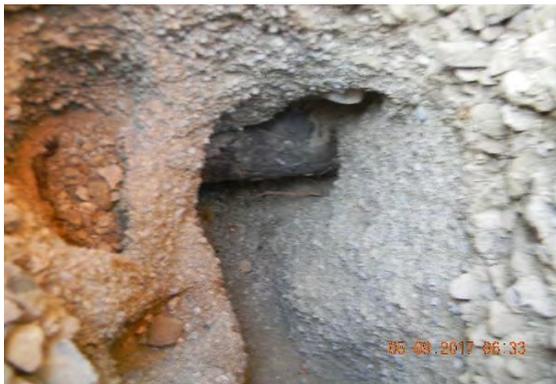
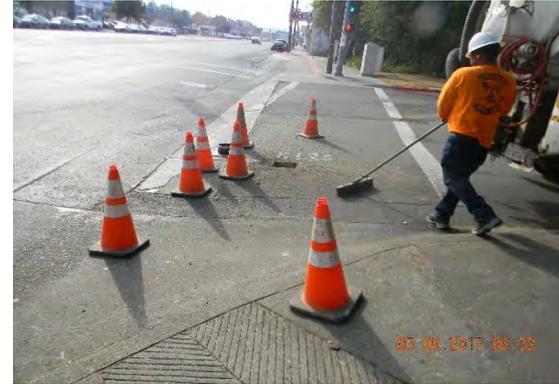
Pothole # 16

Utility	Depth	Material	Soil Type	Location		
4" Gas	22"	Steel	B rock, sand	E 14th St and 165th Ave		
Cut Size	1' x 1'	Asphalt Thickness	5"	Concrete Thickness	0	
Location Reference	34" Southwest from edge of gutter. 98" Southeast from face of curb.

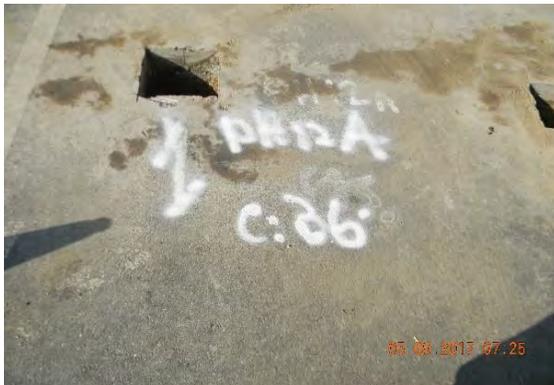
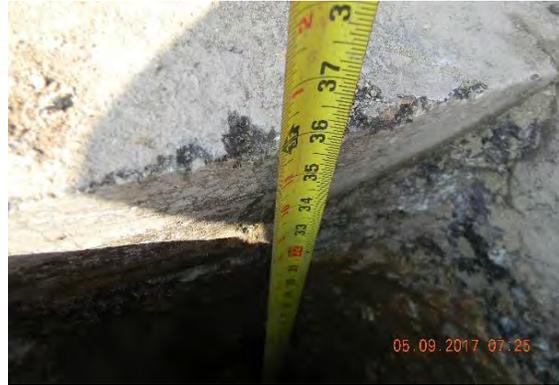
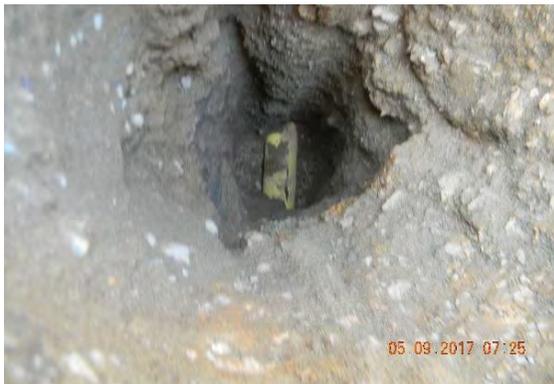
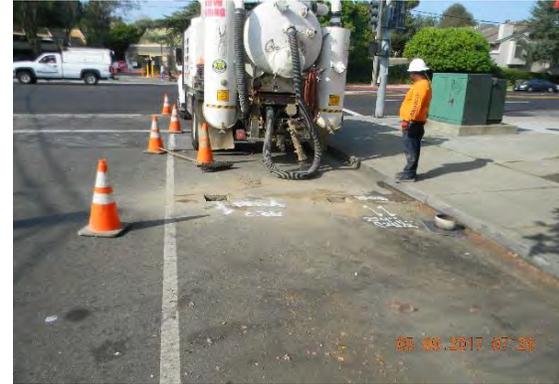
Pothole # 12A

Utility	Depth	Material	Soil Type	Location		
2" Gas	36"	Steel	Road base, clay, sand	E 14th St and 165th Ave		
Cut Size	1' x 1'	Asphalt Thickness	7"	Concrete Thickness	0	
Location Reference	105" Southeast from face of curb. 219" Northeast from traffic light.

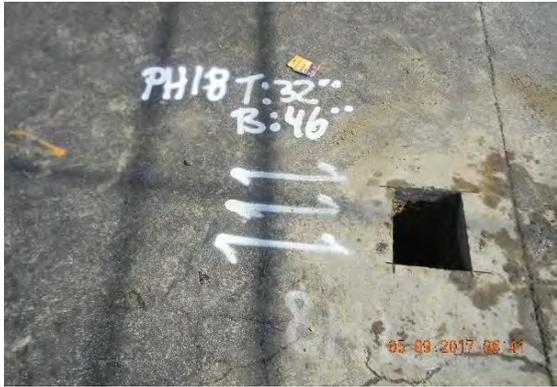
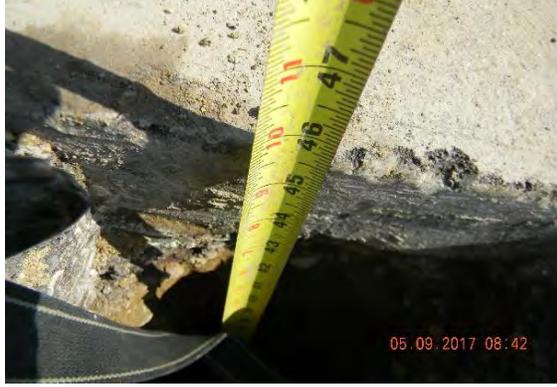
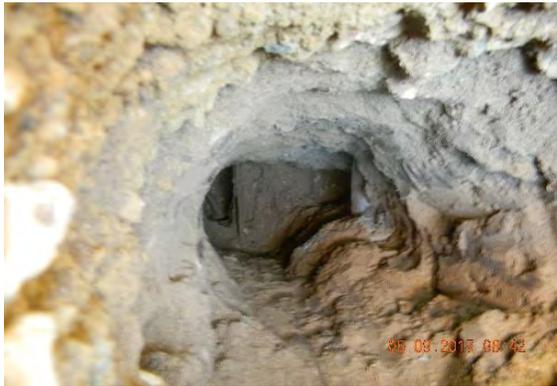
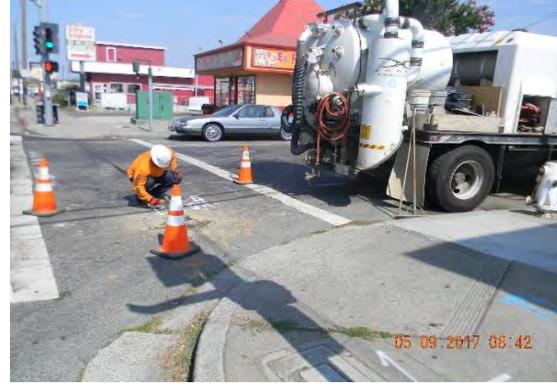
Pothole # 18

Utility	Depth	Material	Soil Type	Location		
Multiple 4" Conduits	Top: 32" Bot: 46"	PVC	Clay, sand	E 14th St and 165th Ave		
Cut Size	1' x 1'	Asphalt Thickness	7"	Concrete Thickness	0	
Location Reference	62" Southwest from edge of crosswalk. 86" Southeast from edge of ATT manhole.

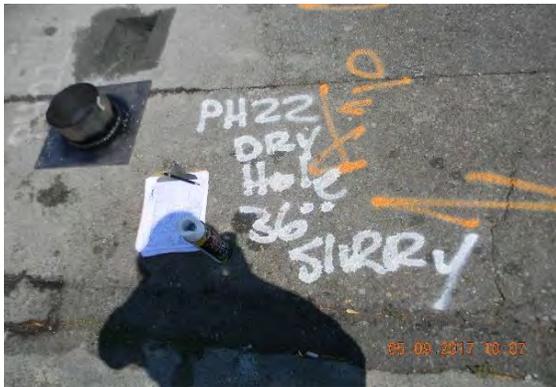
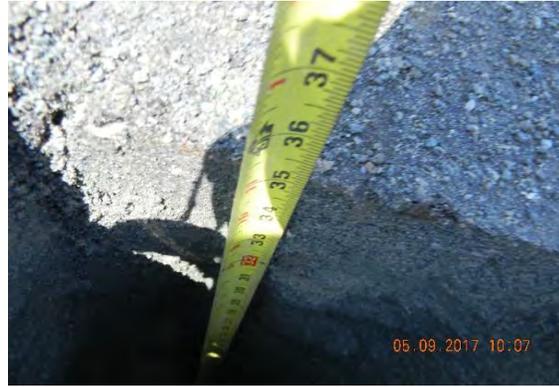
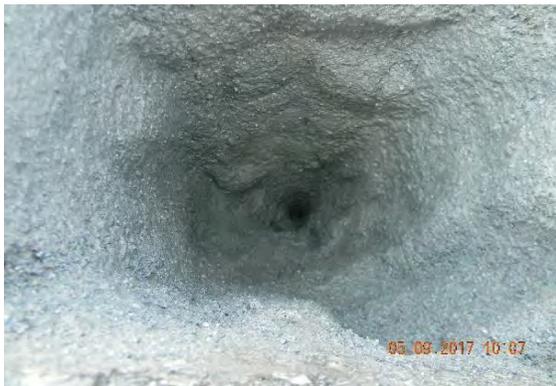
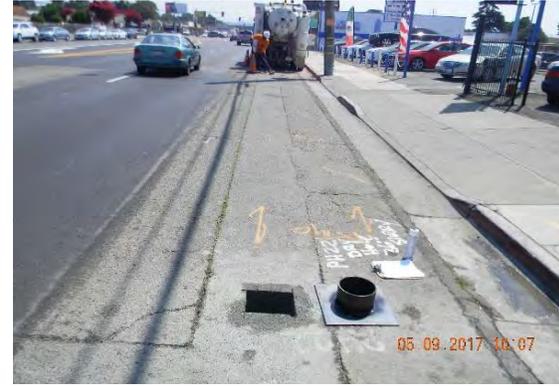
Pothole # 22

Utility	Depth	Material	Soil Type	Location		
Electric	Dry Hole	Slurry	Slurry	E 14th St and 166th Ave		
Cut Size	1' x 1'	Asphalt Thickness	5"	Concrete Thickness	0	
Location Reference	No locate. Cleared to 36". Pothole is 76" Northeast from face of curb. 92" Southeast from edge of water box.

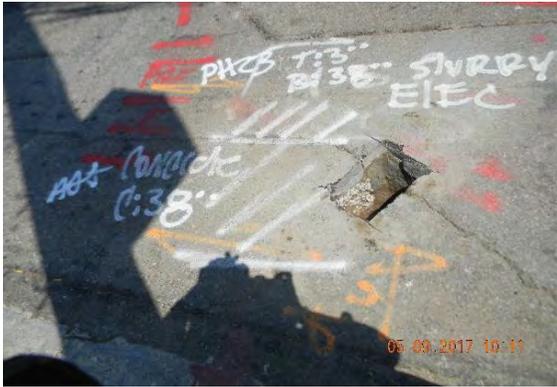
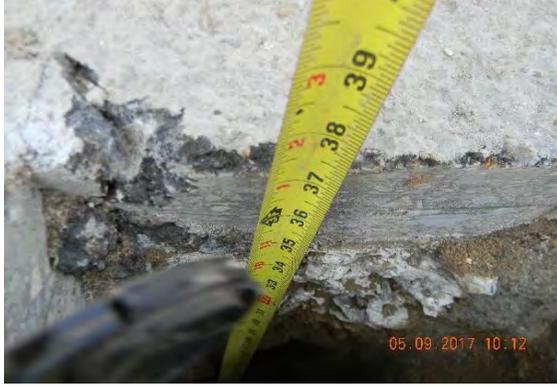
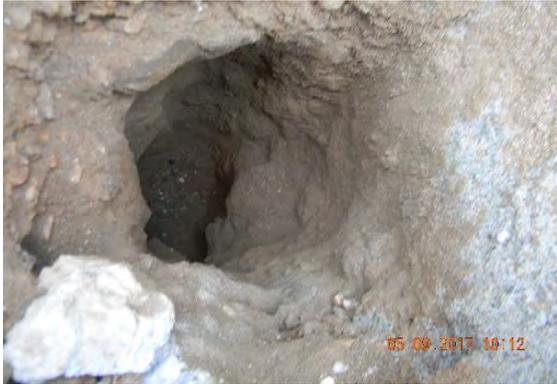
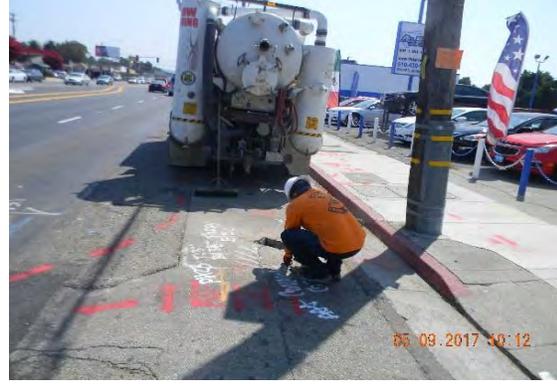
Pothole # 23

Utility	Depth	Material	Soil Type	Location		
Electric	Top: 3" Bot: 40"	Slurry	Dirt, clay	E 14th St and 166th Ave		
Cut Size	1' x 1'	Asphalt Thickness	5"	Concrete Thickness	5"	
Location Reference	60" Northeast from face of curb. 76" Northwest from edge of tv box.

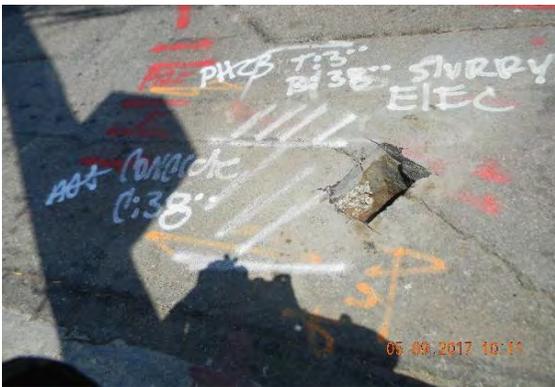
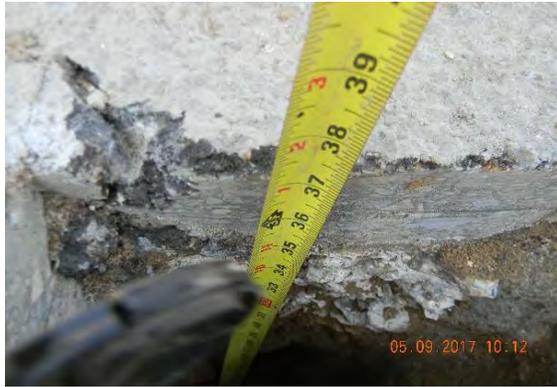
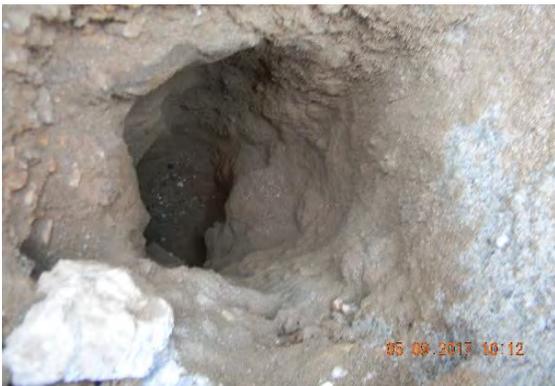
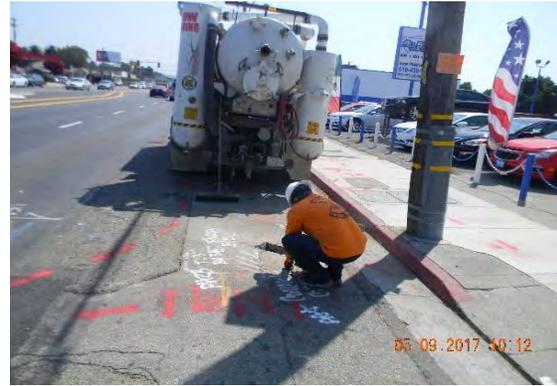
Pothole # 23 (2nd utility)

Utility	Depth	Material	Soil Type	Location		
ATT	38"	Concrete	Dirt, clay	E 14th St and 166th Ave		
Cut Size	1' x 1'	Asphalt Thickness	5"	Concrete Thickness	5"	
Location Reference	60" Northeast from face of curb. 76" Northwest from edge of tv box.

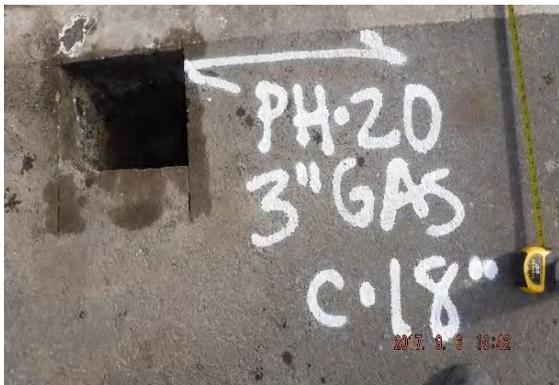
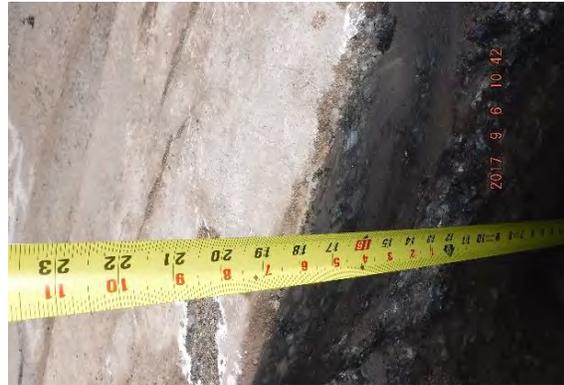
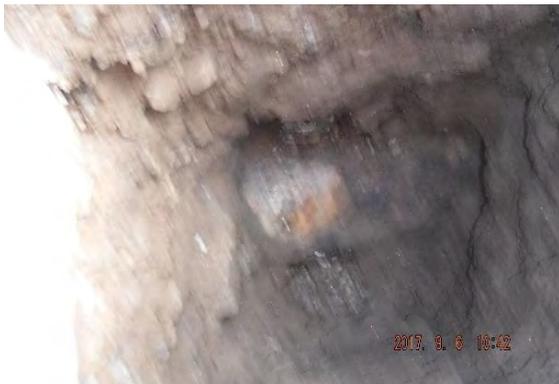
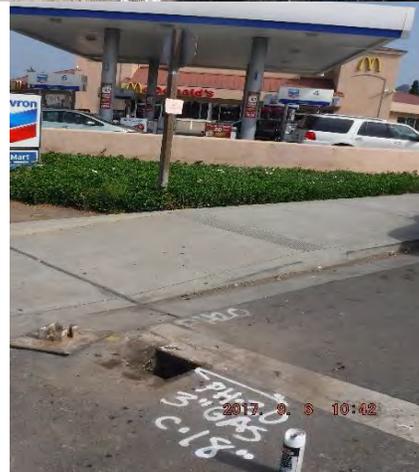
Pothole # 20

Utility	Depth	Material	Soil Type	Location		
3" Gas	18"	Steel	Hard dirt, rocks	E 14th St and 166th Ave		
Cut Size	1' x 1'	Asphalt Thickness	5"	Concrete Thickness	0	
Location Reference	138" Southwest of stop sign. 123" Southeast of stop sign.

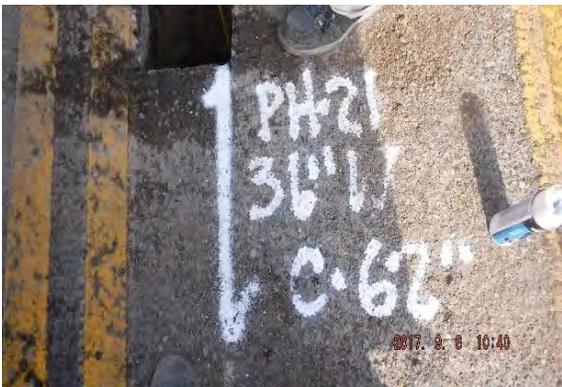
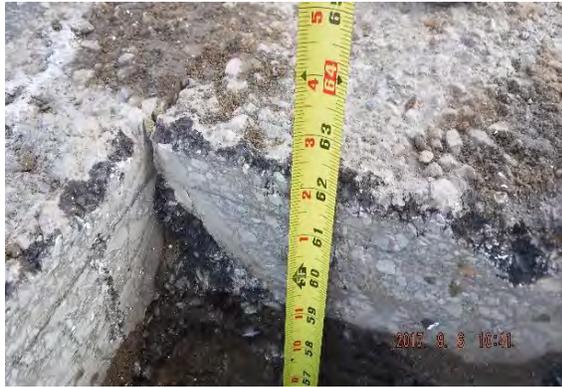
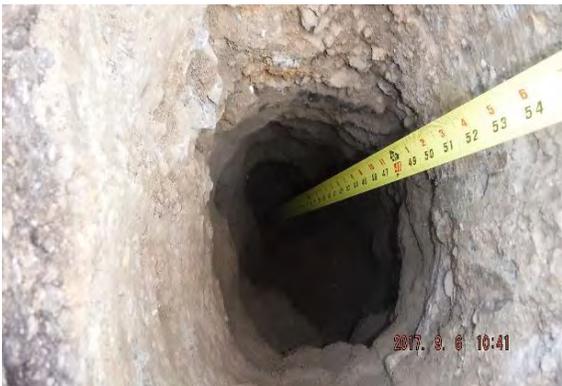
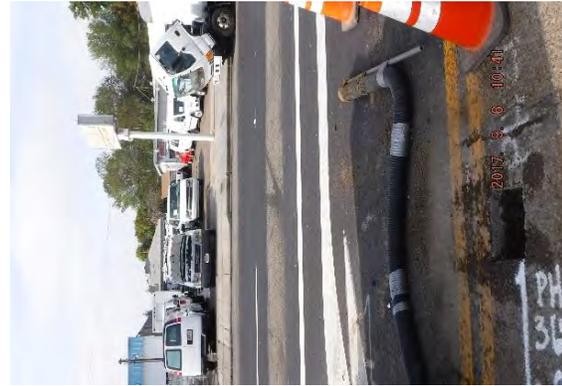
Pothole # 21

Utility	Depth	Material	Soil Type	Location		
36" Water	62"	Steel	Hard dirt, rocks	E 14th St and 166th Ave		
Cut Size	1' x 1'	Asphalt Thickness	5"	Concrete Thickness	0	
Location Reference	25' Northwest of end of double yellow lines. 30' Northeast of face of curb.

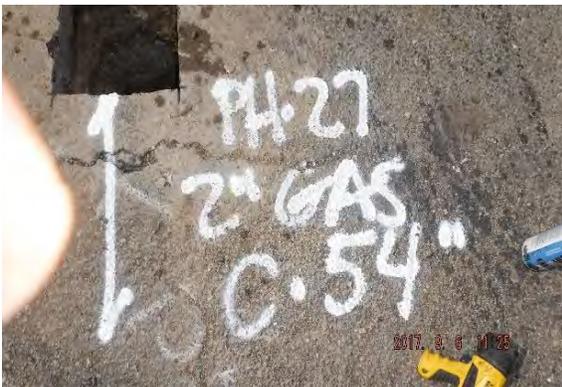
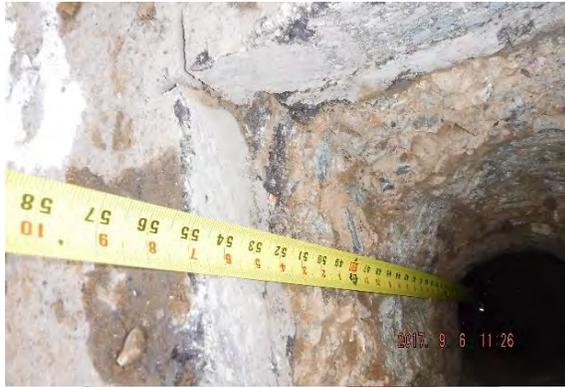
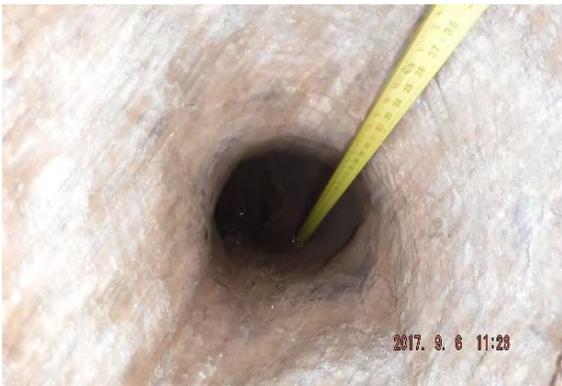
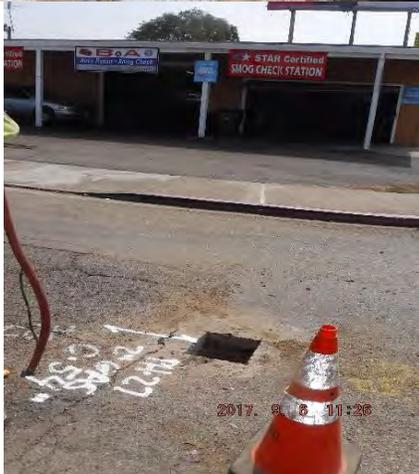
Pothole # 27

Utility	Depth	Material	Soil Type	Location		
2" Gas	54"	Steel	Hard dirt, rocks	E 14th St and 167th Ave		
Cut Size	1' x 1'	Asphalt Thickness	5"	Concrete Thickness	0	
Location Reference	156" Northwest of face of curb. 166" Northeast of crosswalk.

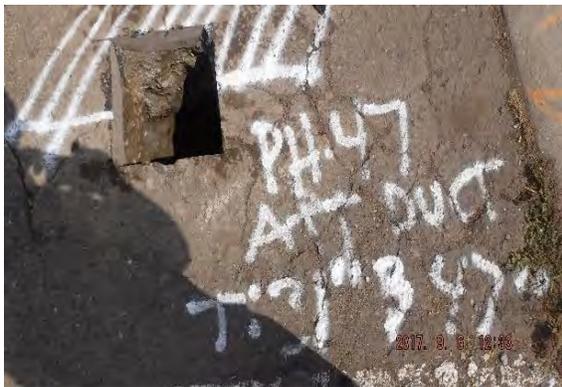
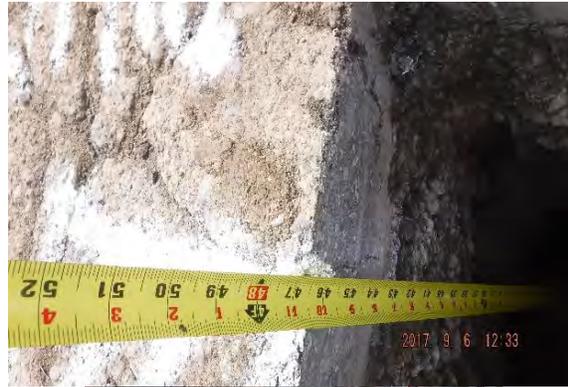
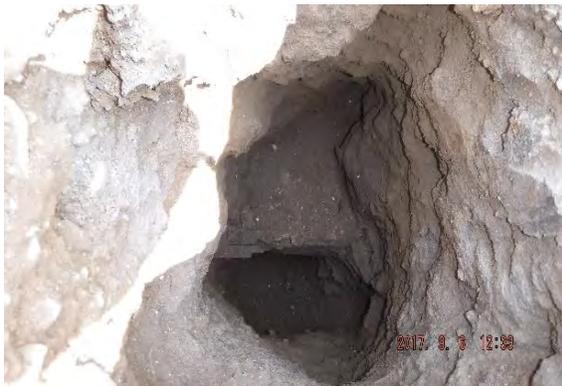
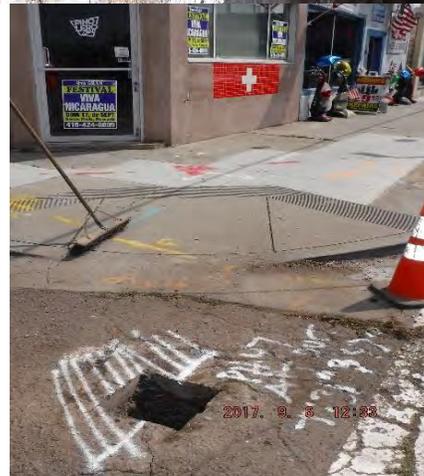
Pothole # 47

Utility	Depth	Material	Soil Type	Location		
ATT Duct	Top: 31" Bot: 47"	Concrete	Hard dirt, rocks	E 14th St and 171st Ave		
Cut Size	1' x 1'	Asphalt Thickness	5"	Concrete Thickness	0	
Location Reference	70" Southeast of water valve. 90" Southwest of water valve.

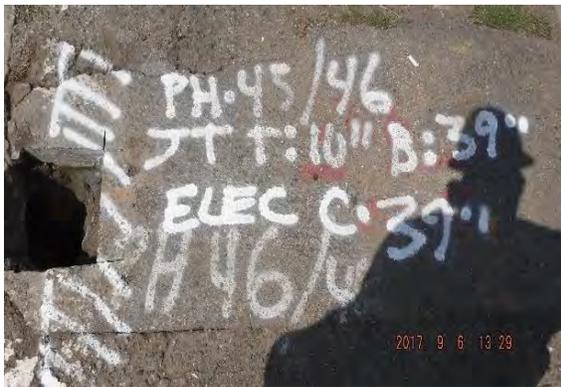
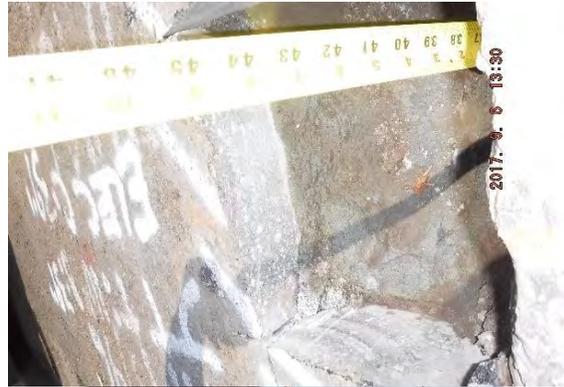
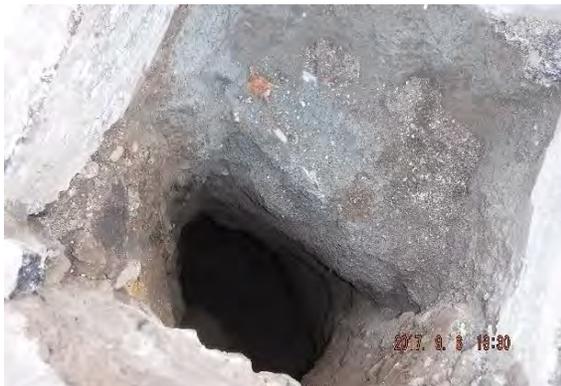
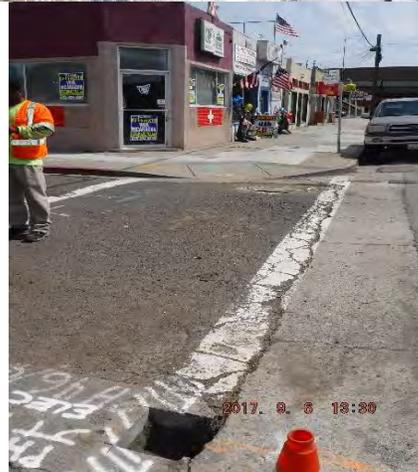
Pothole # 45

Utility	Depth	Material	Soil Type	Location		
JT	Top: 10" Bot: 39"	Slurry	Hard dirt, rocks	E 14th St and 171st Ave		
Cut Size	1' x 2'	Asphalt Thickness	5"	Concrete Thickness	0	
Location Reference	170" Southeast of light pole. 170" Southwest of 171st St sign.

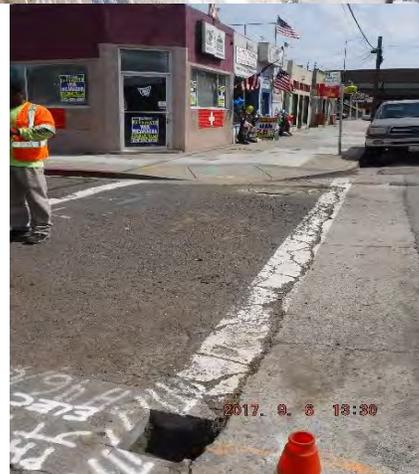
Pothole # 46

Utility	Depth	Material	Soil Type	Location		
Electric	39"	Slurry	Hard dirt, rocks	E 14th St and 171st Ave		
Cut Size	1' x 2'	Asphalt Thickness	5"	Concrete Thickness	0	
Location Reference	170" Southeast of light pole. 170" Southwest of 171st St sign.

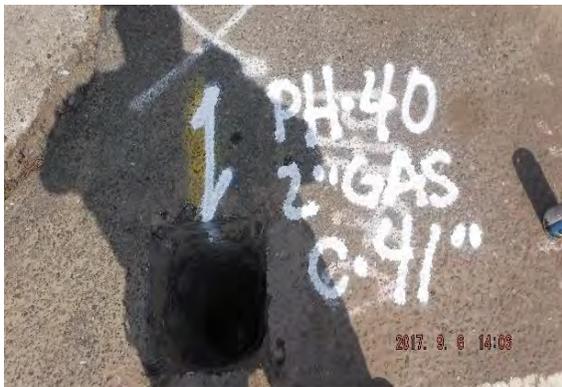
Pothole # 40

Utility	Depth	Material	Soil Type	Location		
2" Gas	41"	Steel	Hard dirt, rocks	E 14th St and 170th Ave		
Cut Size	1' x 1'	Asphalt Thickness	5"	Concrete Thickness	0	
Location Reference	145" Southeast of street light. 58" Southwest of street light.

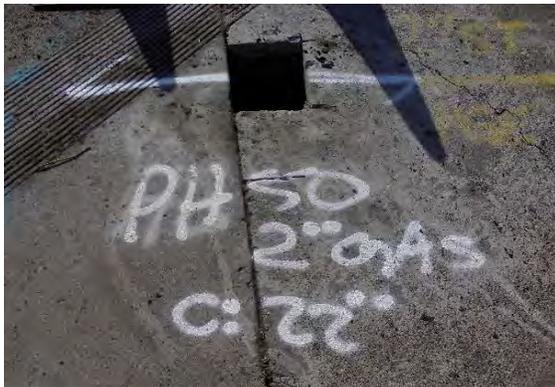
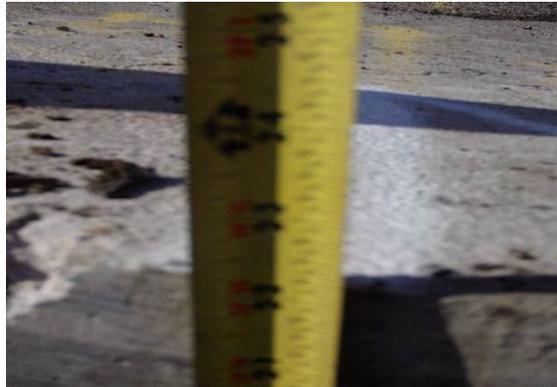
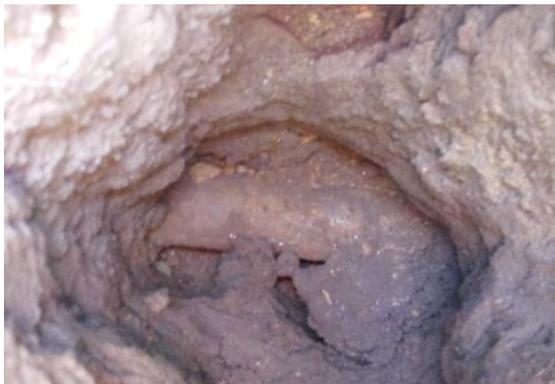
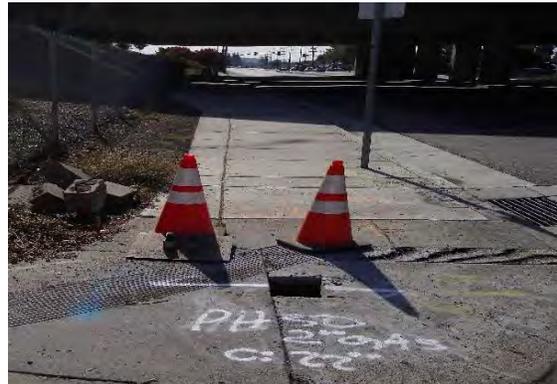
Pothole # 50

Utility	Depth	Material	Soil Type	Location		
2" Gas	22"	Steel	Hard dirt, rocks, clay	E 14 St and 172nd Ave		
Cut Size	1' x 1'	Asphalt Thickness	0	Concrete Thickness	4"	
Location Reference	53" Northeast of edge of curb. 73" Northwest of storm drain grate.

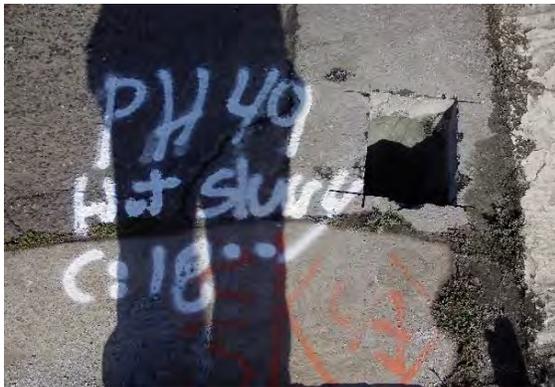
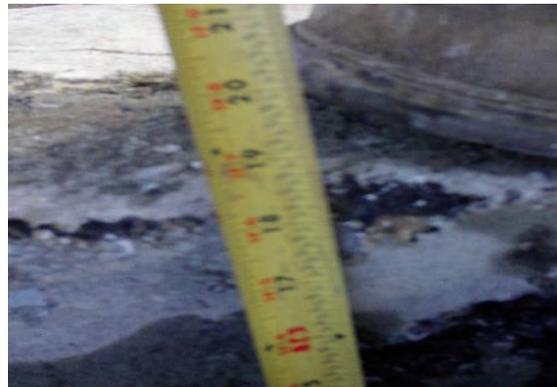
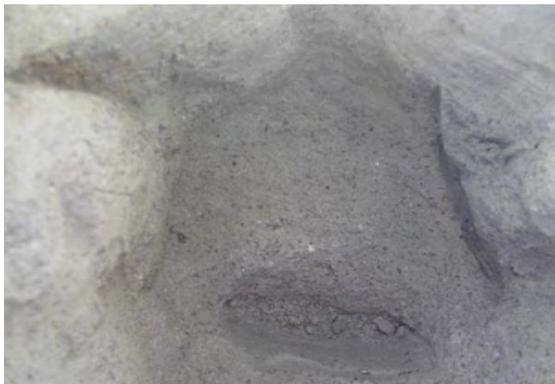
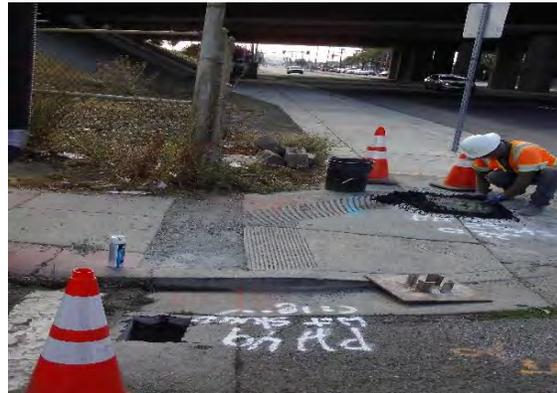
Pothole # 49

Utility	Depth	Material	Soil Type	Location		
Electric	0.00		Hard dirt, rocks, clay	E 14th St and 172nd Ave		
Cut Size	1' x 1'	Asphalt Thickness	5"	Concrete Thickness	0	
Location Reference	Hit slurry at 18". Pothole is 19" Northwest of edge of curb. 6" Southwest of pedestrian crosswalk line.

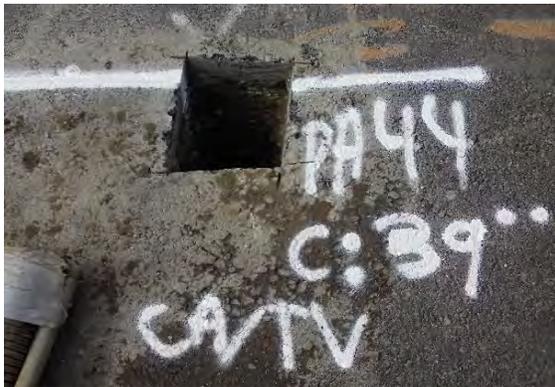
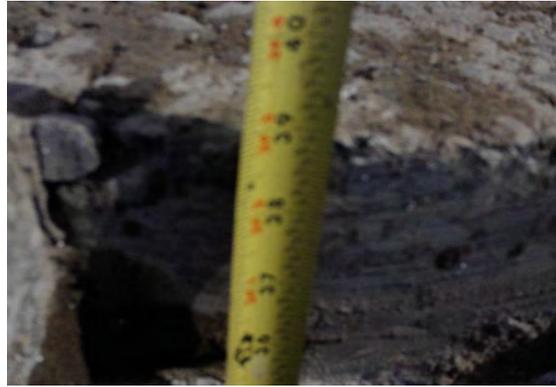
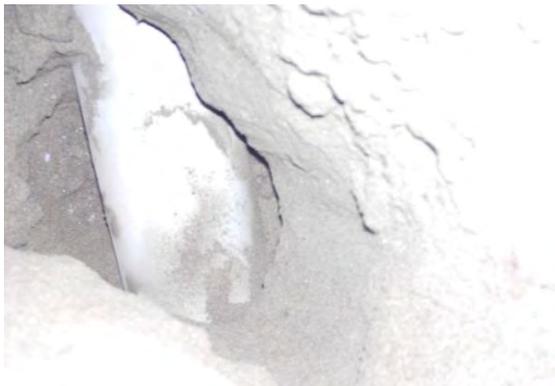
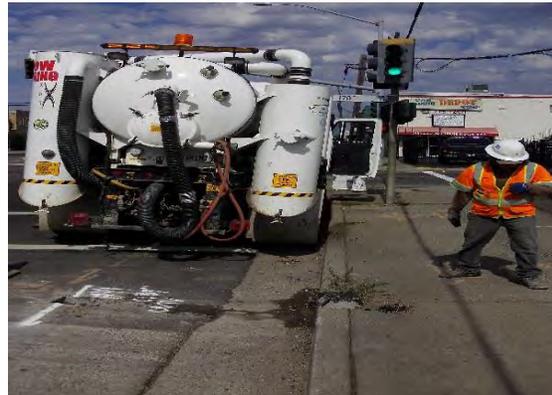
Pothole # 44

Utility	Depth	Material	Soil Type	Location		
4" CATV	39"	PVC	Hard dirt, rocks, clay	E 14th St and 170th Ave		
Cut Size	1' x 1'	Asphalt Thickness	6"	Concrete Thickness	0	
Location Reference	57" Southwest of face of curb. 97" Southeast of pedestrian crosswalk line.

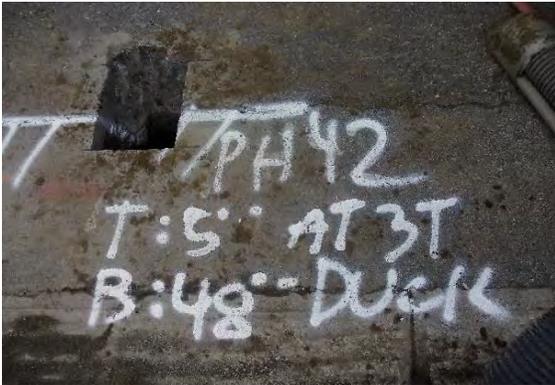
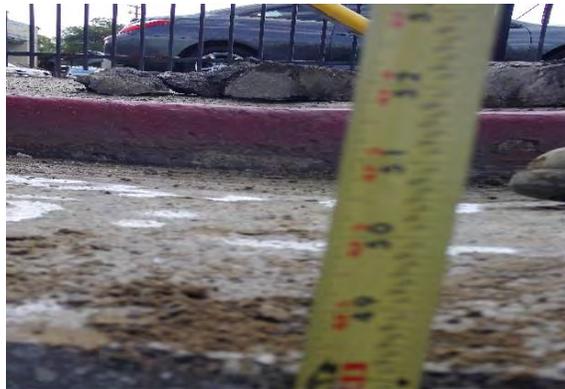
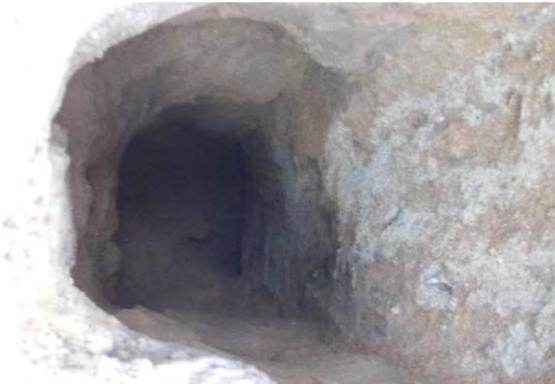
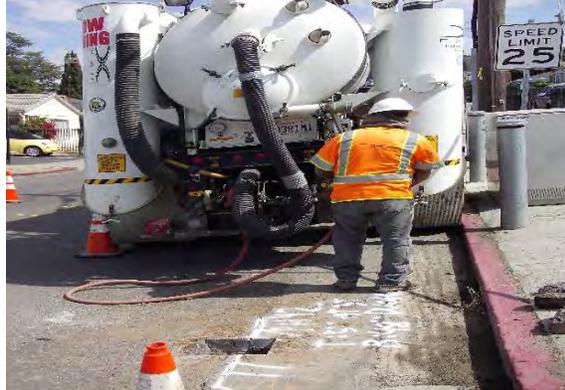
Pothole # 43

Utility	Depth	Material	Soil Type	Location		
ATT, PGE HV	Top: 5" Bot: 48"	Unknown	Hard dirt, rocks, clay	E 14th St and 170th Ave		
Cut Size	1' x 1'	Asphalt Thickness	4"	Concrete Thickness	0	
Location Reference	39" Northwest of face of curb. 55" Northeast of telephone pole.

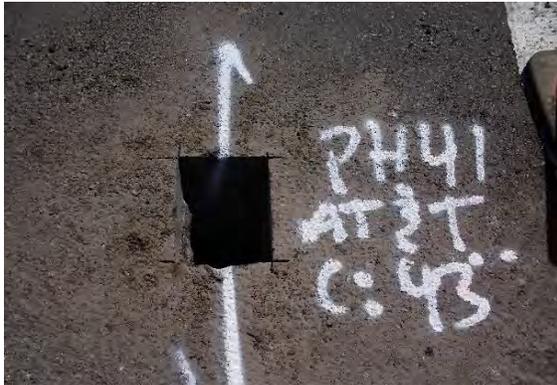
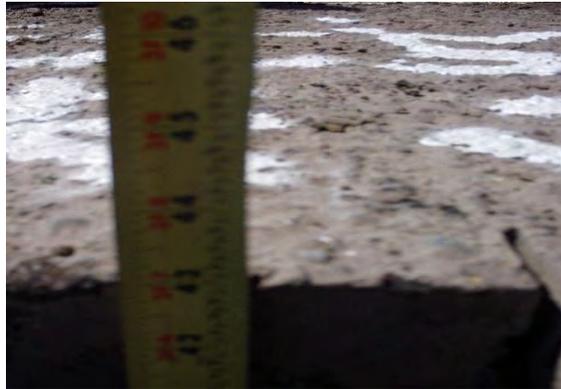
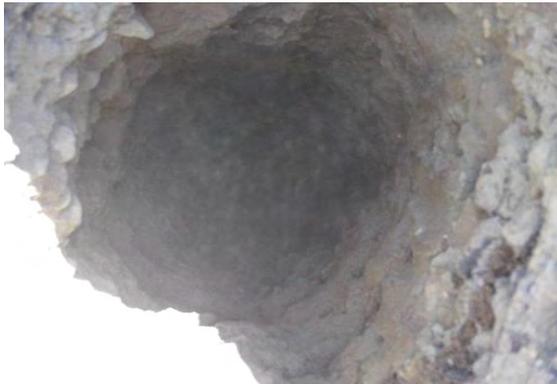
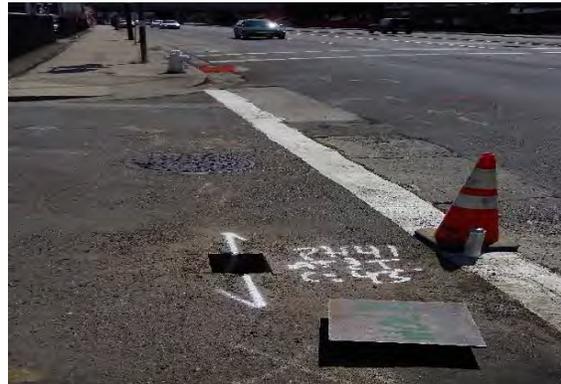
Pothole # 41

Utility	Depth	Material	Soil Type	Location		
ATT Conduits	43"	Unknown	Hard dirt, rocks, clay	E 14th St and 170th Ave		
Cut Size	1' x 1'	Asphalt Thickness	4"	Concrete Thickness	0	
Location Reference	46" Southeast of face of curb. 49" Southwest of traffic light.

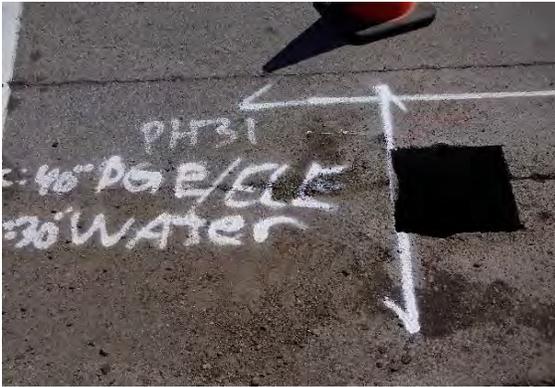
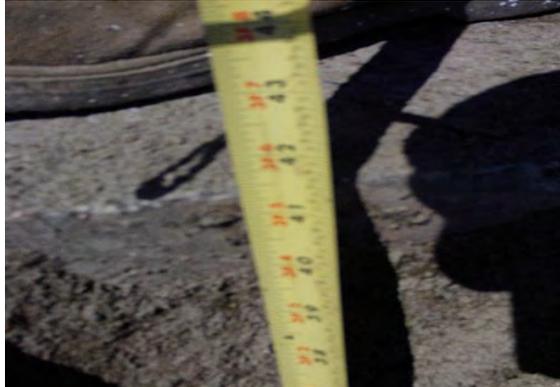
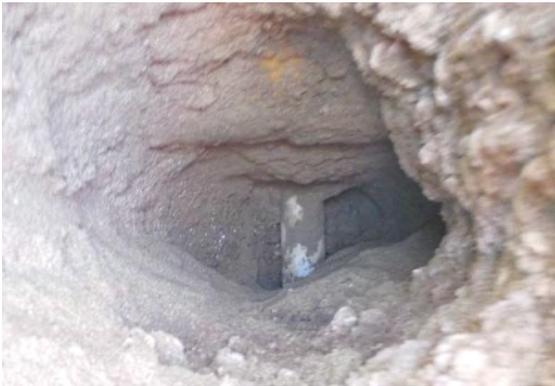
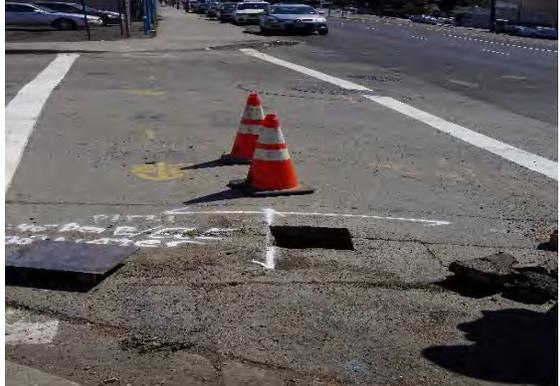
Pothole # 31

Utility	Depth	Material	Soil Type	Location		
Water	30"	Steel	Hard dirt, rocks, clay	E 14th St and 168th Ave		
Cut Size	1' x 1'	Asphalt Thickness	4"	Concrete Thickness	0	
Location Reference	84" Southeast of face of curb. 43" Southwest of pedestrian crosswalk line.

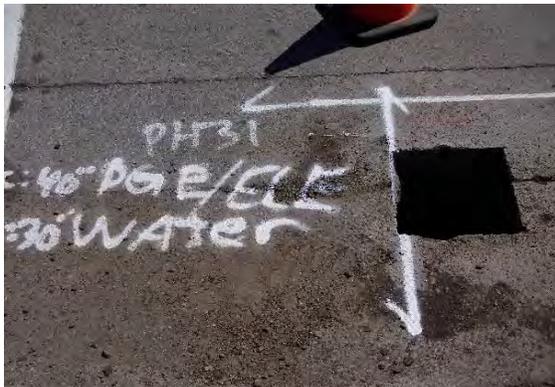
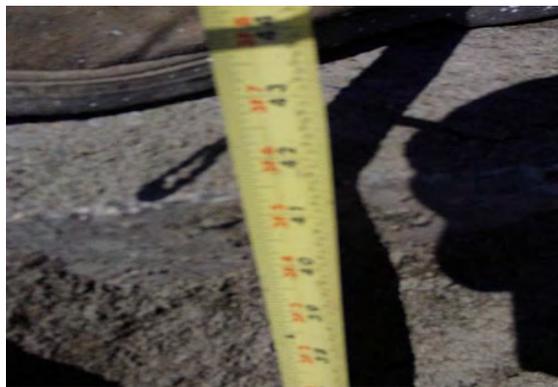
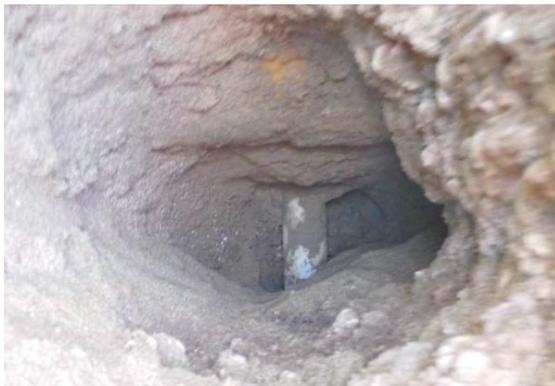
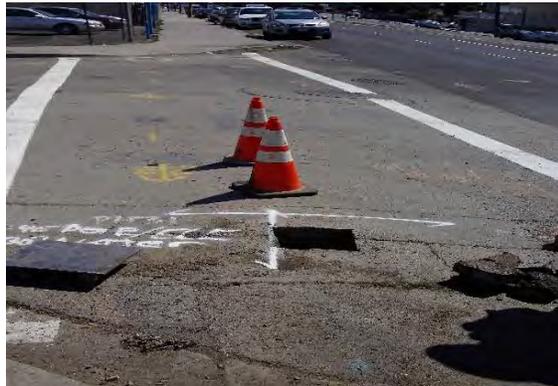
Pothole # 31 (2nd utility)

Utility	Depth	Material	Soil Type	Location		
Electric	40"	PVC	Hard dirt, rocks, clay	E 14th St and 168th Ave		
Cut Size	1' x 1' (2nd util)	Asphalt Thickness	4"	Concrete Thickness	0	
Location Reference	84" Southeast of face of curb. 43" Southwest of pedestrian crosswalk line.

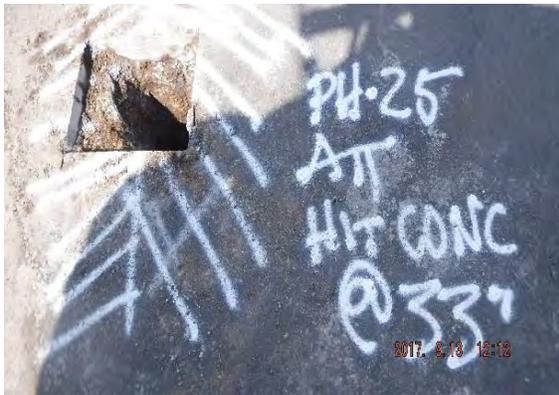
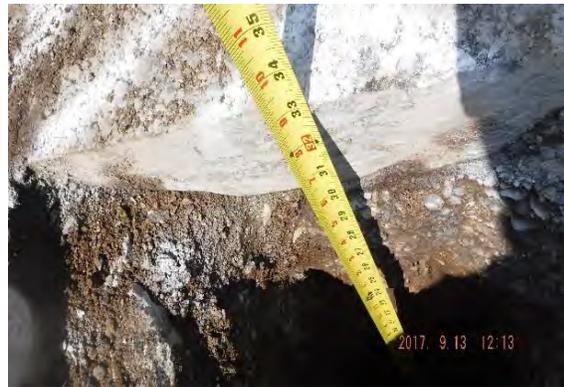
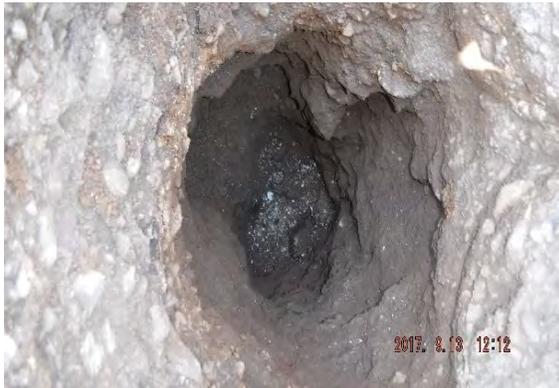
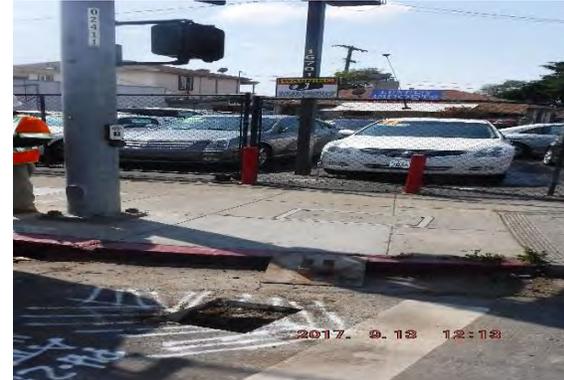
Pothole # 25

Utility	Depth	Material	Soil Type	Location		
ATT Duct	33"	Concrete	Hard clay, dirt, rocks	E 14th St and 167th Ave		
Cut Size	1' x 1'	Asphalt Thickness	5"	Concrete Thickness	0	
Location Reference	37" Northeast of face of curb. 19" Southeast of pedestrian crosswalk.

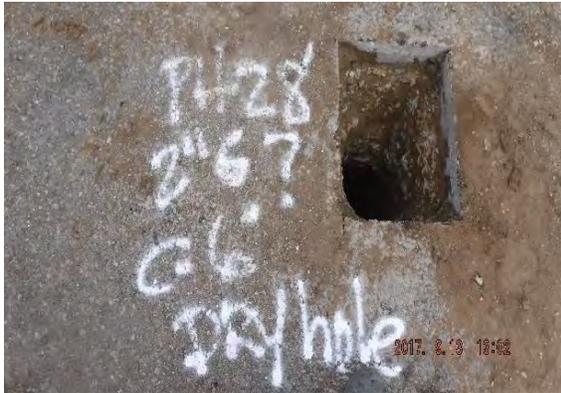
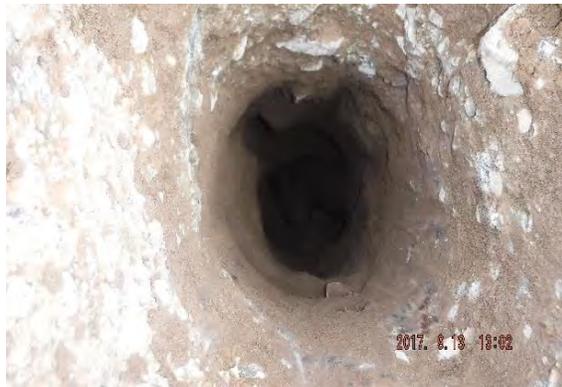
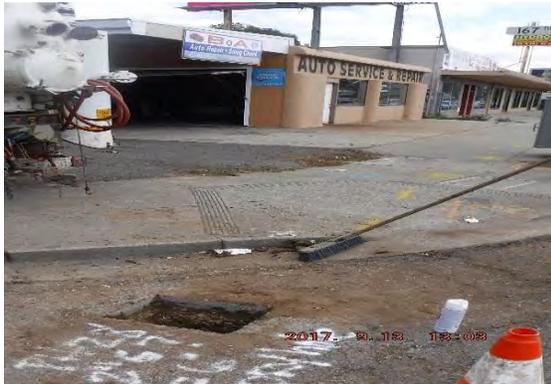
Pothole # 28

Utility	Depth	Material	Soil Type	Location		
2" Gas	Dry Hole	Unknown	Hard clay, dirt, rocks	E 14th St and 167th Ave		
Cut Size	1' x 1'	Asphalt Thickness	5"	Concrete Thickness	0	
Location Reference	129" Southwest of street light. 190" Northwest of street light.

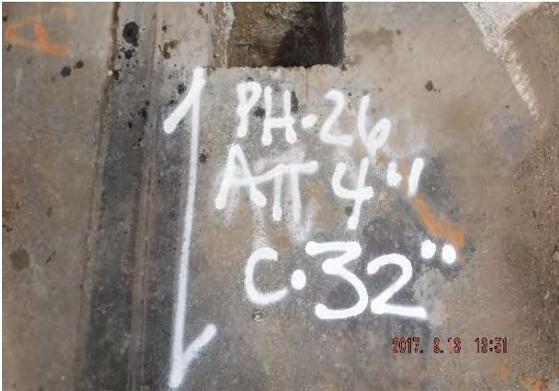
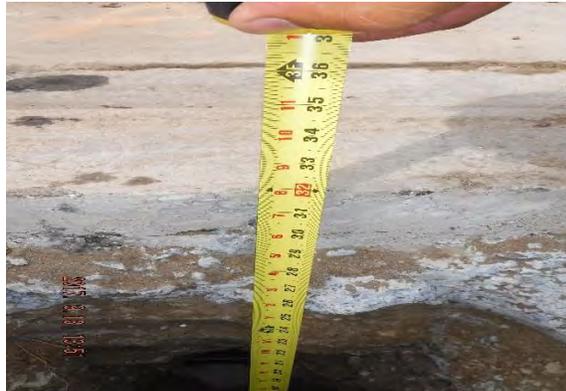
Pothole # 26

Utility	Depth	Material	Soil Type	Location		
4" ATT	32"	Plastic	Hard clay, dirt, rocks	E 14th St and 167th Ave		
Cut Size	1' x 1'	Asphalt Thickness	5"	Concrete Thickness	0	
Location Reference	22" Southeast of face of curb. 34" Southwest of Electric pole.

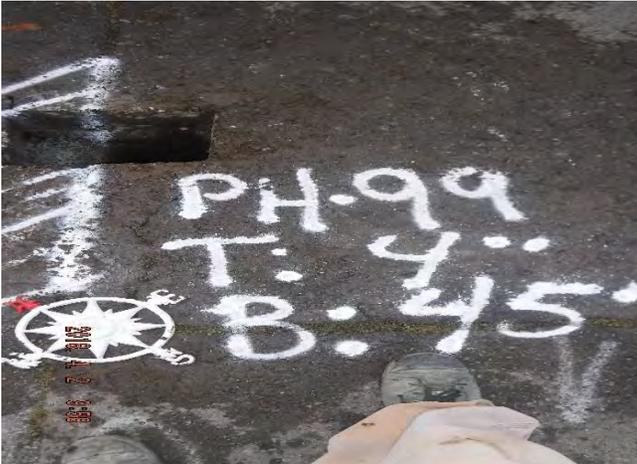
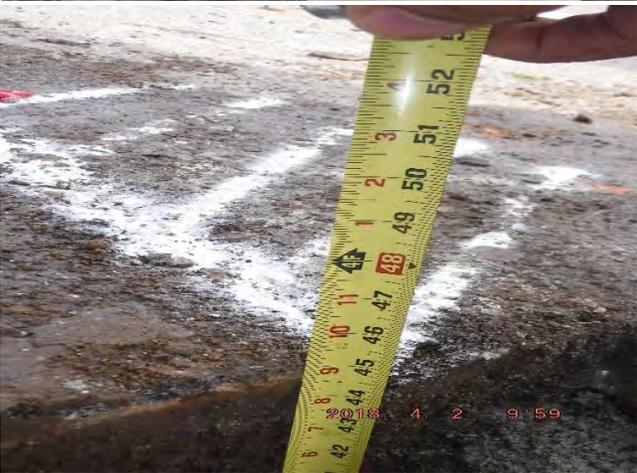
Pothole # 99

Cut Size: 1' x 1'		Location: 64" SW of Face of Curb. 50" NW of Storm Drain.
Asphalt: 4" Concrete: Top: 4" Depth: Bottom: 45" Utility: Joint trench Size: 0 Material: Slurry Soil: Hard dirt, rocks, sand		Notes:

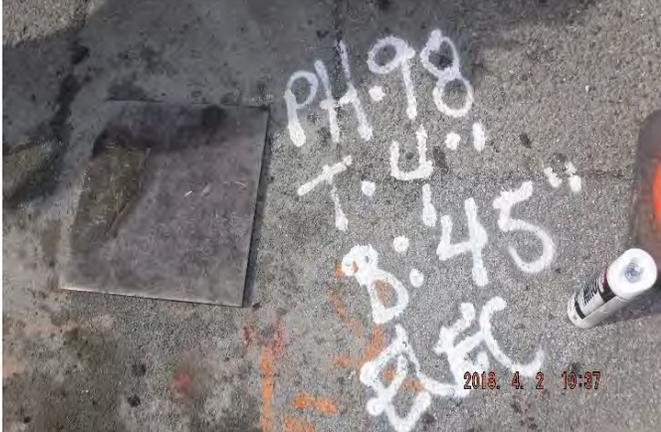
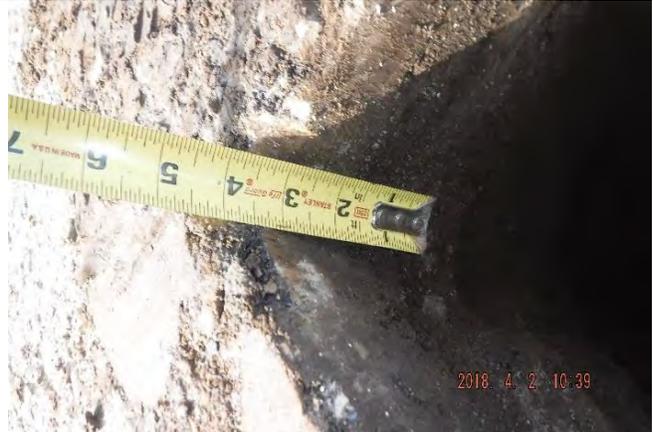
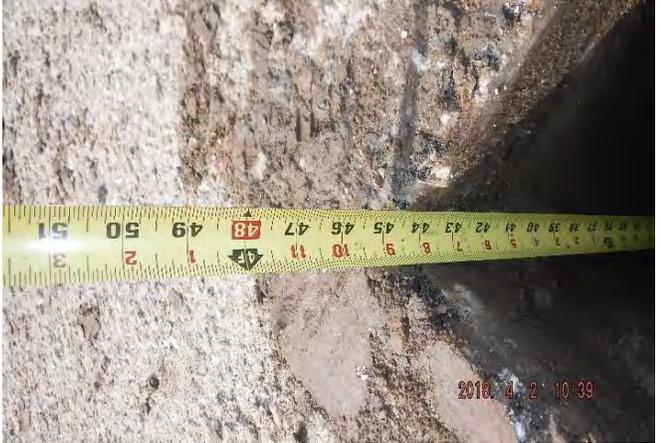
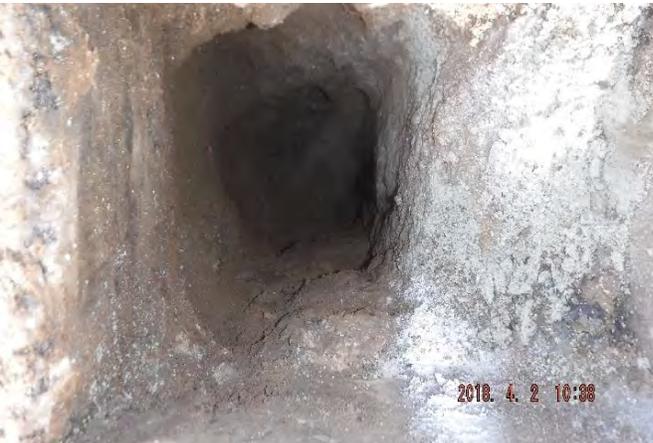
Pothole # 98

<p>Cut Size: 1' x 1'</p> <p>Asphalt: 4"</p> <p>Concrete:</p> <p>Top: 4"</p> <p>Depth: Bottom: 45"</p> <p>Utility: Electrical</p> <p>Size:</p> <p>Material: Slurry</p> <p>Soil: Hard dirt, rocks, sand</p>

<p>Location: 74" SW of Electric Post. 174" SE of Electric Post.</p> <p>Notes:</p>
---	--	---

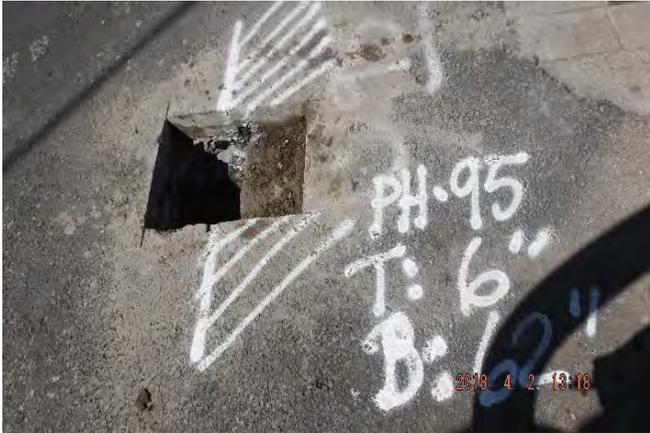
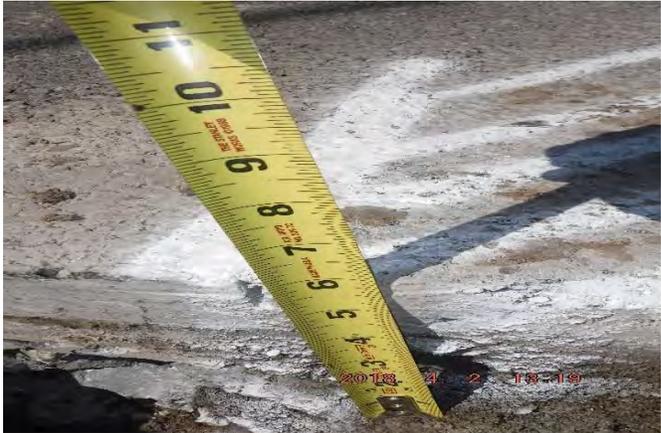
Pothole # 95

Cut Size: 1' x 1'		Location: 72" SW Face of Curb, in-line with Street Light.
Asphalt: 5" Concrete: Top: 6" Depth: Bottom: 62" Utility: Joint trench Size: Material: Slurry Soil: Hard dirt, rocks, sand		Notes:
