EXARO Technologies Corporation

Subsurface Utility Report	
Client	ACPWA - Vincent SendayDiego
Project #	16-1127
City	Hayward
Date	9/18/2017

Pothole # 2A

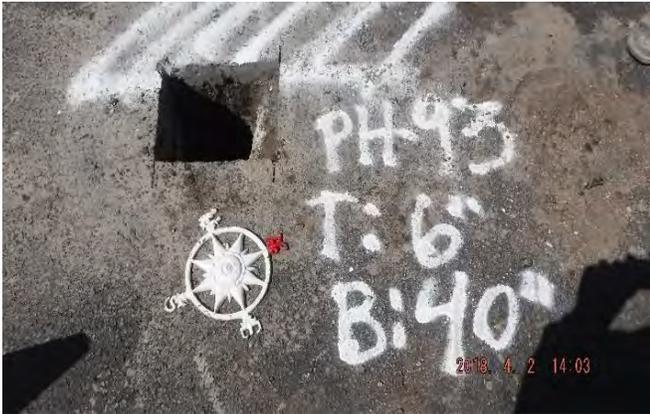
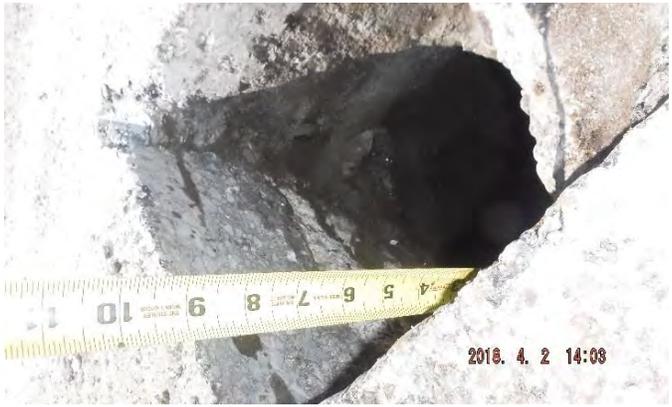
Pothole # 93

<p>Cut Size: 1' x 1'</p>			<p>Location: 170" Southwest of Fire Hydrant. 200" Northwest of Fire Hydrant.</p>
<p>Asphalt: 5"</p> <p>Concrete:</p> <p>Top: 6"</p> <p>Depth: Bottom: 40"</p> <p>Utility: Joint trench</p> <p>Size:</p> <p>Material: Slurry</p> <p>Soil: Hard dirt, rocks, sand</p>	<p>Notes:</p>

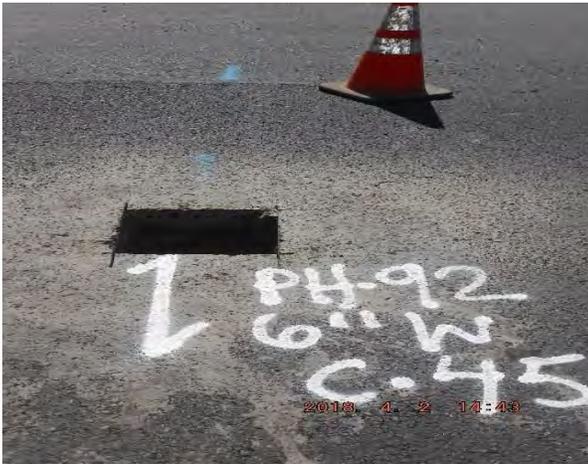
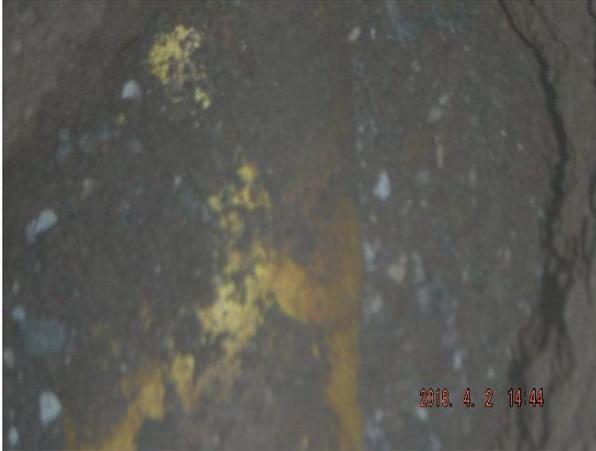
Pothole # 92

Asphalt:	5"	Concrete:		Depth:	45"	Utility:	Water	Size:	6"	Material:	Yellow pipe	Soil:	Hard dirt, rocks, sand	<p>Location: 174" Southwest of crosswalk. 96" SE of Pacific Bell Manhole.</p> <p>Notes:</p>
Asphalt:	5"														
Concrete:															
Depth:	45"														
Utility:	Water														
Size:	6"														
Material:	Yellow pipe														
Soil:	Hard dirt, rocks, sand

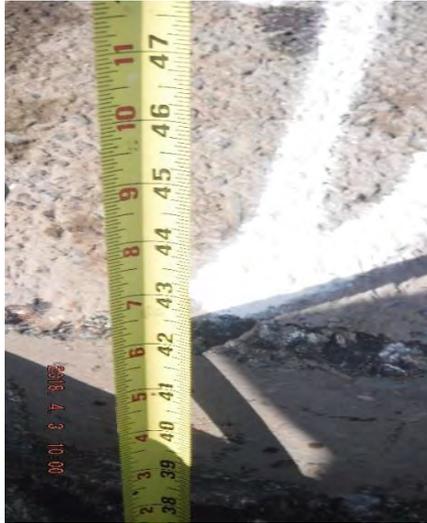
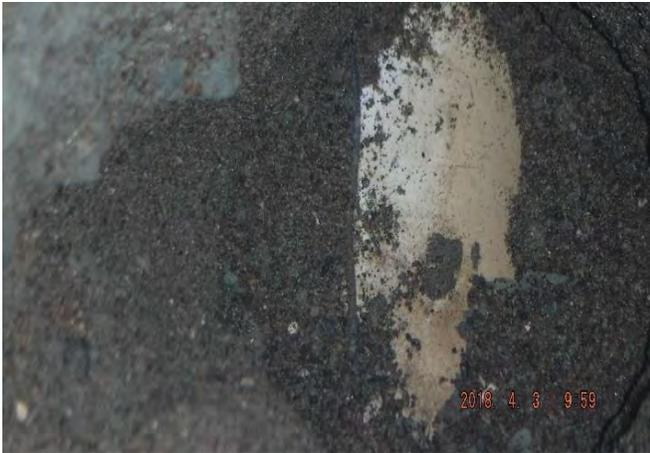
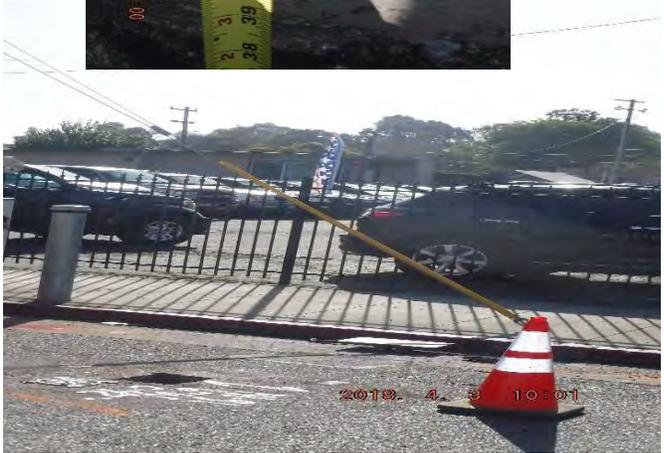
Pothole # 91

<p>Cut Size: 1' x 1'</p> <p>Asphalt: 5"</p> <p>Concrete:</p> <p>Depth: 42"</p> <p>Utility: Water</p> <p>Size: 6"</p> <p>Material: Yellow pipe</p> <p>Soil: Hard dirt, rocks, sand</p>	<p>Location: 128" Northeast of water valve, in-line with valve.</p> <p>Notes:</p>
---	---

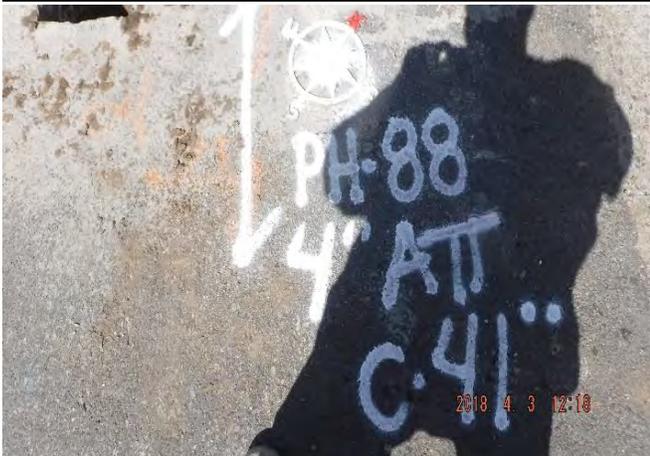
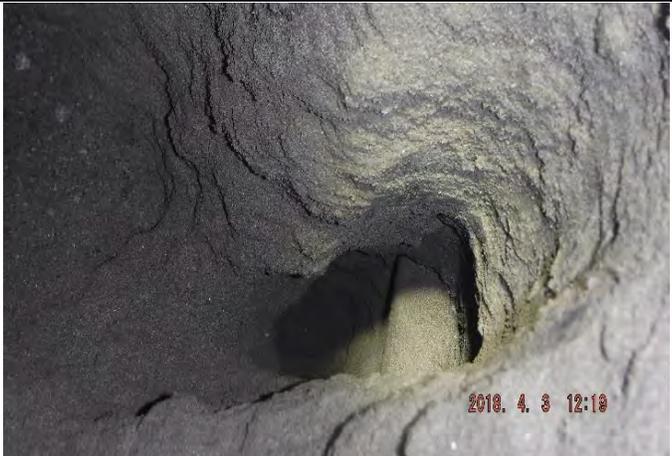
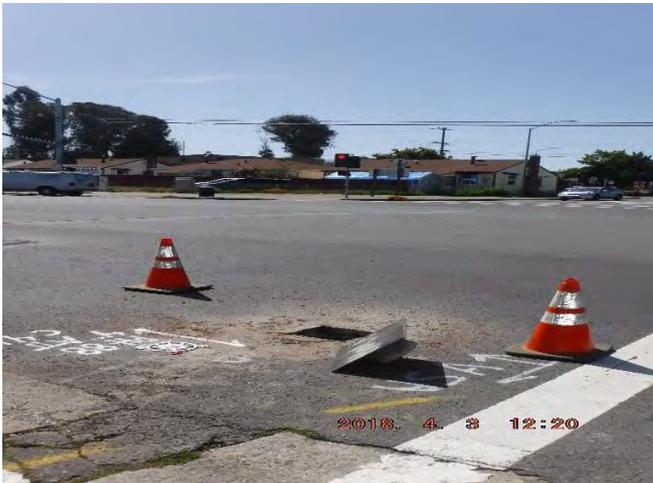
Pothole # 88

<p>Cut Size: 1' x 1'</p> <p>Asphalt: 5"</p> <p>Concrete:</p> <p>Depth: 41"</p> <p>Utility: ATT/JT</p> <p>Size: 4"</p> <p>Material: PVC</p> <p>Soil: Hard dirt, rocks, sand</p>

<p>Location: 60" SW of crosswalk. 43" SE of crosswalk.</p> <p>Notes:</p>
--	--

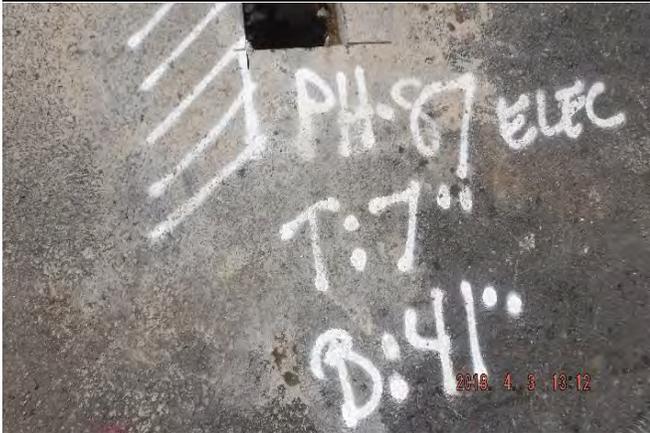
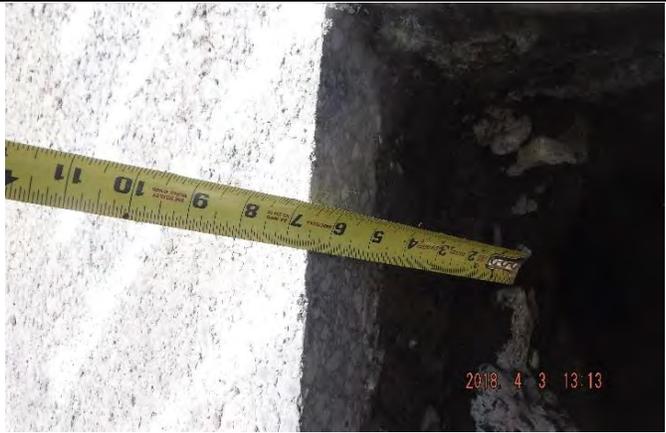
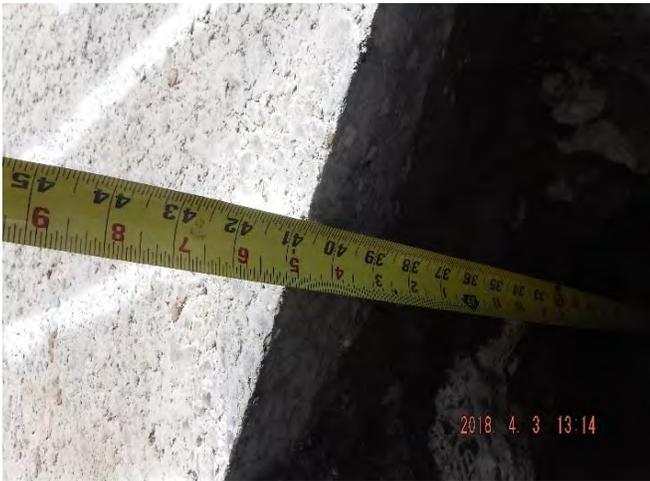
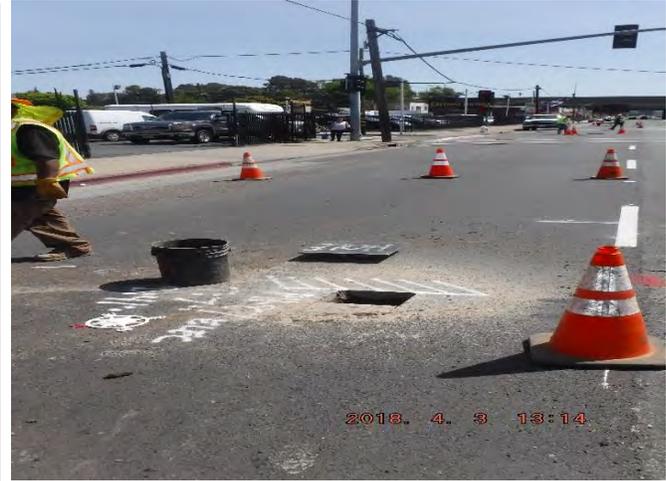
Pothole # 87

<p>Cut Size: 1' x 1'</p> <p>Asphalt: 5"</p> <p>Concrete:</p> <p>Depth: Top: 7" Bottom: 41"</p> <p>Utility: Electrical / JT</p> <p>Size:</p> <p>Material: Unknown</p> <p>Soil: Hard dirt, rocks, sand</p>

<p>Location: 192" SW of face of curb. In front of Bus Stop.</p> <p>Notes:</p>
---	---

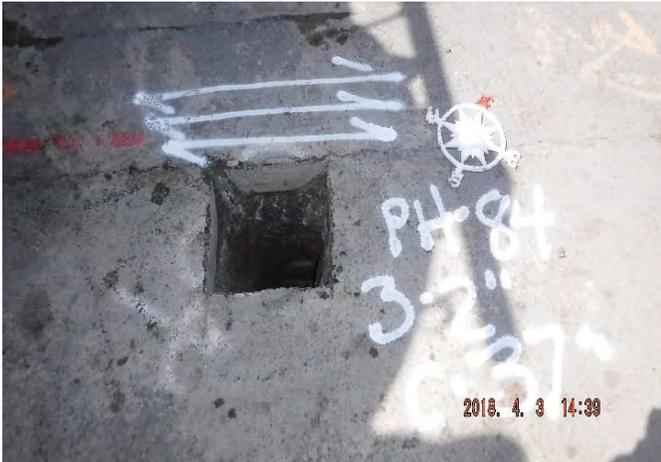
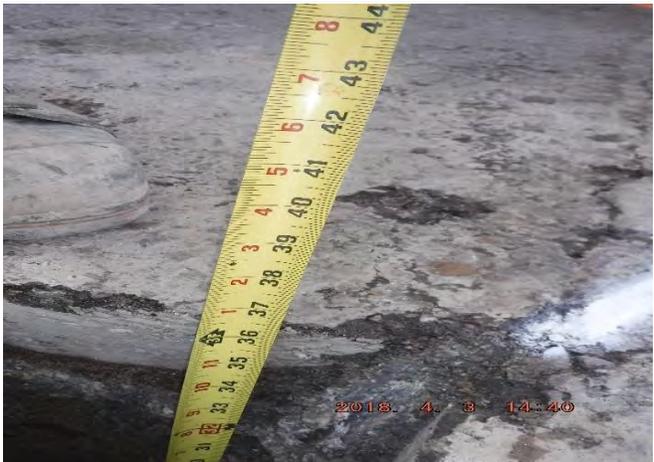
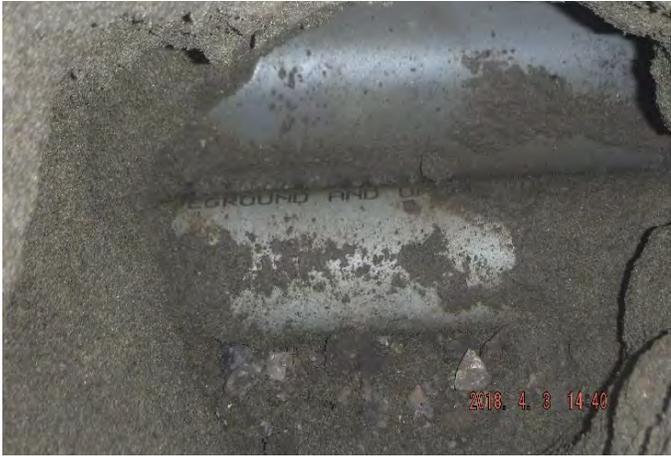
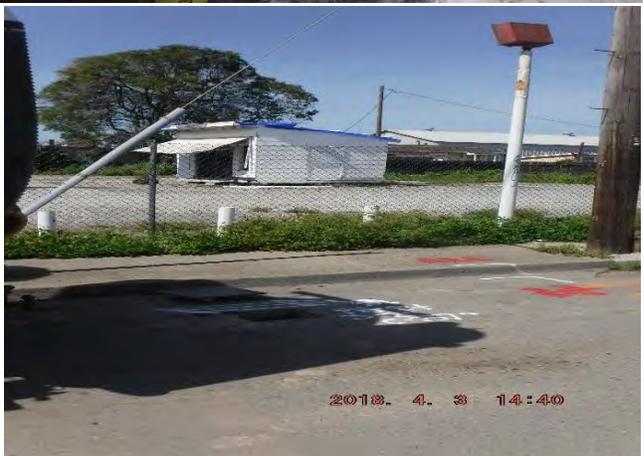
Pothole # 84

<p>Cut Size: 1' x 1'</p> <p>Asphalt: 5"</p> <p>Concrete:</p> <p>Depth: 37"</p> <p>Utility: Joint Trench</p> <p>Size: 3-2"</p> <p>Material: PVC</p> <p>Soil: Hard dirt, rocks, sand</p>

<p>Location: 23" SE of face of curb. 124" SW of electrical pole.</p> <p>Notes:</p>
--	--

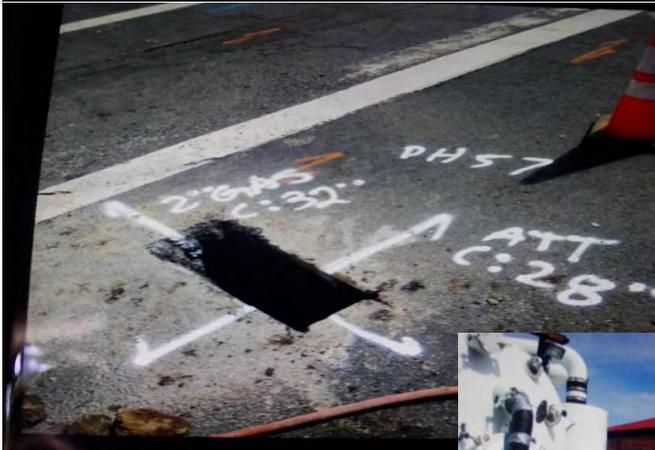
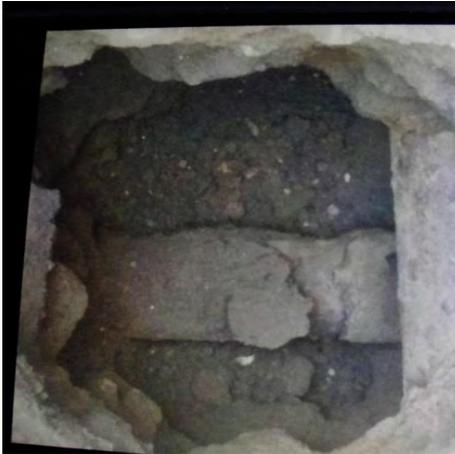
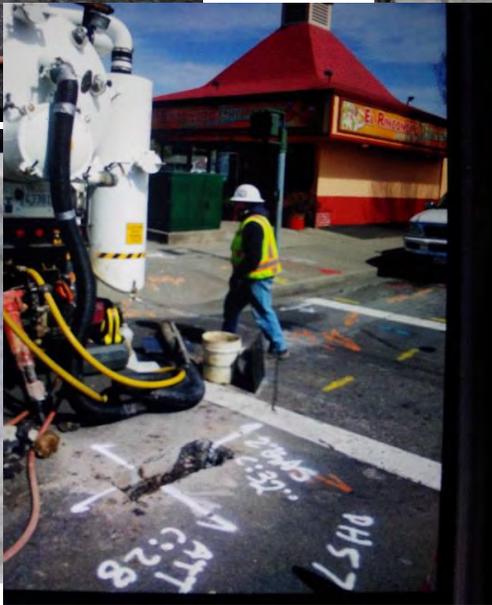
Pothole # 57

Cut Size: 1' x 1'		Location: 40" West of white fog line. 99" E of traffic light.
Asphalt: 10" Concrete: Depth: 28" Utility: AT&T / JT Size: 3" Material: PVC Soil: Hard rocks, mud		Notes:

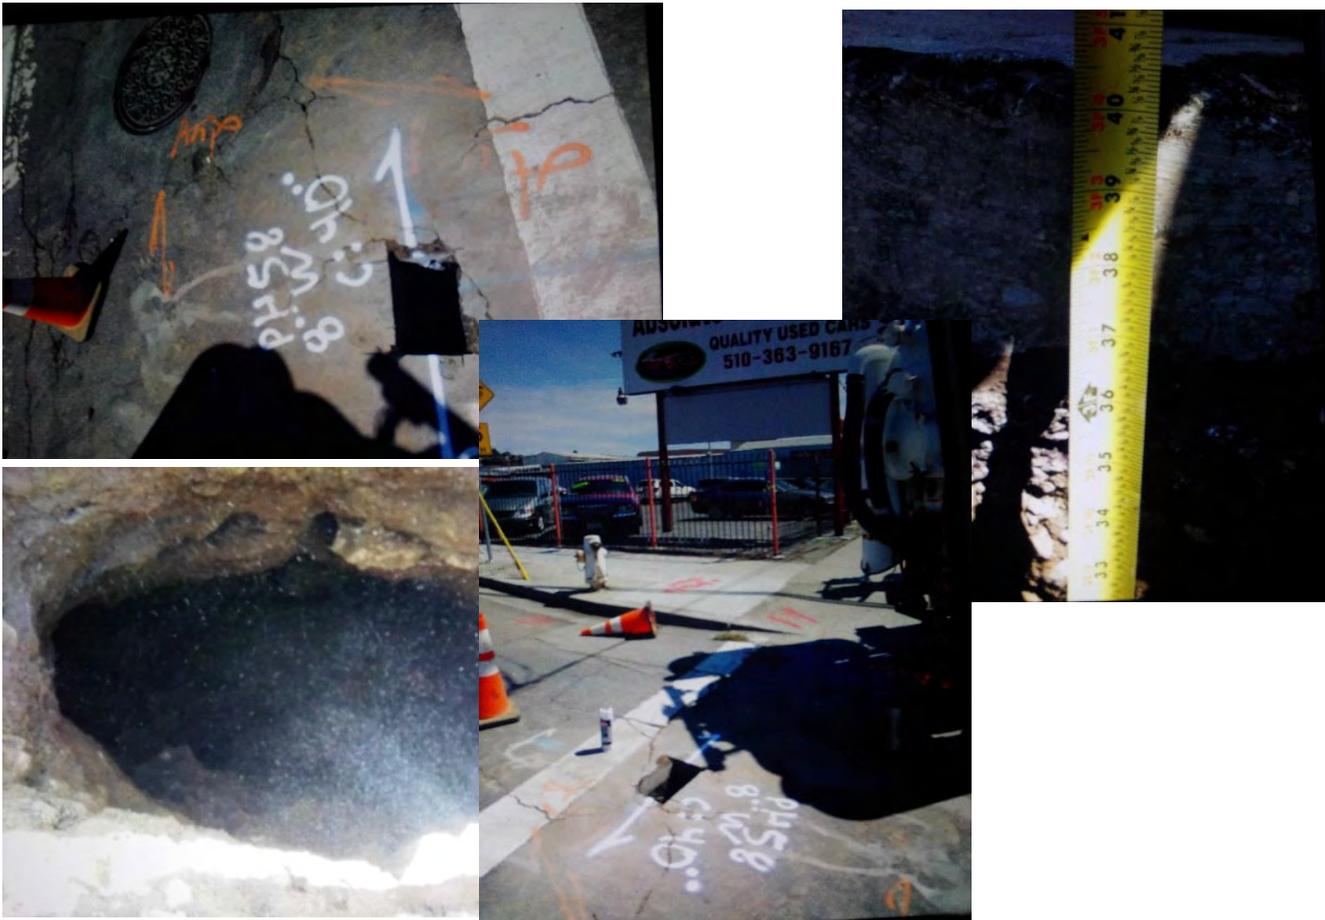
Pothole # 58

<p>Cut Size: 1' x 1'</p> <p>Asphalt: 9"</p> <p>Concrete:</p> <p>Depth: 40"</p> <p>Utility: Water</p> <p>Size: 8"</p> <p>Material: bestos Cement</p> <p>Soil: Hard rocks, mud</p>

<p>Location: 90" NW of edge of curb. 12" SW of crosswalk.</p> <p>Notes:</p>
---	---

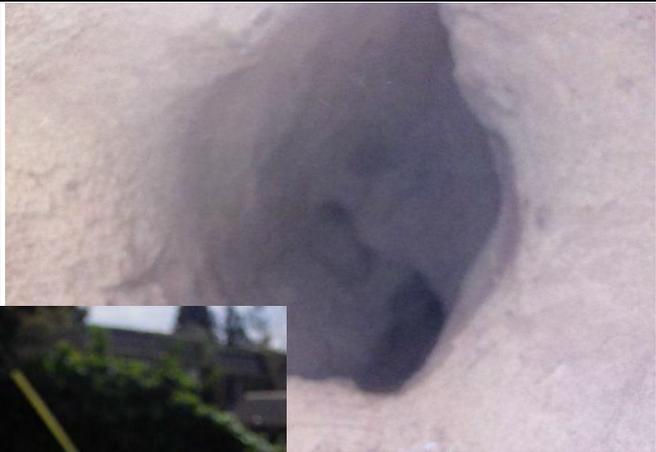
Pothole # 54

<p>Cut Size: 1' x 1'</p> <p>Asphalt: 2"</p> <p>Concrete: 2"</p> <p>Depth: [Diagram shows depth]</p> <p>Utility: Water</p> <p>Size: 8"</p> <p>Material: bestos Cement</p> <p>Soil: Hard rocks, mud</p>	<p>Location: Dryhole, cleared 6'. Pothole is 152" NE of curb. 68" NW of PG&E box.</p> <p>Notes:</p>
---	---

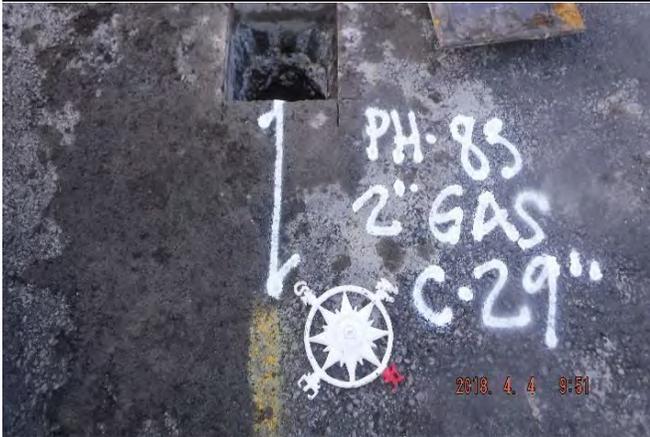
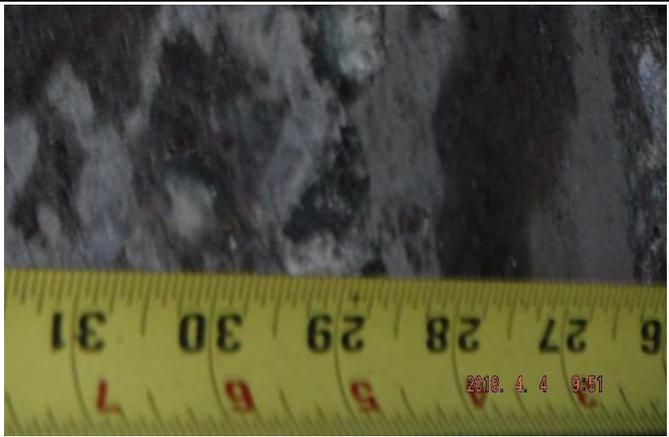
<p>Cut Size: 1' x 1'</p> <p>Asphalt: 5"</p> <p>Concrete:</p> <p>Depth: 29"</p> <p>Utility: Gas</p> <p>Size: 2"</p> <p>Material: Steel</p> <p>Soil: Hard dirt, rocks, sand</p>	<p>Location: 285" SW of gas valve, in-line with valve.</p> <p>Notes:</p>
---	--

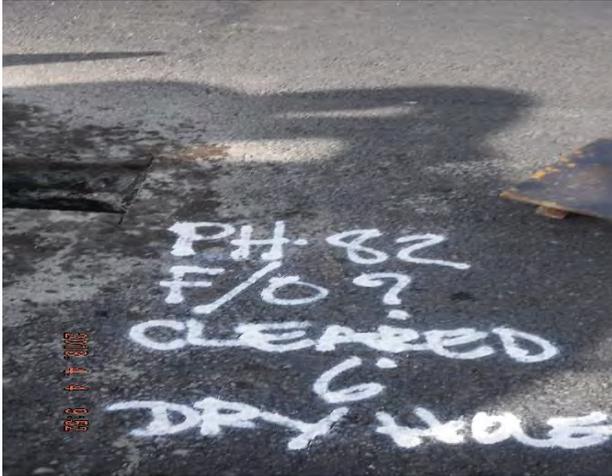
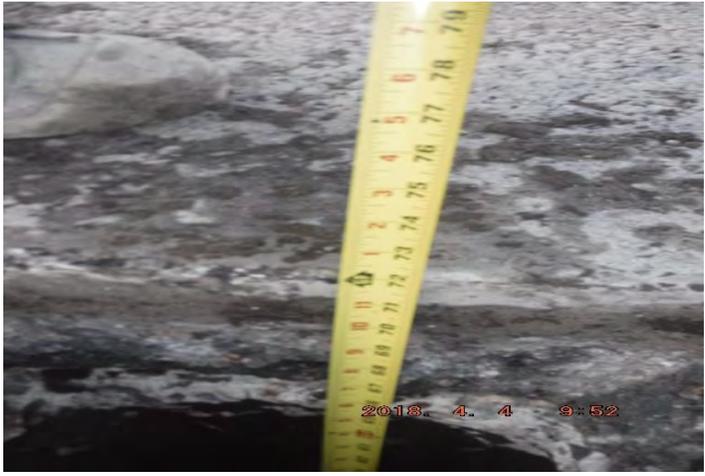
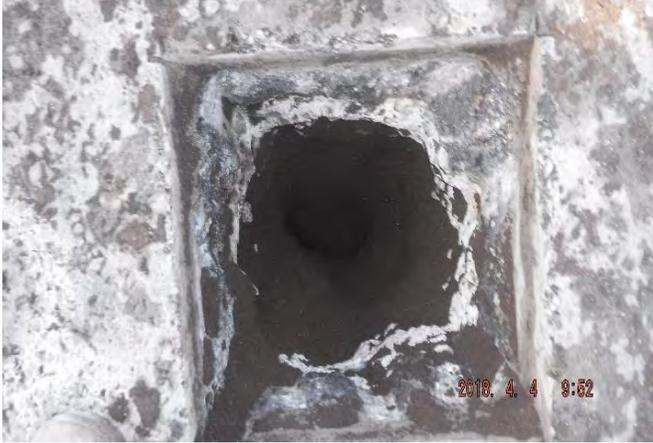
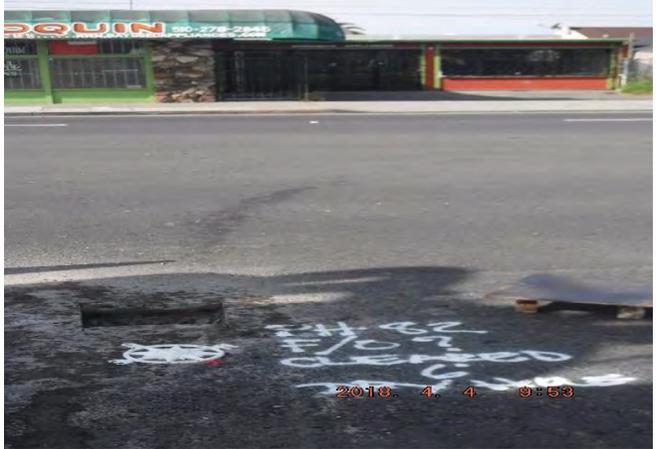
Pothole # 82

<p>Cut Size: 1' x 1'</p> <p>Asphalt: 5"</p> <p>Concrete:</p> <p>Depth: Dry hole</p> <p>Utility: Fiber Optic</p> <p>Size:</p> <p>Material: Unknown</p> <p>Soil: Hard dirt, rocks, sand</p>

<p>Location: 214" SW of fiber optics manhole, in-line with manhole.</p> <p>Notes:</p>
---	---

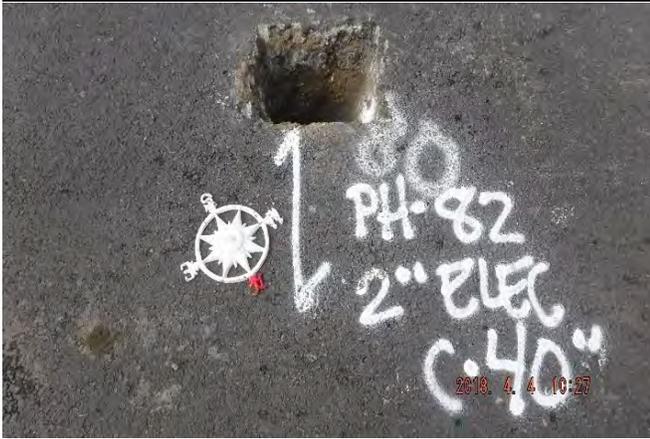
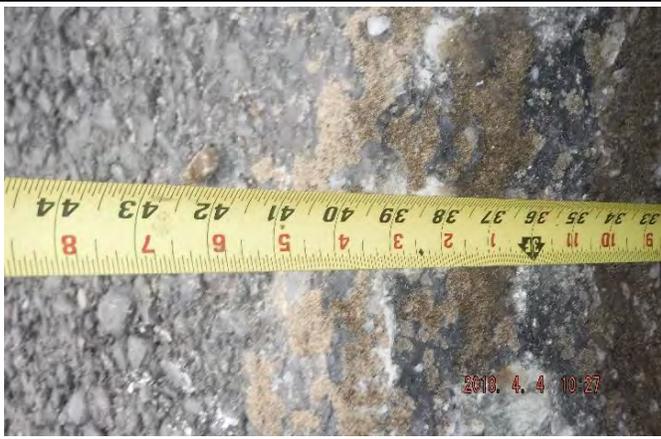
Pothole # 80

<p>Cut Size: 1' x 1'</p> <p>Asphalt: 5"</p> <p>Concrete:</p> <p>Depth: 40"</p> <p>Utility: Electrical</p> <p>Size: 2"</p> <p>Material: PVC</p> <p>Soil: Hard dirt, rocks, sand</p>	<p>Location: 214" SW of crosswalk. 264" NW of manhole.</p> <p>Notes:</p>
--	--

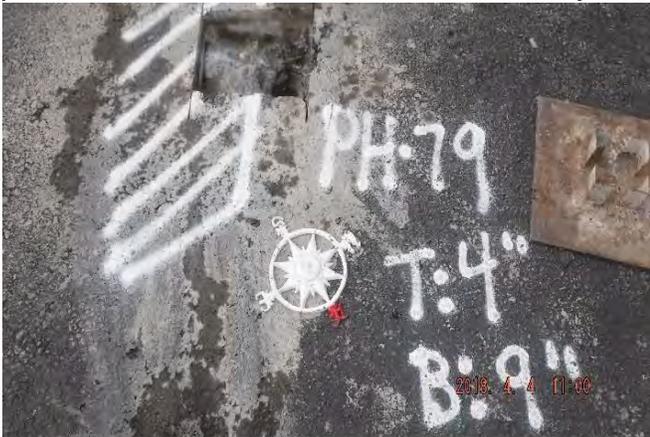
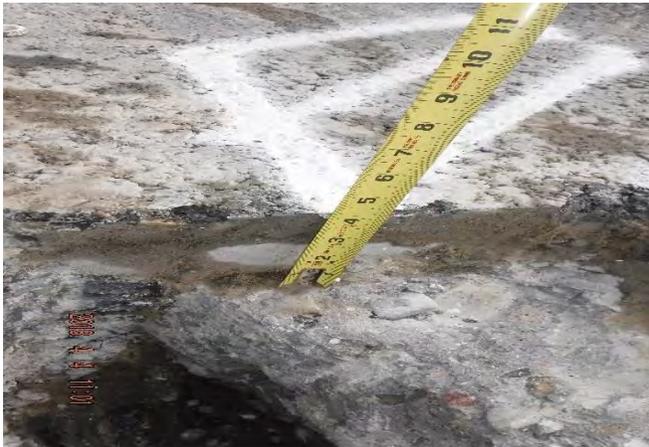
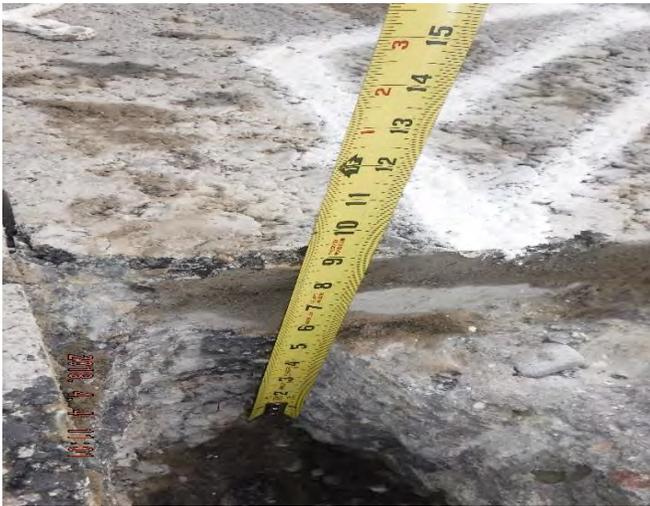
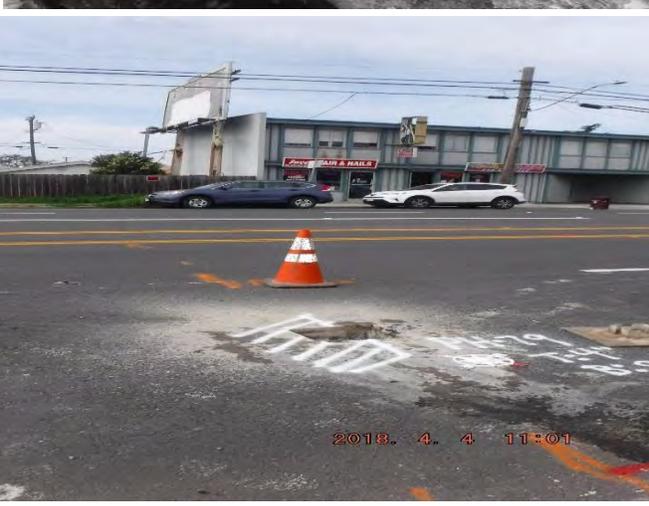
Pothole # 74

<p>Cut Size: 1' x 1'</p> <p>Asphalt: 4"</p> <p>Concrete:</p> <p>Top: 4"</p> <p>Depth: Bottom: 9"</p> <p>Utility: Joint trench</p> <p>Size:</p> <p>Material: Concrete</p> <p>Soil: Hard dirt, rocks, sand</p>

<p>Location: 43" Southeast of electrical box. 64" Northeast of electrical box. Marked #79 on picture.</p>
		<p>Notes:</p>

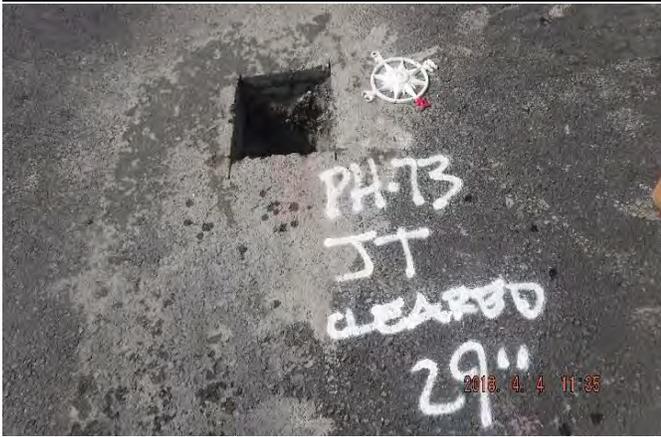
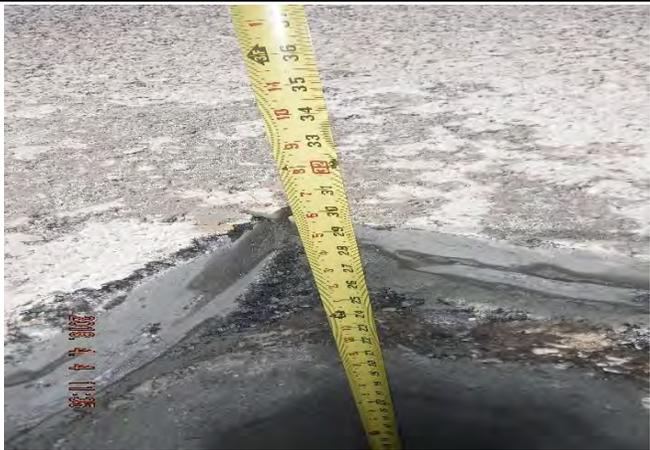
Pothole # 73

Cut Size: 1' x 1'		Location: Hit slurry at 29".169" Southeast of face of curb. 284" Northeast of electrical box.
Asphalt: 4" Concrete: Depth: Hit Slurry Utility: Joint trench Size: Material: Slurry Soil: Hard dirt, rocks, sand		Notes:

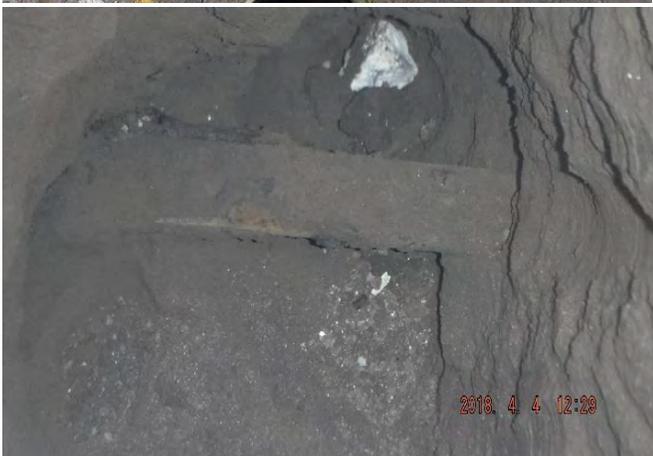
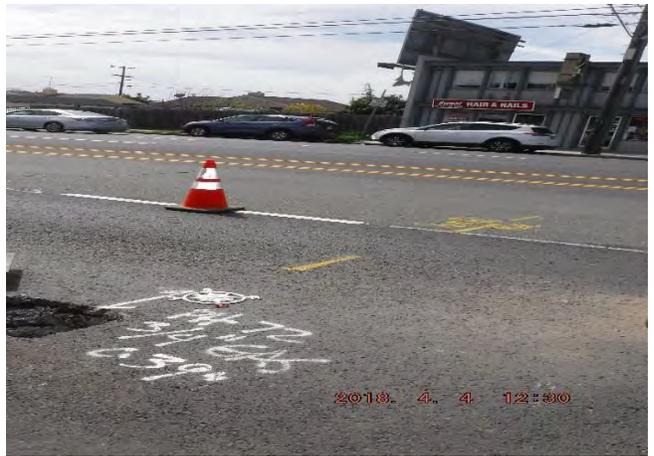
Pothole # 72

Cut Size: 1' x 1'		Location: 132" SW of face of curb. 134" SE of water valve.
Asphalt: 4" Concrete: 8" Depth: 39" Utility: Gas Size: .75" Material: Steel Soil: Hard dirt, rocks, sand		Notes:

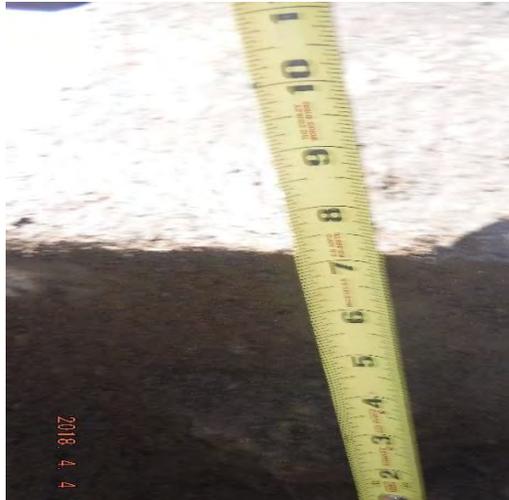
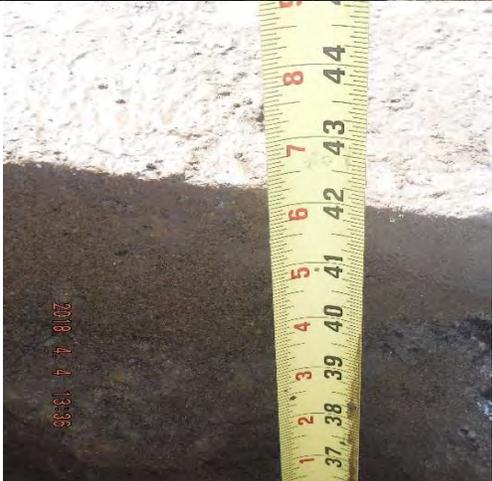
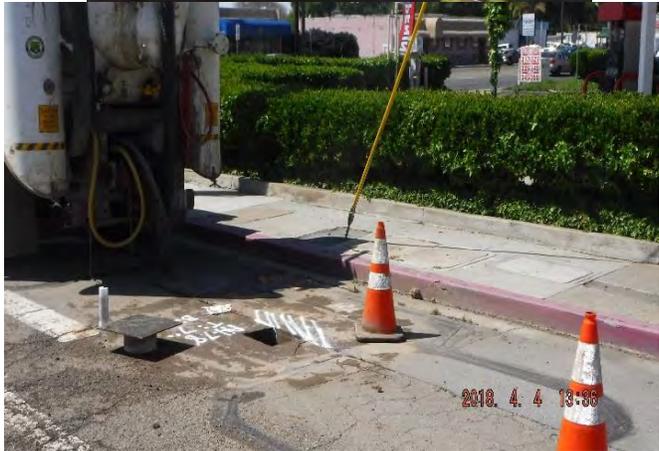
Pothole # 78

<p>Cut Size: 1' x 1'</p> <p>Asphalt: 4"</p> <p>Concrete:</p> <p>Top: 7"</p> <p>Depth: Bottom 42"</p> <p>Utility: Joint trench</p> <p>Size:</p> <p>Material: Slurry</p> <p>Soil: Hard dirt, rocks, sand</p>	<p>Location: 64" Northeast of AT&T box, in line with box.</p> <p>Notes:</p>
--	---

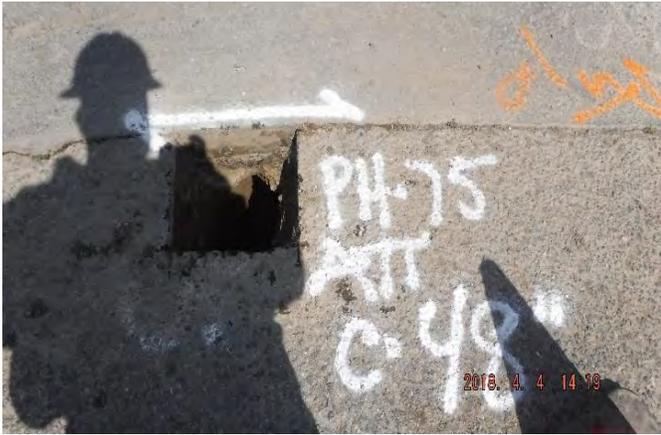
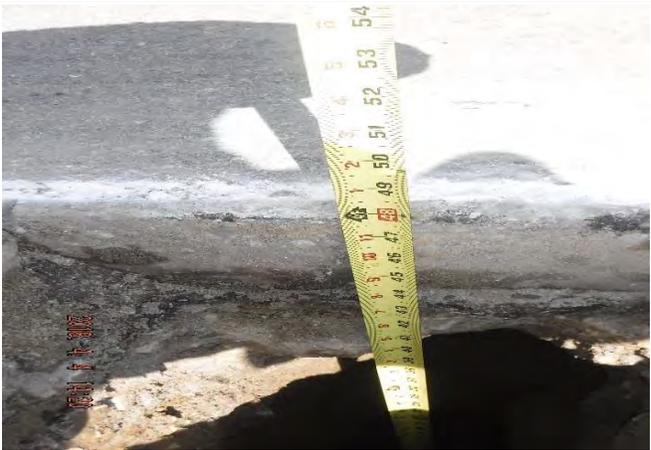
Pothole # 75

Cut Size: 1' x 1'		Location: 140" Southeast of sanitary sewer manhole, in-line with manhole.
Asphalt: 4" Concrete: Depth: 48" Utility: AT&T Size: Material: Steel Case Soil: Hard dirt, rocks, sand		Notes:

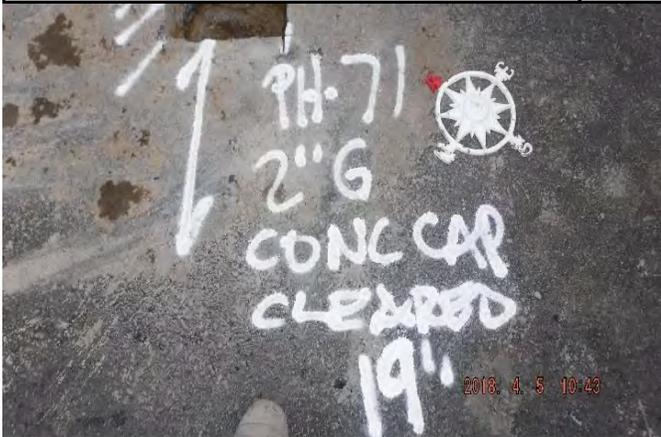
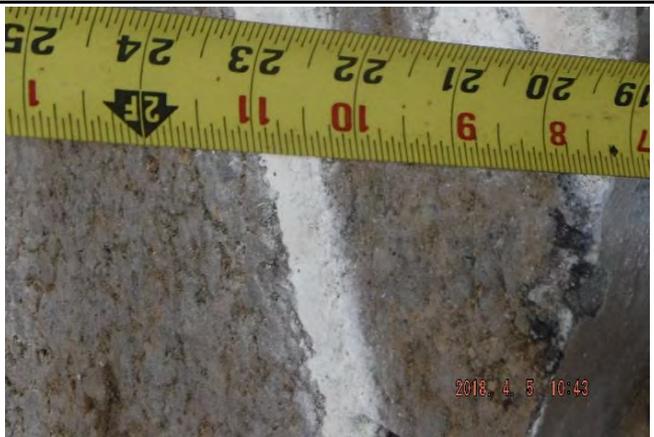
Pothole # 71

<p>Cut Size: 1' x 1'</p> <p>Asphalt: 5"</p> <p>Concrete: 14"</p> <p>Depth: dry hole</p> <p>Utility: Gas</p> <p>Size: 2"</p> <p>Material: Concrete Cap</p> <p>Soil: Hard dirt, rocks, sand</p>

<p>Location: Hit concrete cap at 19" (See Pic). ED location 124" SW of crosswalk. 130" NW of crosswalk.</p> <p>Notes:</p>
---	--	---

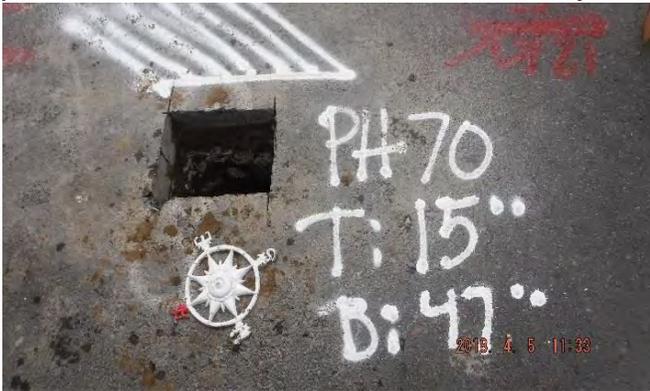
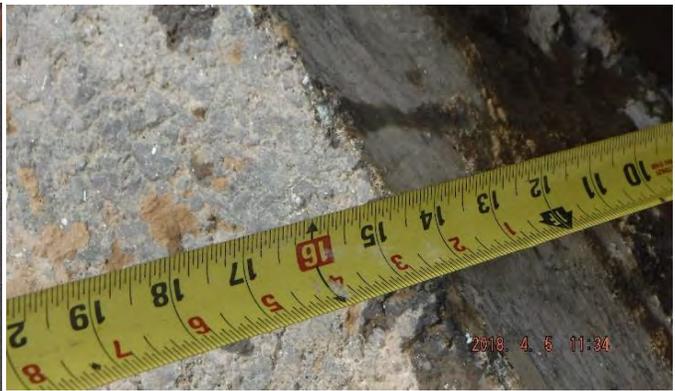
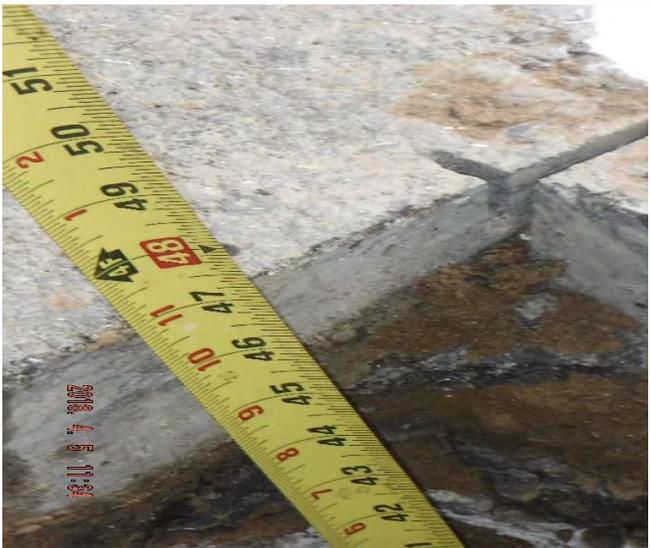
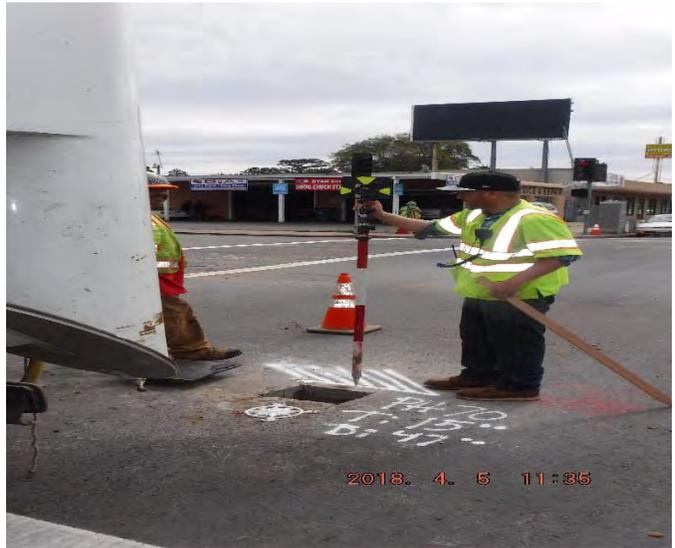
Pothole # 70

<p>Cut Size: 1' x 1'</p> <p>Asphalt: 5"</p> <p>Concrete: 9"</p> <p>Top: 15"</p> <p>Depth: Bottom: 47"</p> <p>Utility: Joint trench</p> <p>Size:</p> <p>Material:</p> <p>Soil: Hard dirt, rocks, sand</p>

<p>Location: 72" SE of crosswalk. 164" SW of crosswalk.</p> <p>Notes:</p>
--	--	---

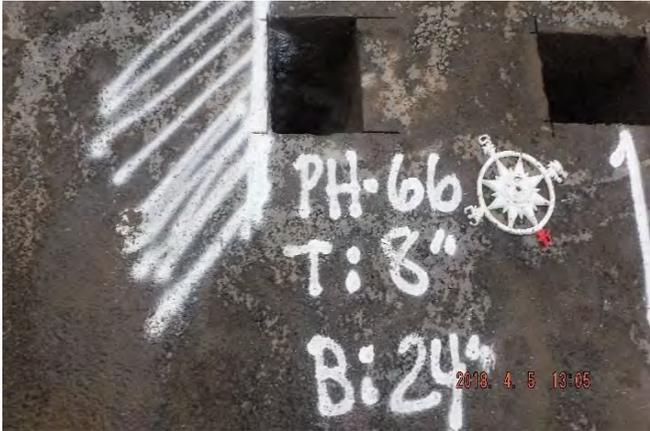
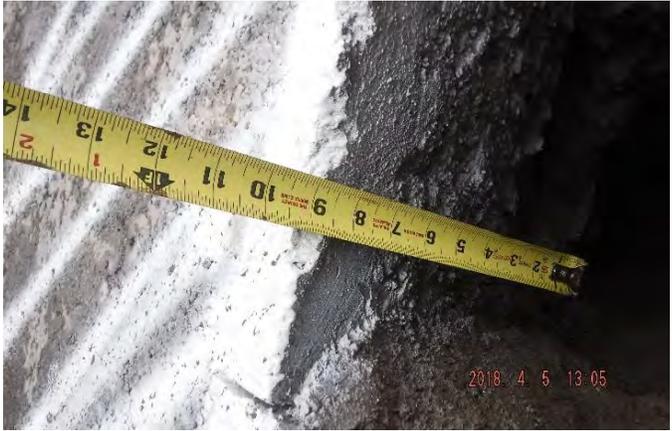
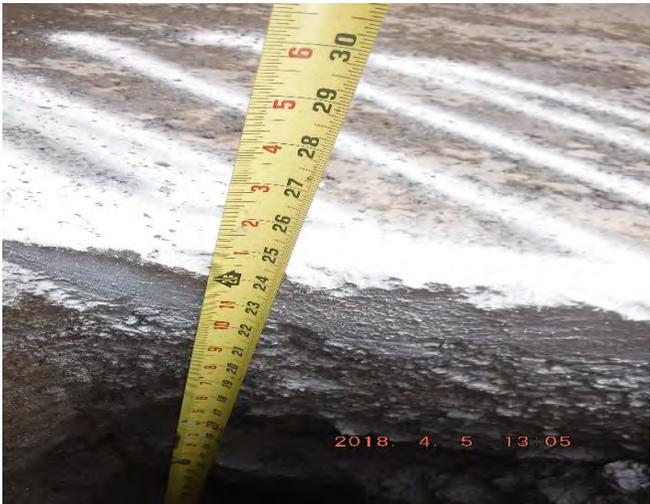
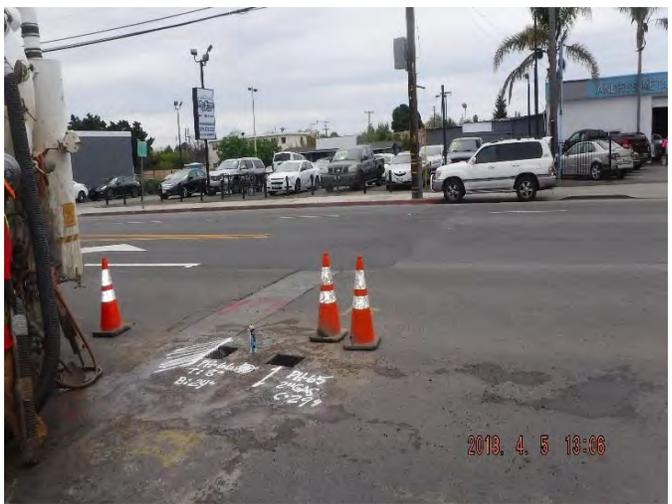
Pothole # 66

<p>Cut Size: 1' x 1'</p>		<p>Location: 269" Southeast of fiber optic manhole. 149" SW of fiber optics manhole.</p>
<p>Asphalt: 5"</p> <p>Concrete:</p>		<p>Notes:</p>
<p>Depth: Top: 8" Bottom: 24"</p> <p>Utility: Joint trench</p> <p>Size:</p> <p>Material:</p> <p>Soil: Hard dirt, rocks, sand</p>

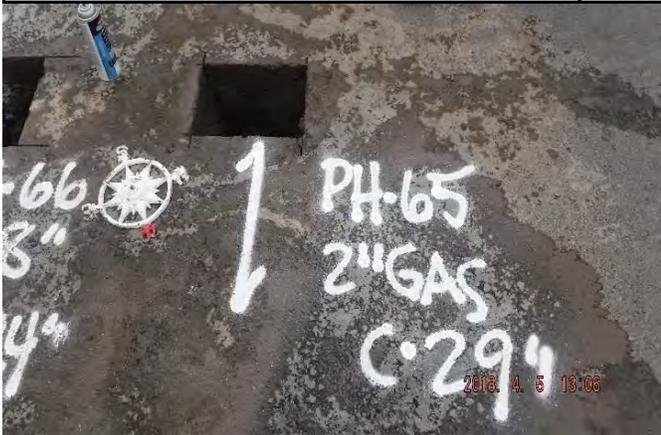
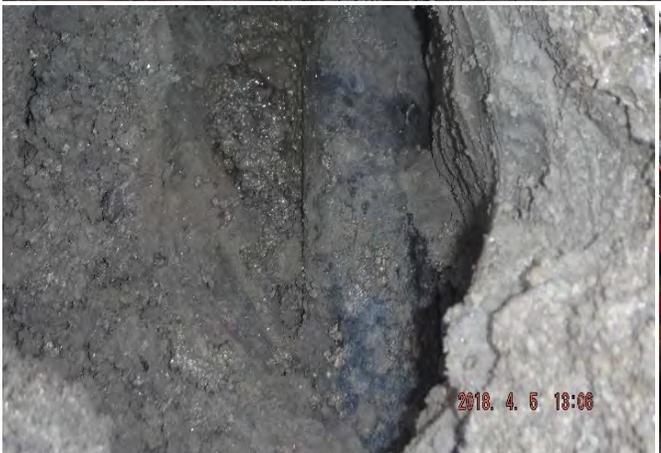
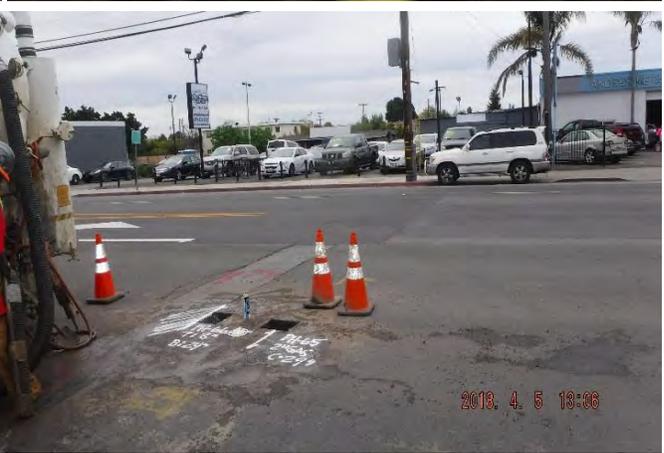
Pothole # 65

<p>Cut Size: 1' x 1'</p> <p>Asphalt: 5"</p> <p>Concrete:</p> <p>Depth: 29"</p> <p>Utility: Gas</p> <p>Size: 2"</p> <p>Material: Steel</p> <p>Soil: Hard dirt, rocks, sand</p>		<p>Location: 269" Southeast of fiber optics manhole. 106" SW of fiber optics manhole.</p> <p>Notes:</p>
---	--	---

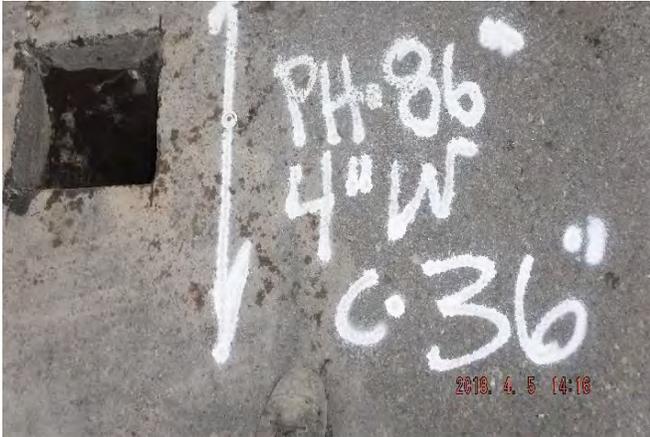
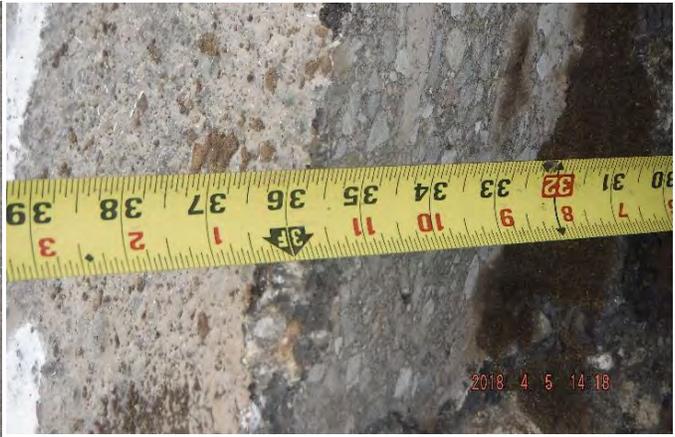
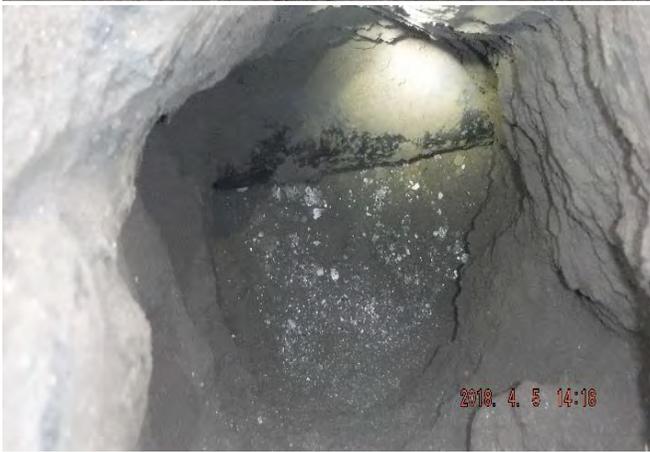
Pothole # 86

<p>Cut Size: 1' x 1'</p> <p>Asphalt: 5"</p> <p>Concrete:</p> <p>Depth: 36"</p> <p>Utility: Water</p> <p>Size: 4"</p> <p>Material: Steel</p> <p>Soil: Hard dirt, rocks, sand</p>	<p>Location: 157" NW of face of curb. 251" NE of crosswalk.</p> <p>Notes:</p>
---	---

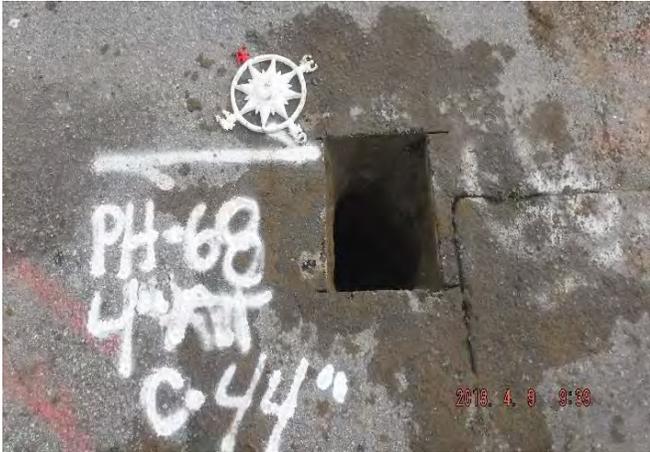
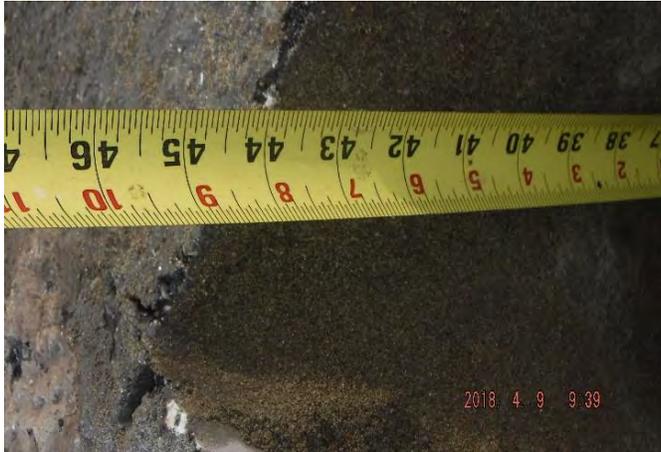
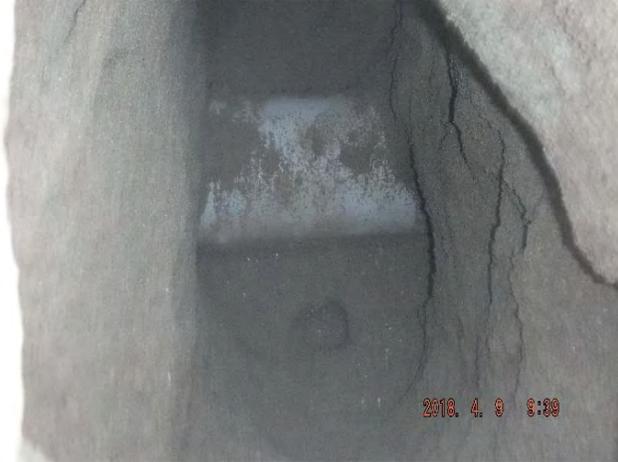
Street: 16611 East 14th Street

Cut Size: 1' x 1'		Location: 65" Northeast of face of curb. 64" SE of electrical pole.
Asphalt: 5" Concrete: Depth: 44" Utility: AT&T Size: 4" Material: PVC Soil: Hard dirt, slurry		Notes:

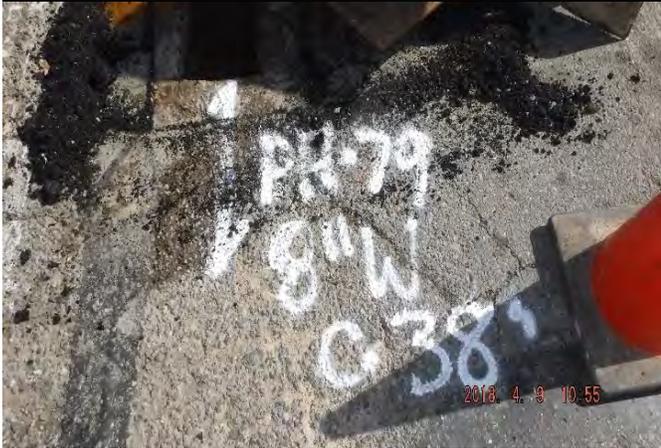
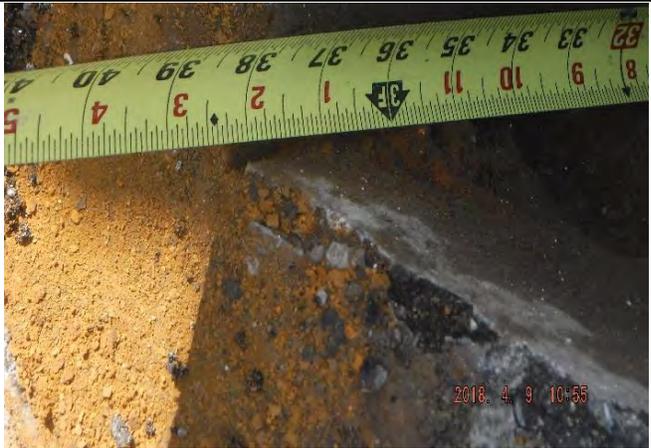
Pothole # 79

Street: 167th Ave. & East 14th Street

Cut Size: 1' x 1'		Location: 216" NE of Water valve, in-line with valve.
Asphalt: 5" Concrete: Depth: 38" Utility: Water Size: 8" Material: Steel Soil: Hard dirt, slurry		Notes:

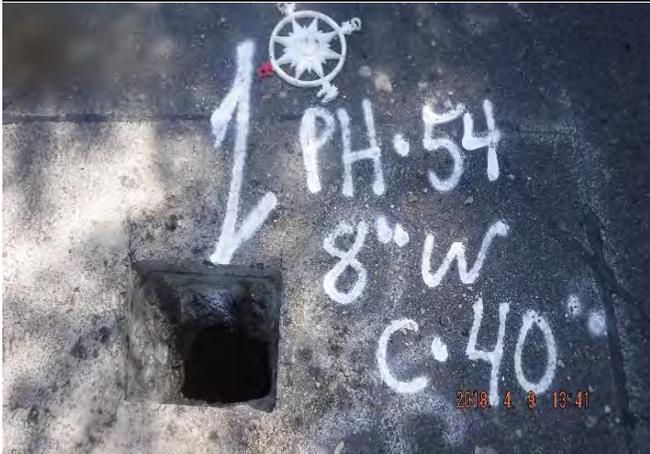
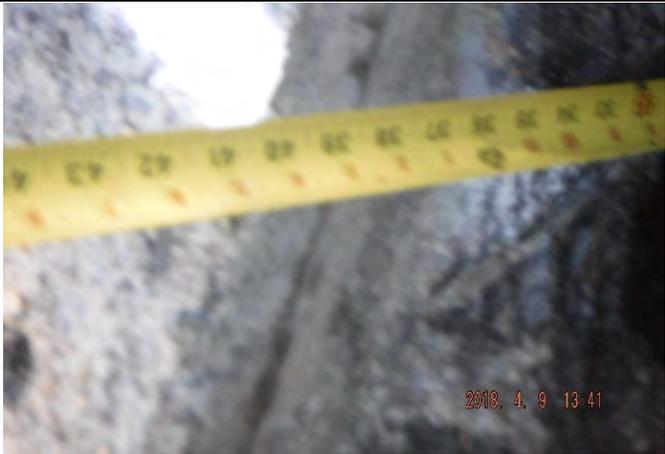
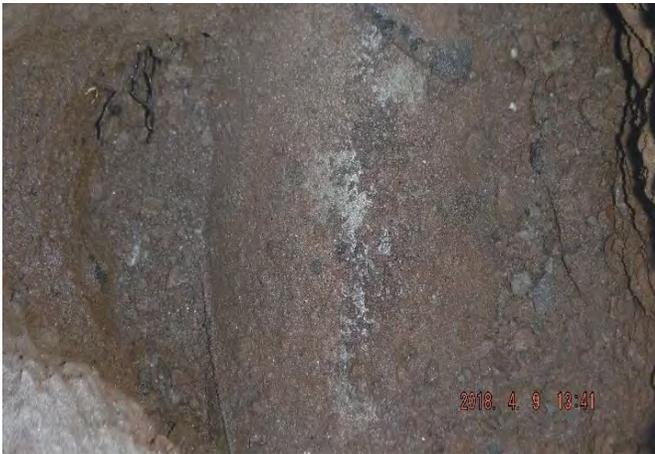
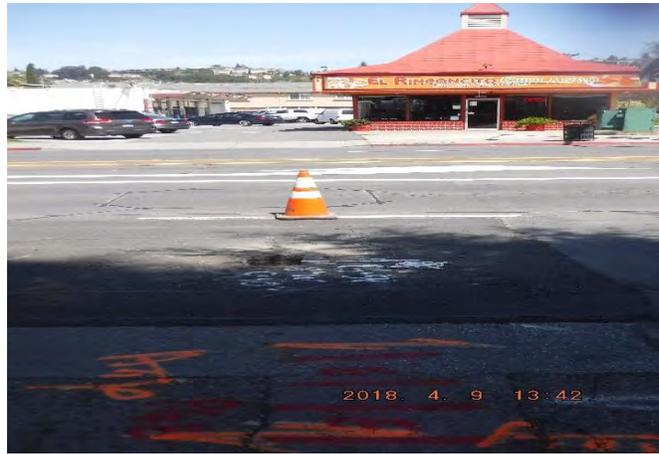
Pothole # 54

Street: 165th Ave. & East 14th Street

<p>Cut Size: 1' x 1'</p> <p>Asphalt: 5"</p> <p>Concrete:</p> <p>Depth: 40"</p> <p>Utility: Water</p> <p>Size: 8"</p> <p>Material: Steel</p> <p>Soil: Hard dirt, slurry</p>	<p>Location: 150" Northeast of face of curb. 122" SE of EBMUD valve.</p> <p>Notes:</p>
--	--
