EXARO Technologies Corporation

Subsurface Utility Report	
Client	ACPWA - Vincent SendayDiego
Project #	16-1127
City	Hayward
Date	9/18/2017

Pothole # 2A

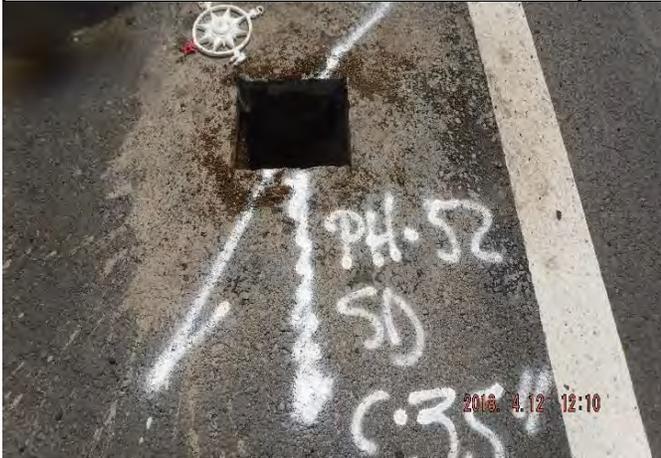
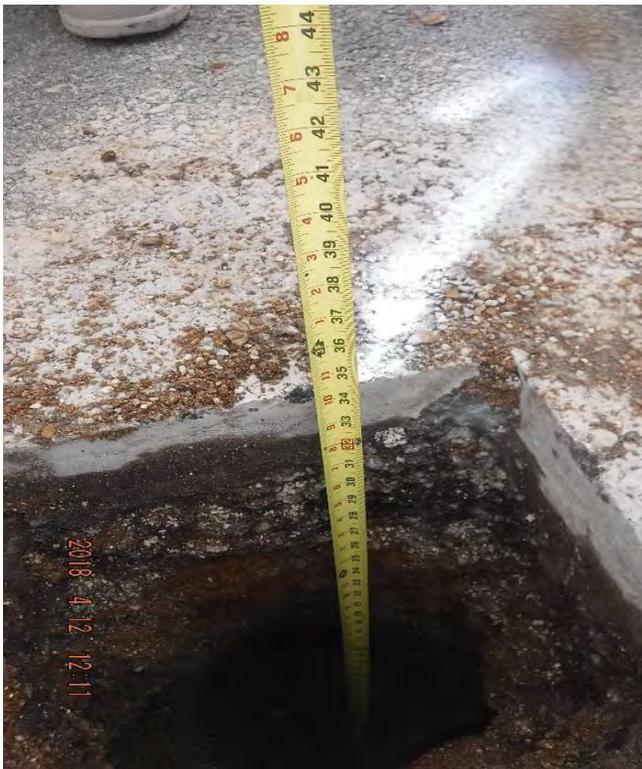
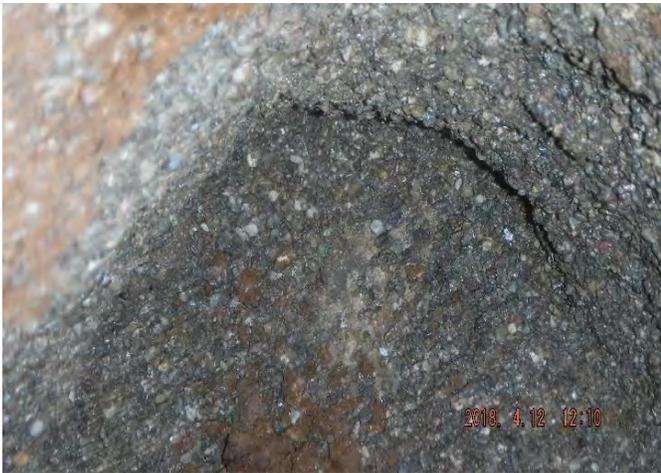
Pothole # 52

Street: 16496 East 14th Street

<p>Cut Size: 1' x 1'</p> <p>Asphalt: 5"</p> <p>Concrete:</p> <p>Depth: 35"</p> <p>Utility: Storm Drain</p> <p>Size:</p> <p>Material: bestos Ceme</p> <p>Soil: Hard dirt, rocks</p>

<p>Location: 35" Northeast of white right turn lane. 89" NW of water valve.</p> <p>Notes:</p>
--	---

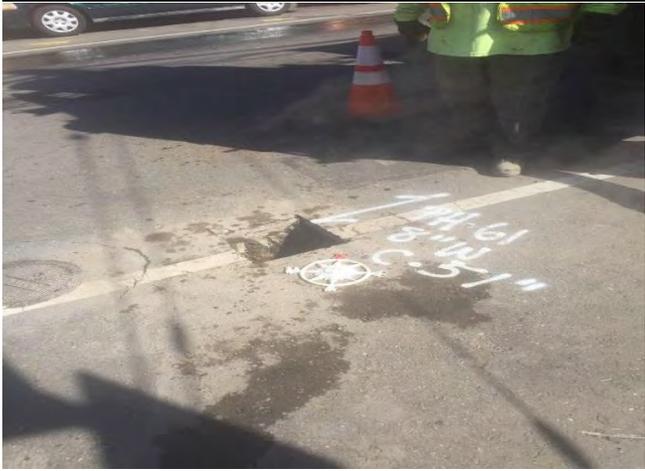
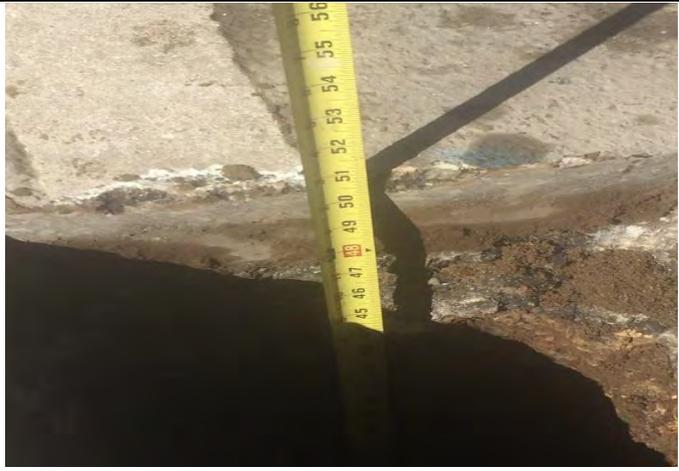
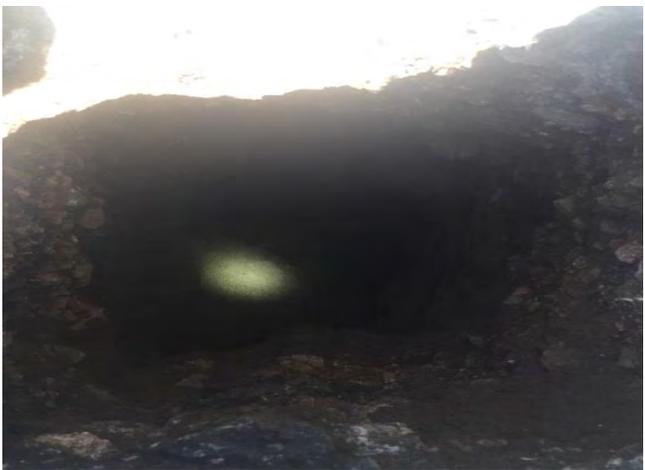
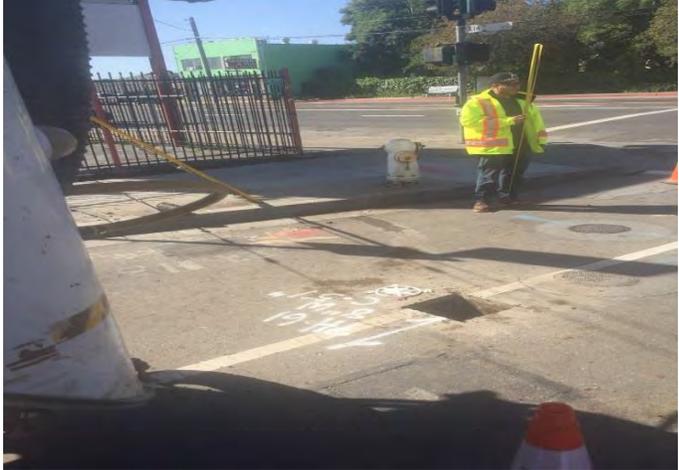
<p>Location: 26" Northeast of Water Valve, in-line with valve.</p> <p>Notes:</p>
--	--

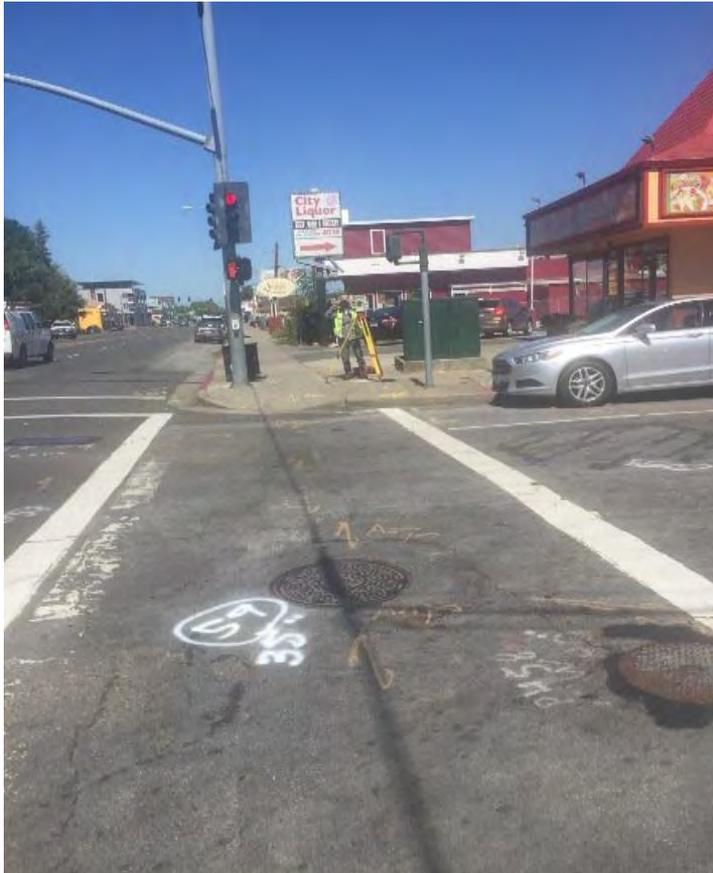
<p>Location: at center of Crosswalk, see pic.</p>
	<p>Notes:</p>
