**UPDATED LIMITED GEOLOGICAL SITE ASSESSMENT AND
GEOTECHNICAL RECOMMENDATIONS REPORT
CASTLEWOOD REDWOOD TANKS REPLACEMENT
PLEASANTON, CALIFORNIA**

BSK PROJECT NO. G16-062-11L

**SUBJECT: Updated Limited Geological Site Assessment and
Geotechnical Recommendations Report
Castlewood Redwood Tanks Replacement
Pleasanton, California**

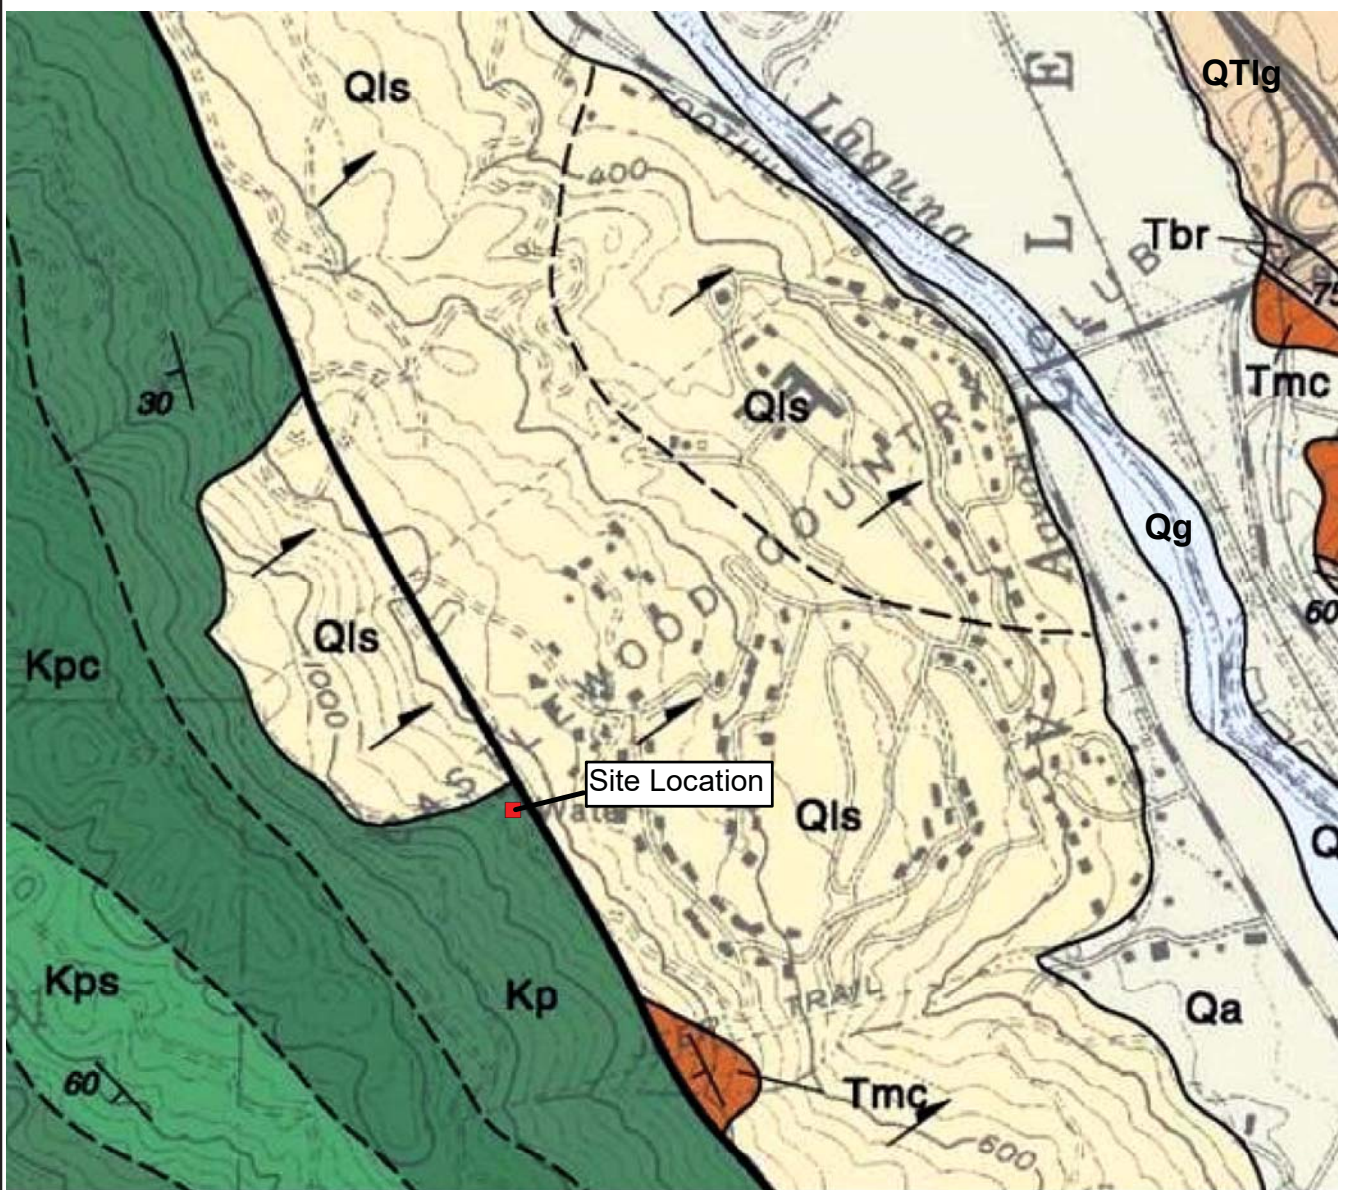
GEOLOGIC MAP
 Castlewood Redwood Tanks Replacement
 Pleasanton, California

Reference: Dibblee, T.W., and Minch, J.A. (2005), Geologic Map of the Dublin Quadrangle, Contra Costa and Alameda Counties, California: Dibblee Geological Foundation, Dibblee Foundation Map DF-164, Scale 1:24,000.

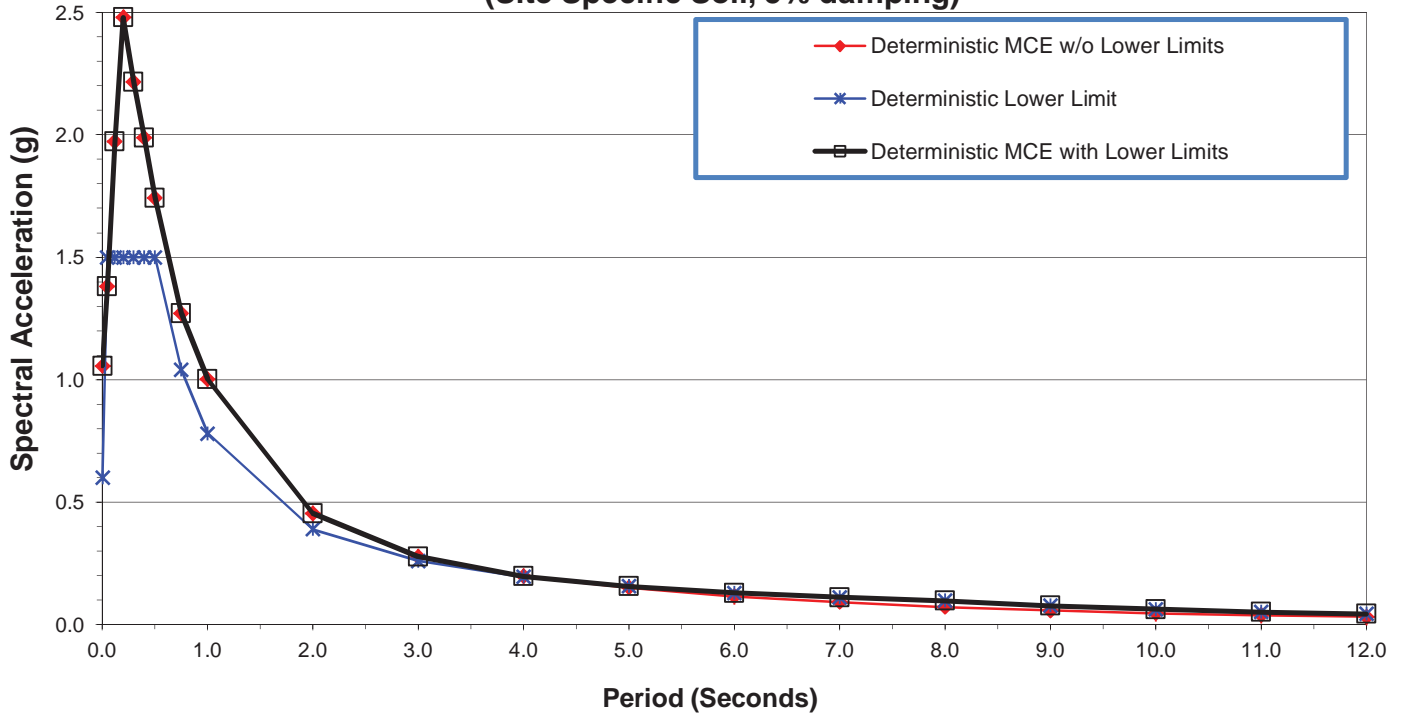
PLATE
 5

**Deterministic Response Spectra
Maximum Considered Earthquake
Maximum Rotated Horizontal Component
(Site Specific Soil, 5% damping)**

Period (Second)	Attenuation Relationship						
	Deterministic MCE with Lower Limits (g)	Deterministic MCE w/o Lower Limits (g)	Sa (Median) (g)	Sa (BA08) (g)	Sa (CB08) (g)	Sa (CY08) (g)	Sa (AS08) (g)
Calaveras Fault, California Gridded 0.2 sec. To 0.4 sec.							
PGA	1.057	1.057	1.057	1.085	0.938	1.155	1.096

The MCER deterministic lower limits using the above parameters and the 84th percentile deterministic site specific response spectrum adjusted using the deterministic lower limits are shown on Plate 5.

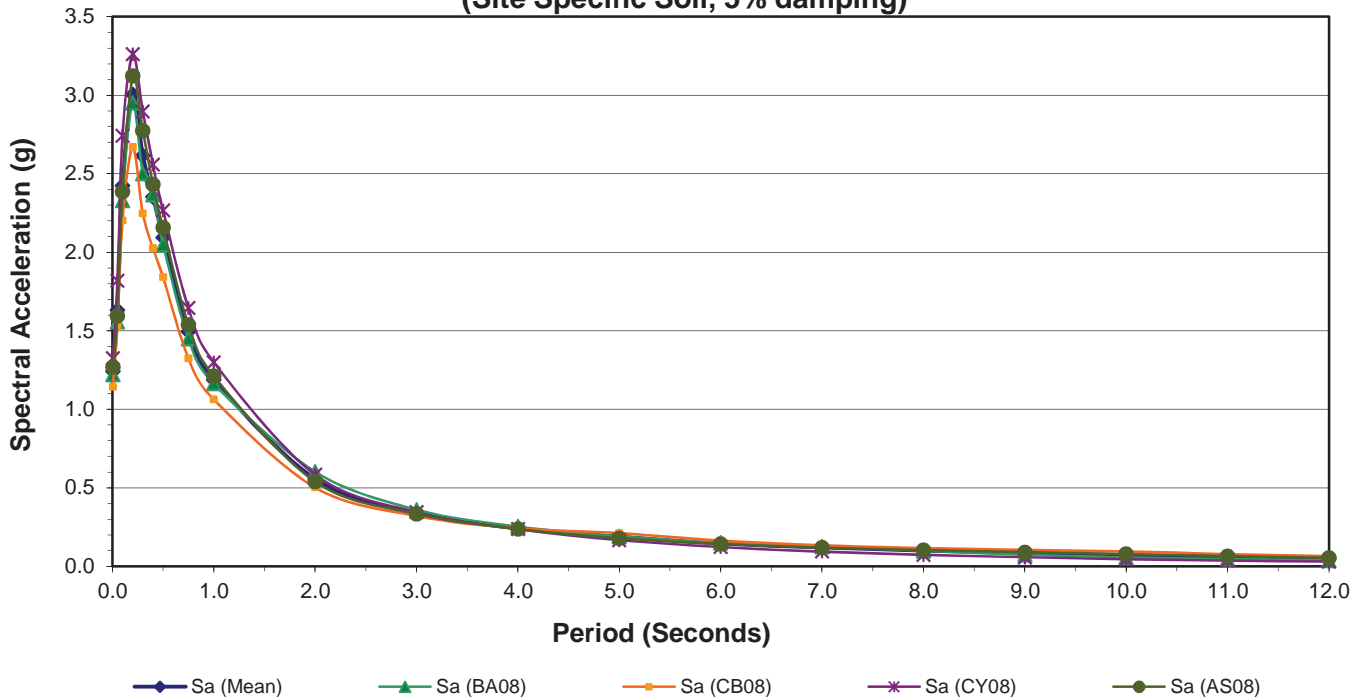
**Uniform Hazard Spectra
(Maximum Considered Earthquake)
Spectral Response
Maximum Rotated Horizontal Component
(Site Specific Soil, 5% damping)**

Period (Second)	Sa (Mean) (g)	Attenuation Relationship			
		(BA08) (g)	(CB08) (g)	(CY08) (g)	Sa (AS08) (g)
PGA	1.242	1.221	1.142	1.326	1.269
0.05	1.632	1.558	1.535	1.819	1.594
0.1	2.423	2.331	2.202	2.741	2.386
0.2	3.004	2.952	2.670	3.261	3.122
0.3	2.616	2.501	2.247	2.897	2.775
0.4	2.352	2.366	2.026	2.558	2.432
0.5	2.094	2.049	1.841	2.268	2.156
0.75	1.494	1.450	1.323	1.645	1.537
1.0	1.188	1.164	1.063	1.300	1.212
2.0	0.557	0.603	0.502	0.583	0.539
3.0	0.340	0.360	0.321	0.345	0.334
4.0	0.242	0.253	0.242	0.236	0.237
5	0.189	0.191	0.212	0.167	0.178
6	0.145	0.149	0.164	0.122	0.142
7	0.120	0.124	0.134	0.094	0.120
8	0.101	0.099	0.116	0.073	0.103
9	0.084	0.074	0.105	0.057	0.089
10	0.072	0.057	0.095	0.045	0.078
11	0.059	0.047	0.078	0.036	0.064
12	0.050	0.039	0.066	0.030	0.054

The probabilistic MCER ground motion was determined using the method in ASCE 7-10, Section 21.2.1.1. Estimates of the MCER probabilistic ground motion were computed using the software program EZ-Frisk (Version 7.65) developed by Risk Engineering. The analysis included active faults within 200 km of the site. Mean maximum rotated component acceleration values were computed using the same attenuation relationships and soil amplification as specified in the deterministic analysis above. The acceleration values from each of attenuation relationships were averaged using equal weight. The probabilistic MCE spectral acceleration values based upon our analysis are plotted on Plate 6.

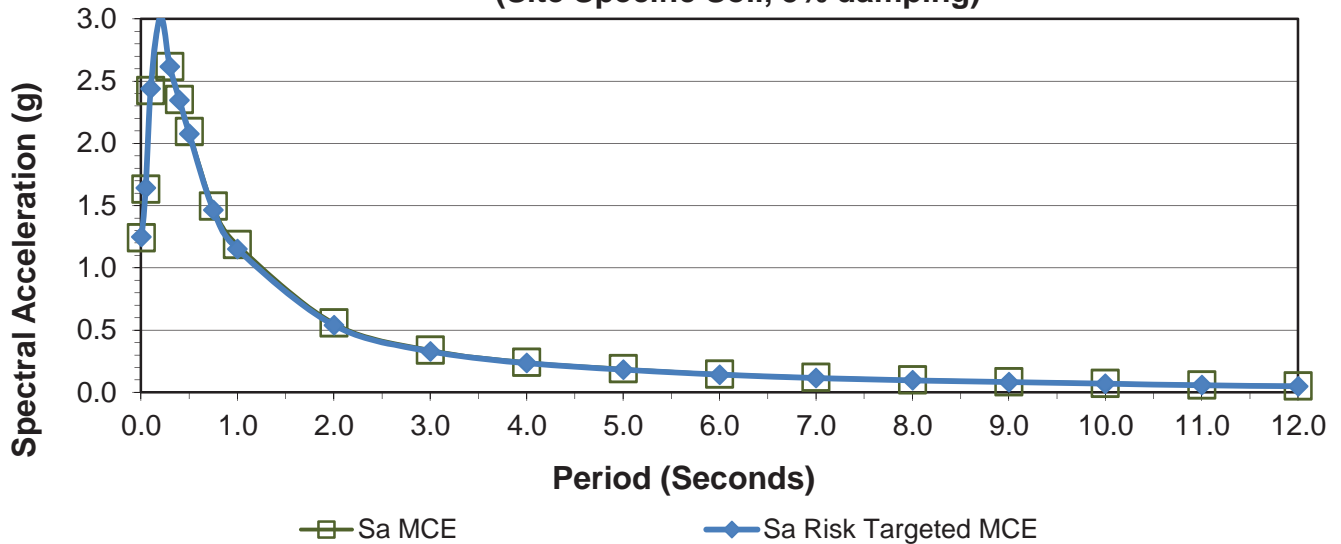
**Uniform Hazard Spectra
Risk-Targeted Maximum Considered Earthquake
Spectral Response Maximum Rotated Horizontal Component
(Site Specific Soil, 5% damping)**

Period (Second)	Sa MCE (g)	Risk Coefficient C_R	Sa Risk Targeted MCE (g)
PGA	1.242	1.006	1.249
0.05	1.632	1.006	1.642
0.1	2.423	1.006	2.438
0.2	3.004	1.006	3.022
0.3	2.616	1.000	2.616
0.4	2.352	0.997	2.345
0.5	2.094	0.992	2.077
0.75	1.494	0.980	1.464
1	1.188	0.969	1.151
2	0.557	0.969	0.539
3	0.340	0.969	0.329
4	0.242	0.969	0.235
5	0.189	0.969	0.183
6	0.145	0.969	0.141
7	0.120	0.969	0.116
8	0.101	0.969	0.097
9	0.084	0.969	0.081
10	0.072	0.969	0.070
11	0.059	0.969	0.057
12	0.050	0.969	0.049

Notes: C_R From USGS Web Application

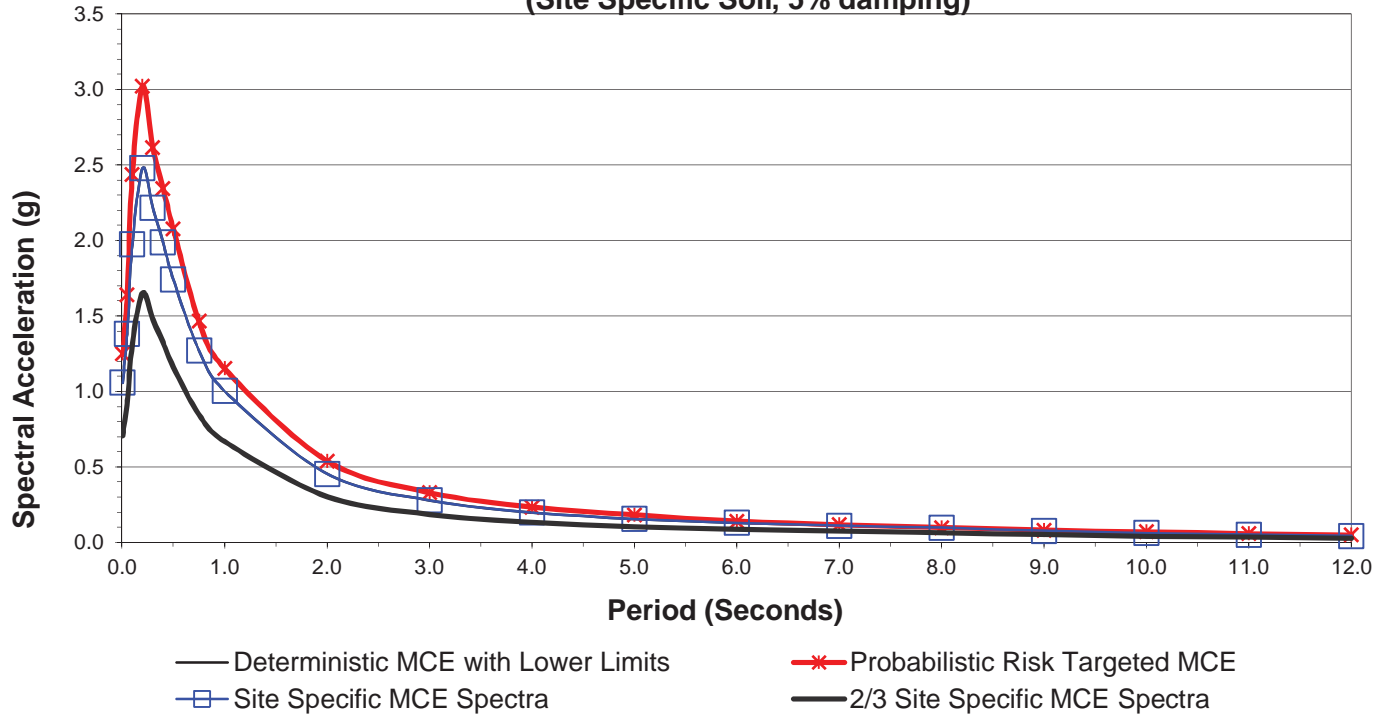
**Maximum Considered Earthquake
Response Spectra
Probabilistic - Deterministic
(Site Specific Soil, 5% damping)**

Period (Second)	Deterministic MCE with Lower Limits Sa (g)	Probabilistic Risk Targeted MCE Sa (g)	Site Specific MCE Spectra Sa (g)	2/3 Site Specific MCE Spectra Sa (g)
PGA	1.057	1.249	1.057	0.705
0.05	1.380	1.642	1.380	0.920
0.1	1.973	2.438	1.973	1.315
0.2	2.479	3.022	2.479	1.653
0.3	2.216	2.616	2.216	1.477
0.4	1.988	2.345	1.988	1.325
0.5	1.743	2.077	1.743	1.162
0.75	1.271	1.464	1.271	0.847
1.0	1.002	1.151	1.002	0.668
2.0	0.455	0.539	0.455	0.303
3.0	0.278	0.329	0.278	0.185
4.0	0.198	0.235	0.198	0.132
5	0.156	0.183	0.156	0.104
6	0.130	0.141	0.130	0.087
7	0.111	0.116	0.111	0.074
8	0.098	0.097	0.097	0.065
9	0.077	0.081	0.077	0.051
10	0.062	0.070	0.062	0.042
11	0.052	0.057	0.052	0.034
12	0.043	0.049	0.043	0.029

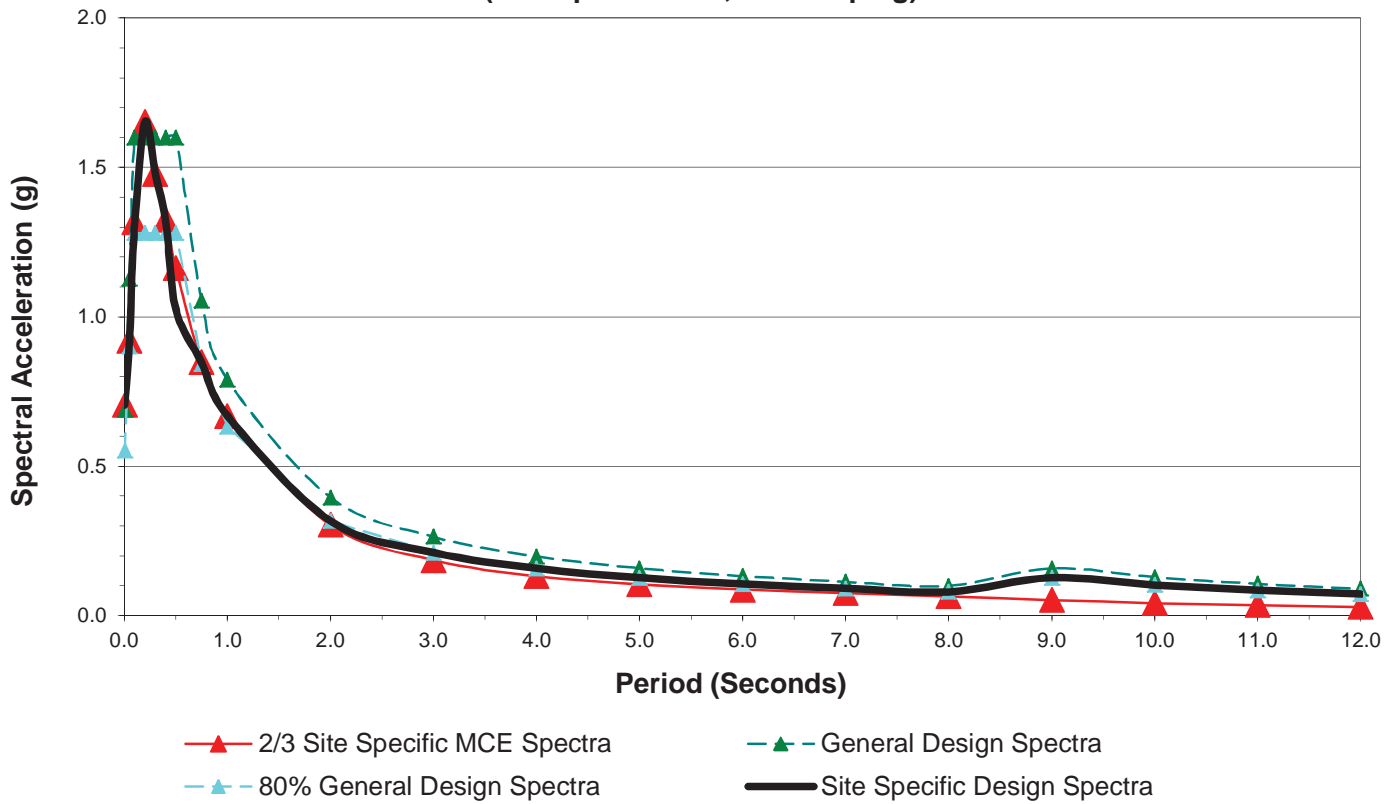
**Design Response Spectra
(Site Specific Soil, 5% damping)**

Period (Second)	2/3 Site Specific MCE Spectra Sa (g)	General Design Spectra Sa (g)	80% General Design Spectra Sa (g)	Site Specific Design Spectra Sa (g)
PGA	0.705	0.689	0.551	0.705
0.05	0.920	1.126	0.901	0.920
0.1	1.315	1.600	1.280	1.315
0.2	1.653	1.600	1.280	1.653
0.3	1.477	1.600	1.280	1.477
0.4	1.325	1.600	1.280	1.325
0.5	1.162	1.600	1.280	1.024
0.8	0.847	1.053	0.842	0.847
1.0	0.668	0.790	0.632	0.668
2.0	0.303	0.395	0.316	0.316
3.0	0.185	0.263	0.211	0.211
4.0	0.132	0.197	0.158	0.158
5	0.104	0.158	0.126	0.126
6	0.087	0.132	0.105	0.105
7	0.074	0.113	0.090	0.090
8	0.065	0.099	0.079	0.079
9	0.051	0.158	0.126	0.126
10	0.042	0.128	0.102	0.102
11	0.034	0.106	0.085	0.085
12	0.029	0.089	0.071	0.071

Notes: General=General Response Spectrum based on 2013 CBC

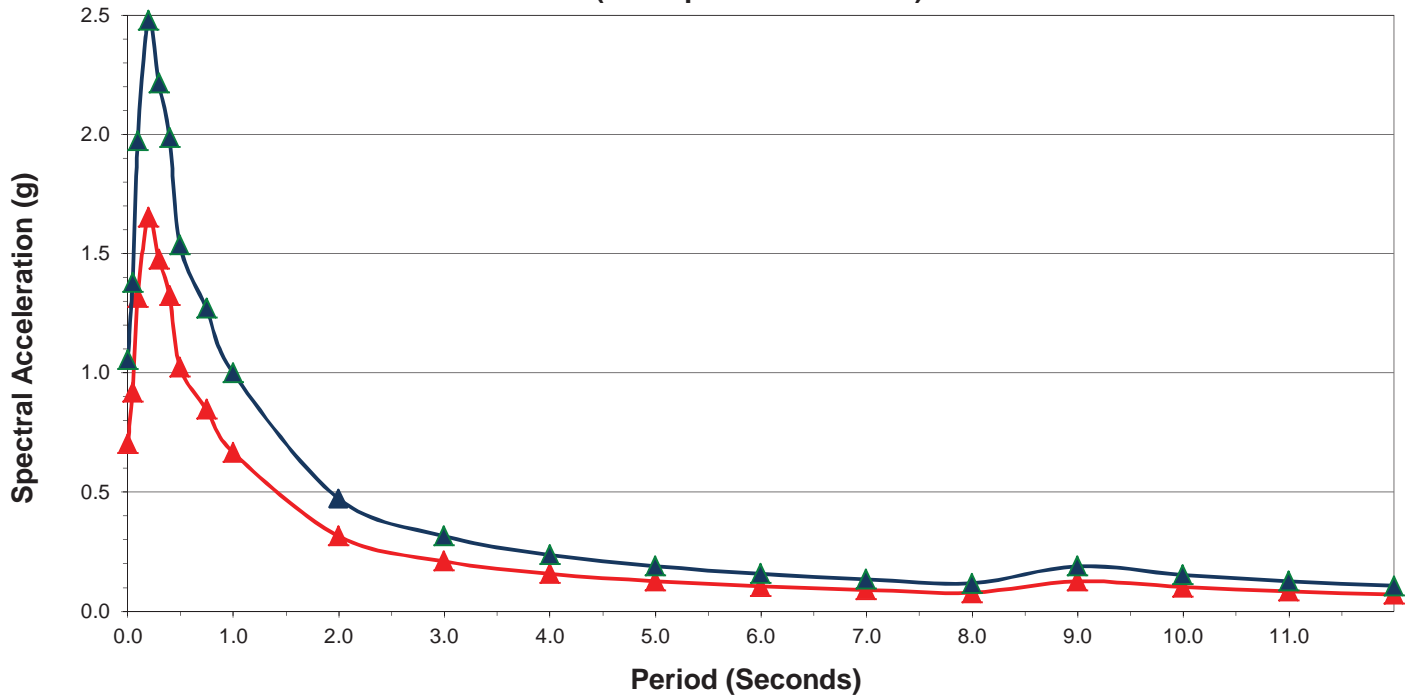
Impulsive and Convective Design Response Spectra (Site Specific Soil/Rock)

▲ Impulsive Components
5% Damping Design Spectra

▲ Convective Component
0.5 % Damping Design Response Spectra

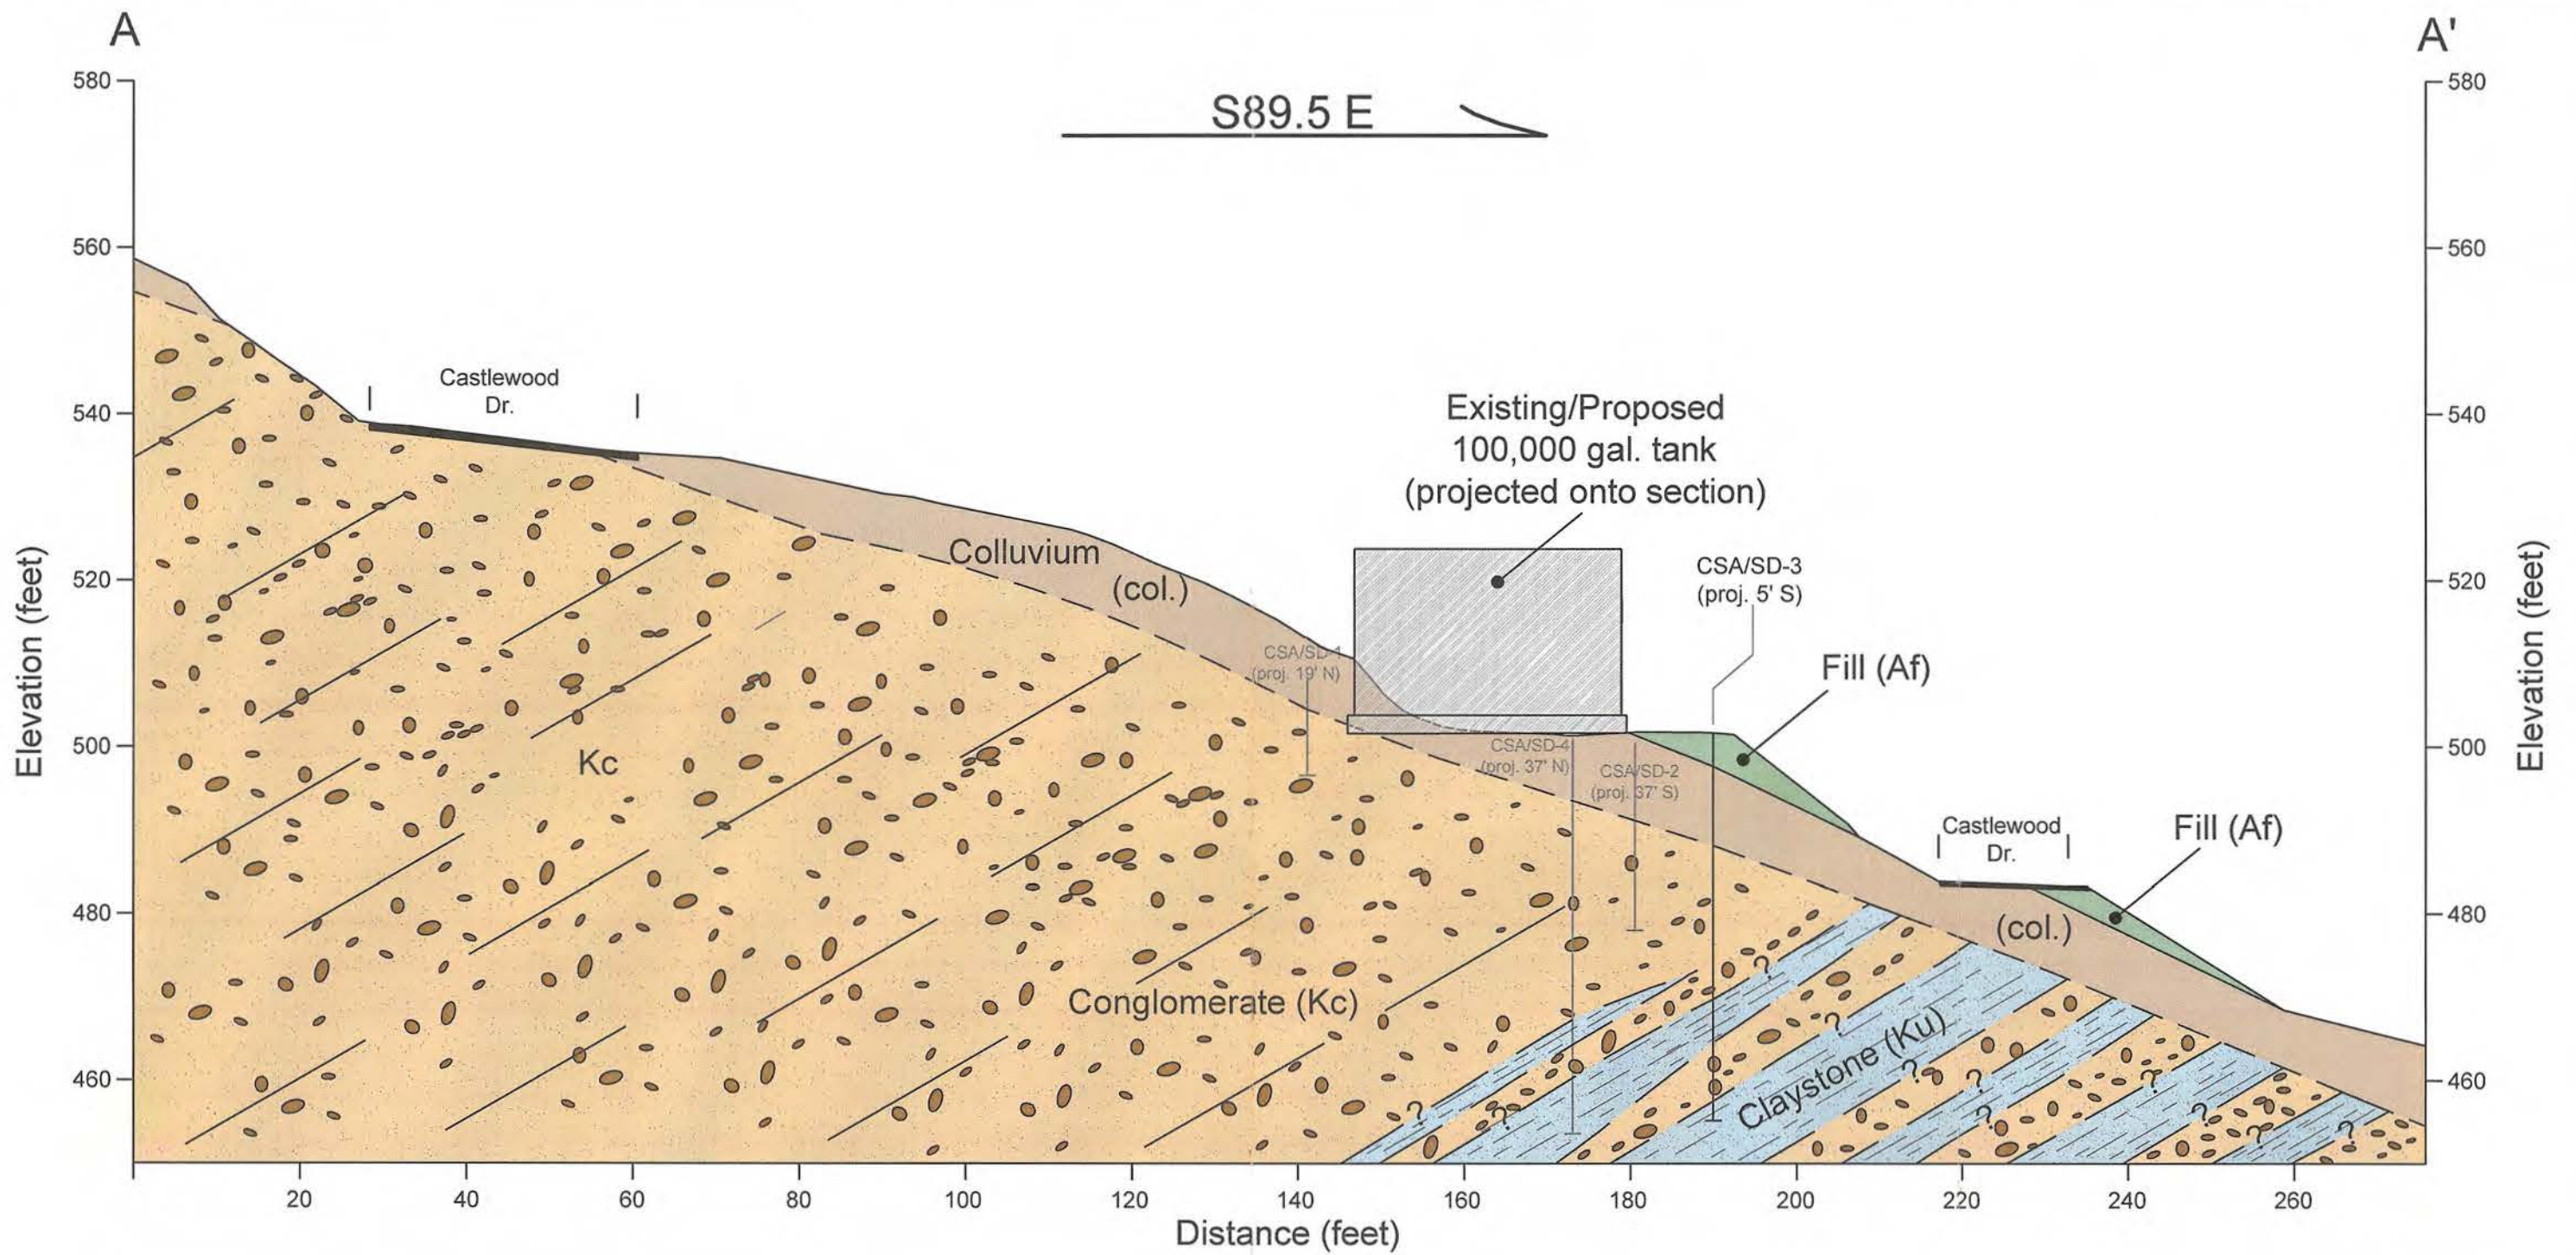
COTTON, SHIRES & ASSOCIATES, INC CONSULTING ENGINEERS AND GEOLOGISTS		
Engineering Geologic Cross Section A- California Water Service Company Castlewood Tanks - Zone 2 PLEASANTON, CALIFORNIA		
GEO/ENG BY AM	SCALE 1"=20'	PROJECT NO E0357
APPROVED BY DTS/TS	DATE JANUARY 2008	FIG NO. 4

Surficial Units

- Af** Fill - Sandy silt; light orange brown, medium stiff to very stiff, dry
- col.** Colluvium - Sandy Silt with Gravels; dark yellowish brown, stiff to very stiff, moist.

Based on Figure 4 in Appendix A, an average depth of 10 feet may be assumed for the combined fill/colluvium layers underneath the existing tanks.

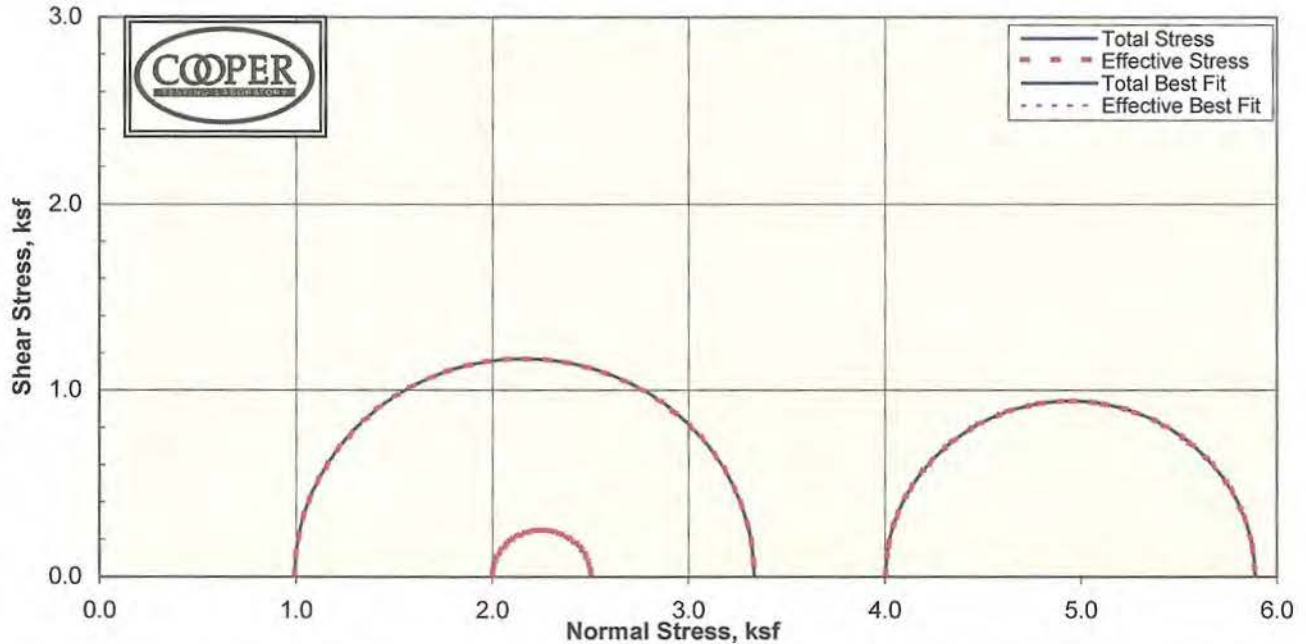
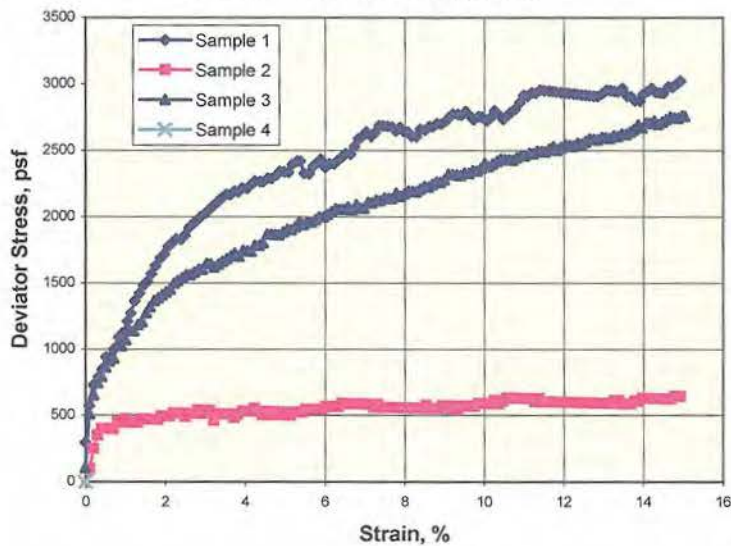
Triaxial Consolidated Undrained

(ASTM D4767 MODIFIED)

Stress-Strain Response

Sample:	1	2	3	4
MC, %	18.8	9.8	10.3	
Dry Dens, pcf	105.4	106.3	123.4	
Sat. %	84.6	45.0	76.3	
Void Ratio	0.599	0.585	0.365	
Diameter in	2.42	2.41	2.42	
Height, in	5.00	5.01	5.00	
	Final			
MC, %	22.9	23.3	17.8	
Dry Dens, pcf	104.1	103.4	113.8	
Sat. %	100.0	100.0	100.0	
Void Ratio	0.618	0.629	0.481	
Diameter, in	2.43	2.44	2.52	
Height, in	5.01	5.02	4.99	
Cell, psi	55.4	62.4	76.3	
BP, psi	48.5	48.5	48.5	
	Effective Stresses At:			
Strain, %	5.0	5.0	5.0	
Deviator ksf	2.342	0.502	1.885	
Excess PP	0.000	0.000	0.000	
Sigma 1	3.336	2.504	5.889	
Sigma 3	0.994	2.002	4.003	
P, ksf	2.165	2.253	4.946	
Q, ksf	1.171	0.251	0.943	
Stress Ratio	3.357	1.251	1.471	
Rate in/min	0.001	0.001	0.001	
Total C	N/A	ksf		
Total Phi	N/A	Degrees		
Eff. C	N/A	ksf		
Eff. Phi	N/A	Degrees

REMARKS: Strengths picked at 5% strain. Samples were back-pressure saturated. Drainage valves were closed prior to consolidation. Samples were consolidated 1.5 psi during saturation.

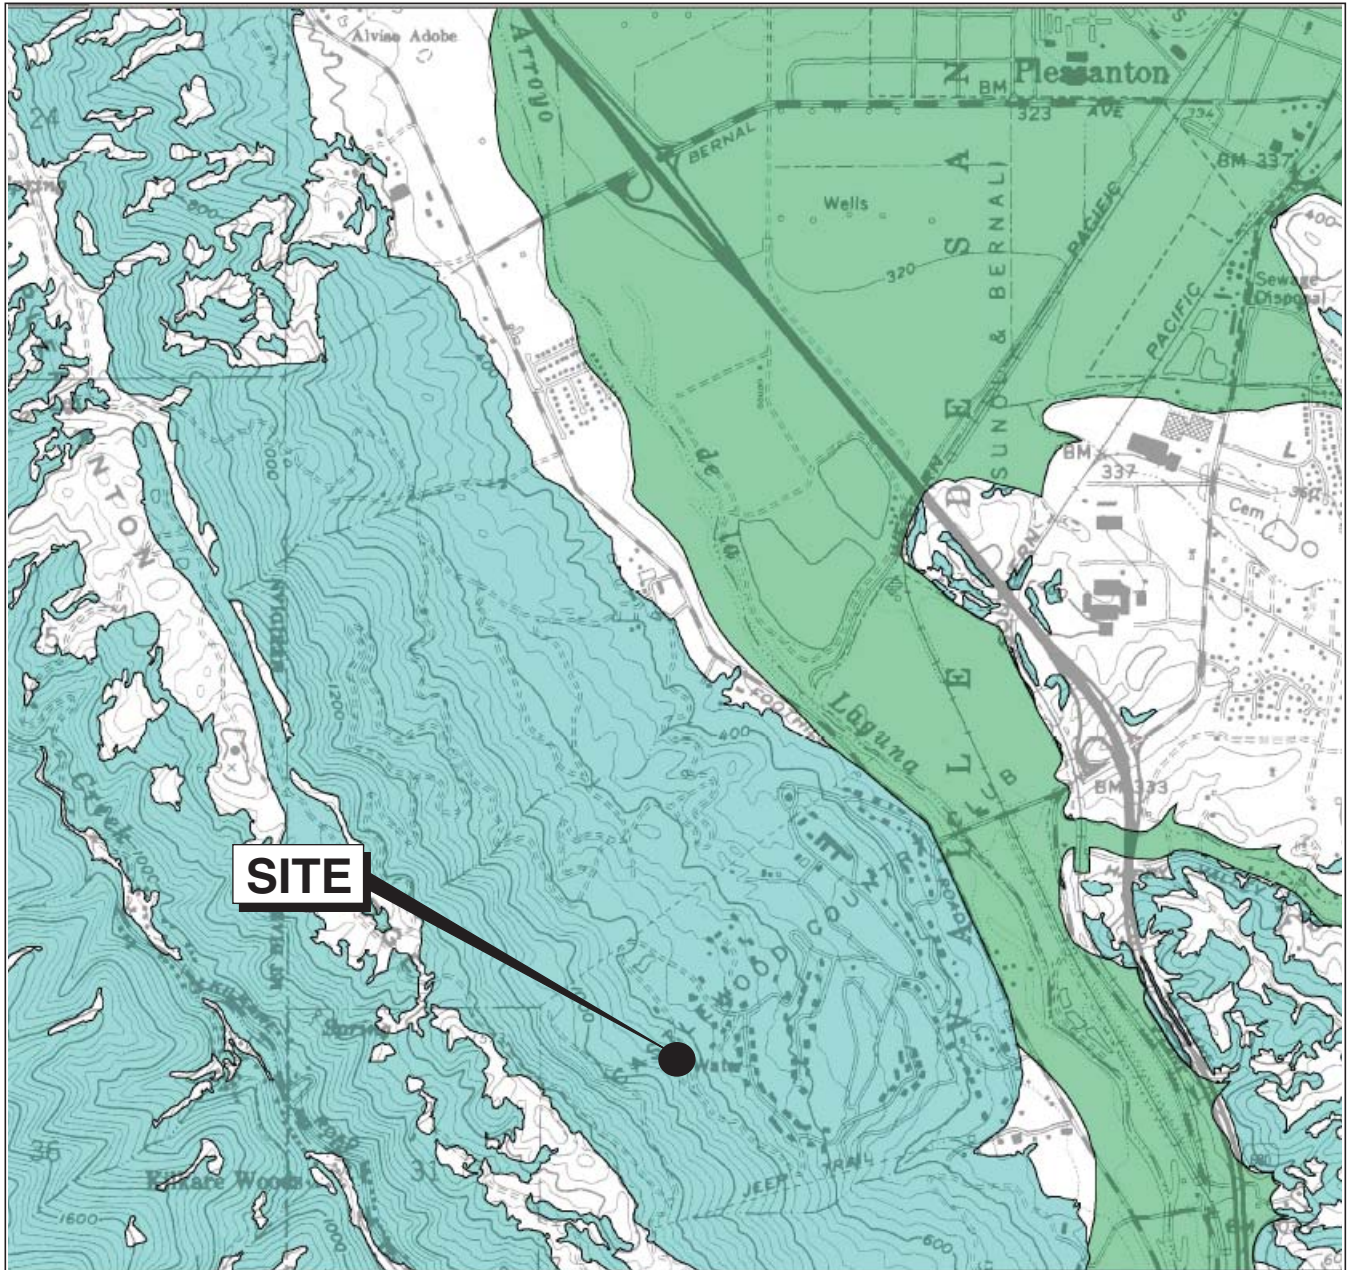
Figure 6

Reference:
 State of California, California Geological Survey "Seismic Hazard Zones" Dubin Quadrangle, August 27, 2008.

- Zone of Liquefaction
- Earthquake-induced Landslides

Due to the presence of shallow bedrock at the tank site and the depth of groundwater (47 feet BGS according to boring CSA/SD-4), we conclude that the potential for liquefaction to occur at the site to be very low. As shown on the Regional Seismic Hazard Zones Map, Figure 6, in Appendix A, this is consistent with the seismic hazard mapping by the California Geological Survey (CGS) for the Dublin quadrangle, which shows the tank site outside the zone of potential liquefaction.

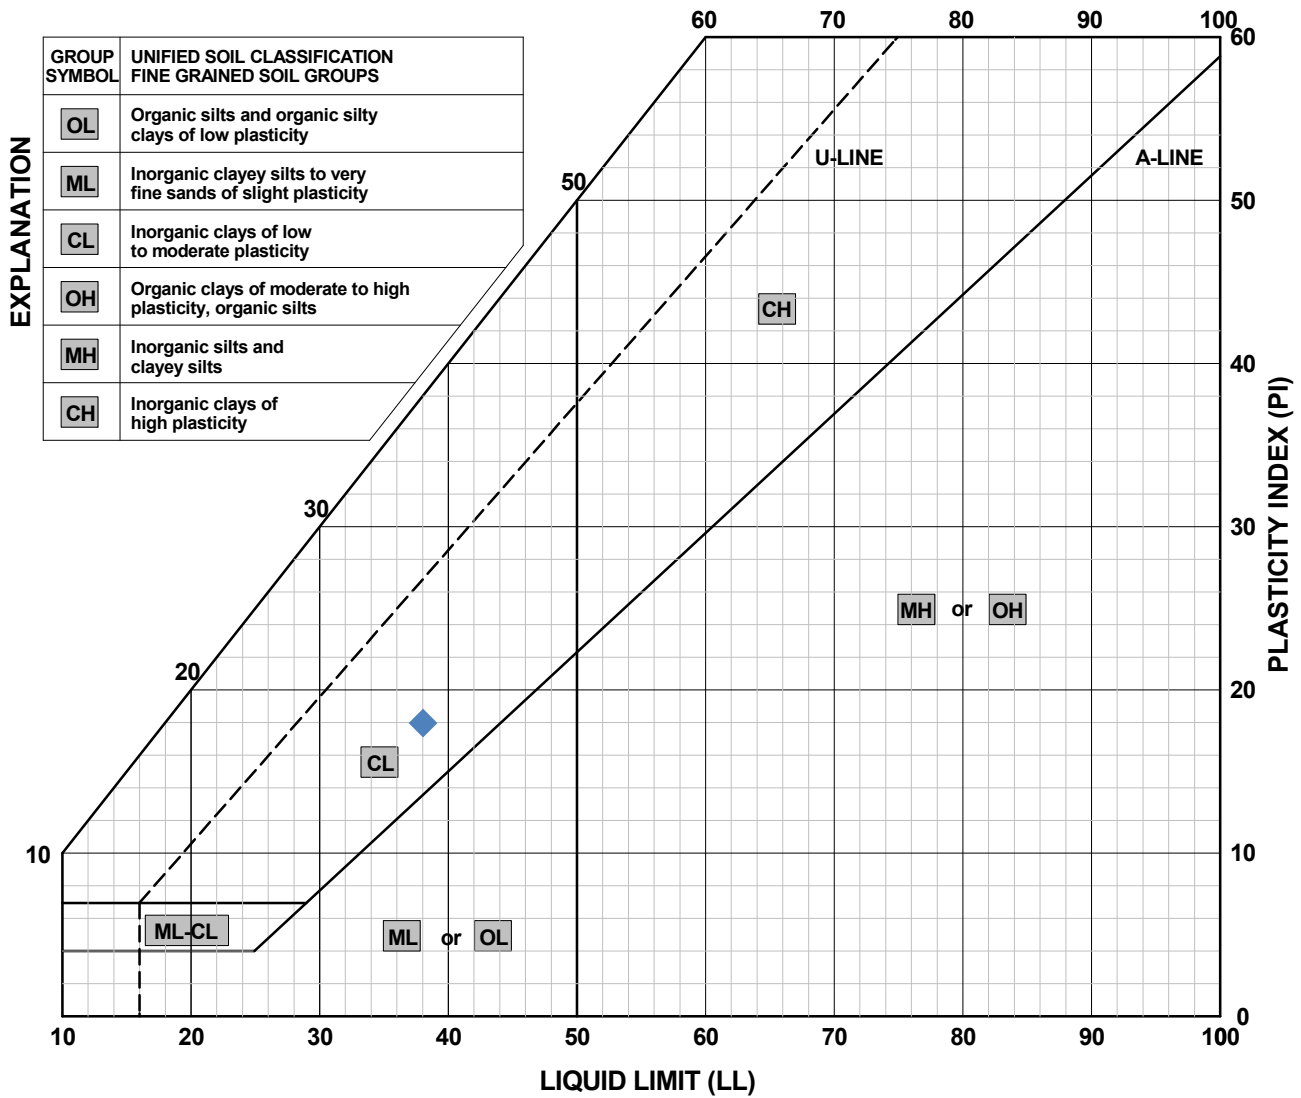
LEGEND:	SOURCE	DEPTH (ft)	LL	PL	PI	DESCRIPTION
◆	S-2	1.0	38	20	18	Olive Brown Clayey Sand with Gravel (SC)

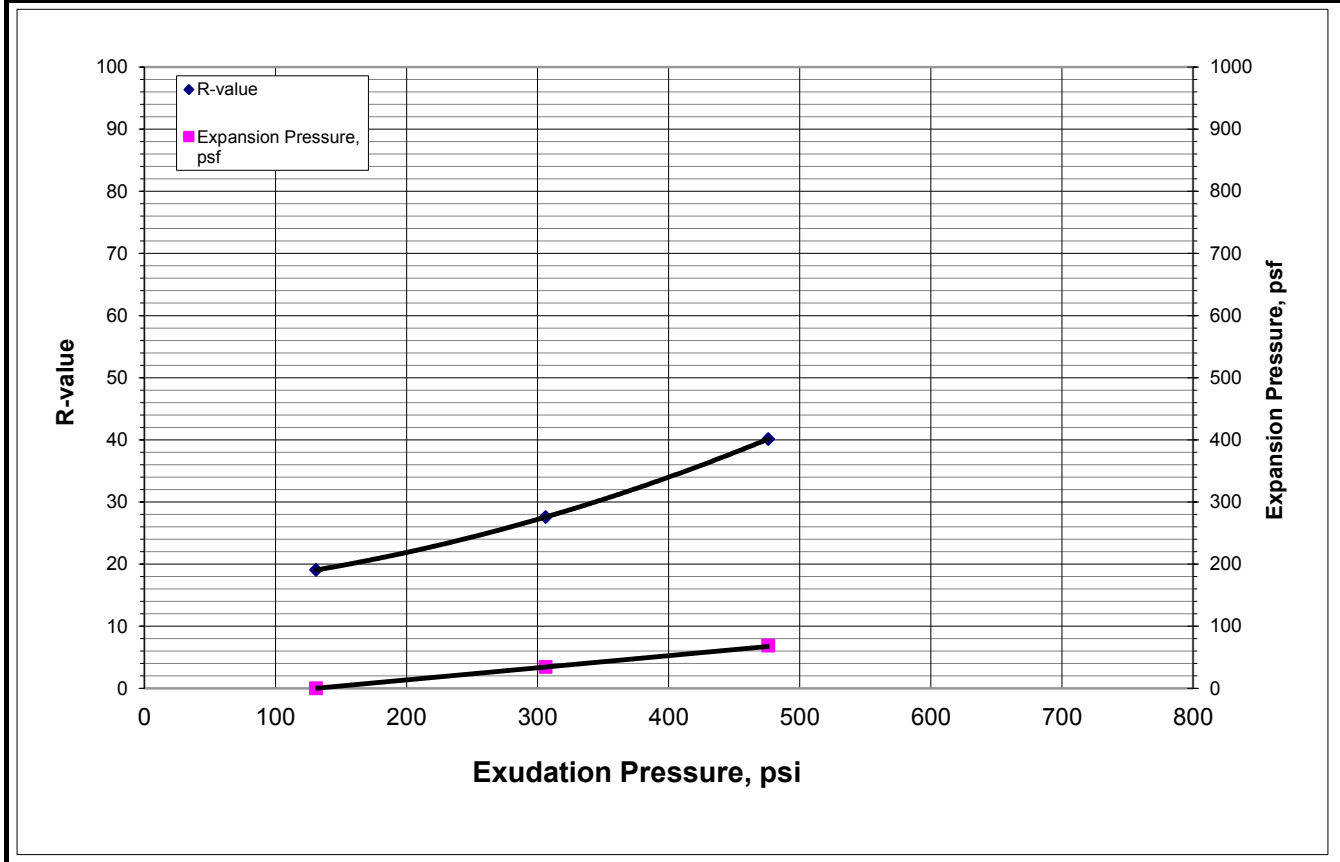
Job No.: 664-068	Date: 04/13/16	Initial Moisture, 16.5%
Client: BSK Associates	Tested MD	R-value by Stabilometer 27
Project: G16-062-11L	Reduced RU	Expansion Pressure 35 psf
Sample S-1 @ 0-1'	Checked DC	
Soil Type: Olive Brown Clayey Sand (SC)

Specimen Number	A	B	C	D	Remarks:
Exudation Pressure, psi	131	306	476		
Prepared Weight, grams	1200	1200	1200		
Final Water Added, grams/cc	70	35	10		
Weight of Soil & Mold, grams	3060	3000	3133		
Weight of Mold, grams	2106	2098	2098		
Height After Compaction, in.	2.5	2.45	2.55		
Moisture Content, %	23.3	19.9	17.5		
Dry Density, pcf	93.7	93.0	104.6		
Expansion Pressure, psf	0.0	34.4	68.8		
Stabilometer @ 1000					
Stabilometer @ 2000	120	106	90		
Turns Displacement	3.54	3.2	2.9		
R-value	19	28	40
